**An Archaeological Evaluation, Land at Former Sittingbourne Mill (Phase 2),
Sittingbourne,
Kent.**

**ASE Project No: 170107
Site Code: SIT17**

ASE Report No: 2017194

By Jake Wilson

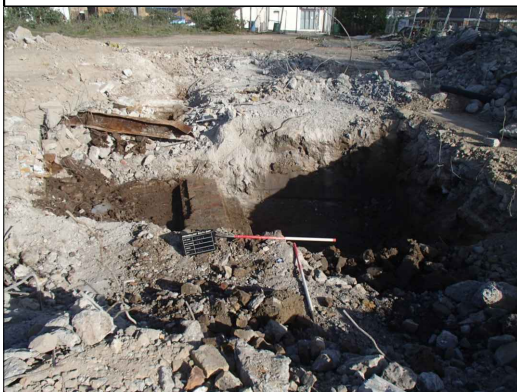
Trench 1 looking north

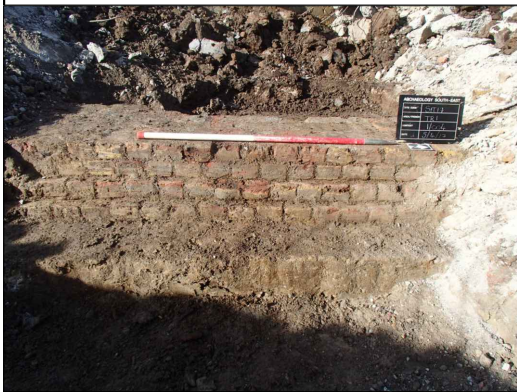
- 4.2.1 Trench 1 was located on a northwest-southeast alignment and measured 10m x 5m in length. A single northwest-southeast wall [1/004] was observed beneath two layers of made ground and the concrete slab surface [1/001]. The natural comprised a superficial clay head deposit with fragments of chalk [1/005].

Wall [1/004] looking west

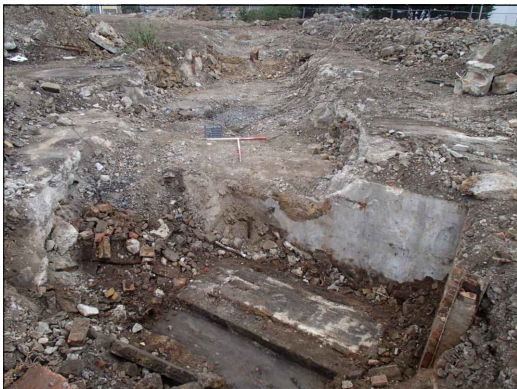
4.3.1 Trench 3 was located on a north-south alignment and measured 30m x 5m in length. Multiple walls were observed beneath a single layer of made ground and the concrete slab surface [3/001]. Large concrete foundations covered most of this trench. The natural [3/016] comprised a superficial clay head deposit with fragments of chalk.

Trench 3 looking north

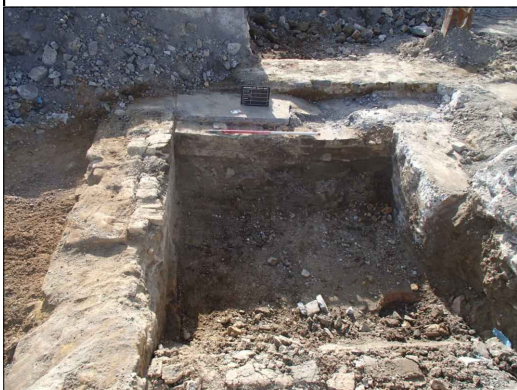
- 4.3.4 Between walls [3/003], [3/004] and [3/005] another made ground deposit was observed which was composed of a firm black-brown silt clay with frequent brick inclusion throughout [3/006].

- 4.3.6 A smaller course of bricks [3/005] also ran parallel to [3/004] though it was truncated by a large modern concrete foundation block at its southern end. It was made up of the same brick, coursing and bond as [3/003] and [3/004] which suggests a contemporary date. The wall's construction cut and associated backfill (contexts [3/014] and [3/015]) were imperceptible

Feature [3/003], [3/004] and [3/005] looking east

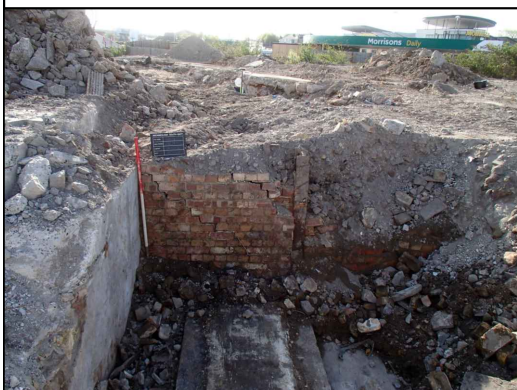
- 4.3.3 A northeast-southwest red brick wall, [3/007] was observed in the south of Trench 3. It was situated within construction cut [3/008] with imperceptible backfill [3/009]. It was built in English bond with irregular courses and was dated no earlier than 1927. This is the same brick type as wall [5/009], suggesting a phase of development in the early part of the 20th century. At its base was concrete floor [3/008], a raised platform built adjacent to wall [3/007].

Feature [3/007] looking east

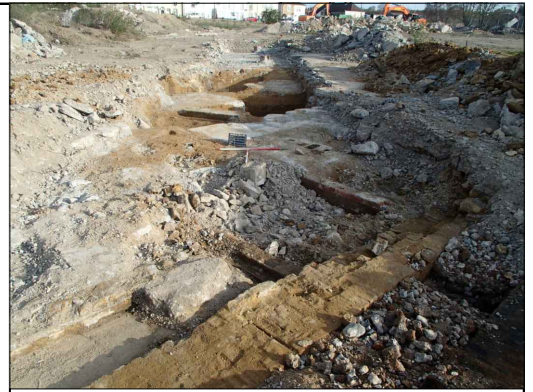
- 4.5.1 Trench 5 was located on a northwest-southeast alignment and measured 30m x 5m in length. Multiple walls were observed beneath two layers; a mixed building debris [5/001] and concrete slab [5/002]. Large modern concrete and steel foundations [5/005] were present in the majority of the trench. The natural [5/006] comprised a superficial clay head deposit with fragments of chalk.

Trench 5 looking north

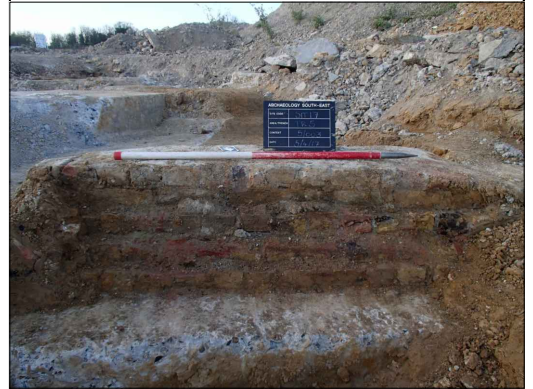
- 4.5.3 Wall [5/003] ran on a west northwest-east southeast alignment and was heavily truncated by two large concrete foundation blocks [5/005]. Comprised of yellow brick with regular coursing in an English bond the wall was stepped at its base leading down to concrete footing [5/011]. Its construction cut [5/016] and associated backfill [5/017] were imperceptible.

Feature [5/003] looking south

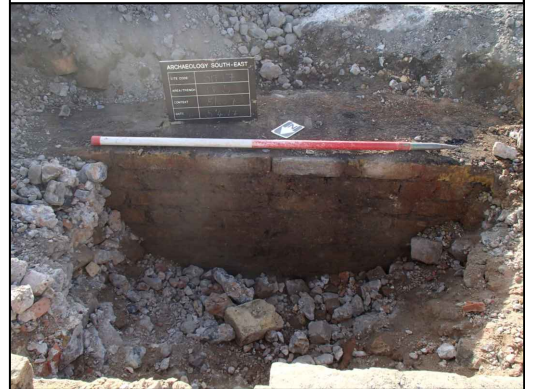
4.5.6 Another large wall [5/007] ran on a northeast-southwest alignment and parallel to [5/004]. Unlike the other brickwork in the trench [5/007] was built with dark red/brown bricks in an English bond with regular coursing. Possible scorch marks were also observed on the northern brick face. Samples taken date the bricks to the 18th century making it one of the earliest structures on site. Its slightly L-shaped construction cut [5/022] was backfilled by redeposited natural [5/023].

Feature [5/007] looking south east

- 7.4.5 The 18th century activity may relate to the 'Papper Mill', recorded on a map of Kent dated 1769 (www.canterburytrust.co.uk). The possible scorch marks noted on wall [5/007] which dates to this phase may be indicative of the reasons for some of the mill buildings abandonment/decline.

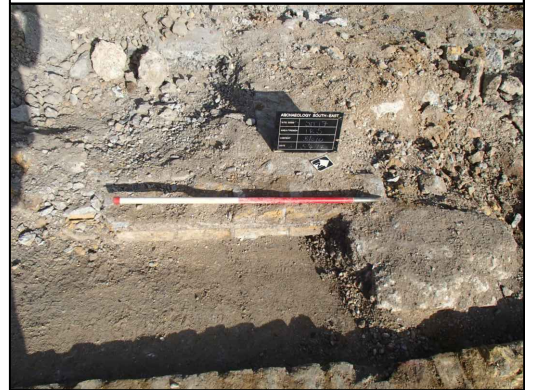
Feature [5/010] looking north west

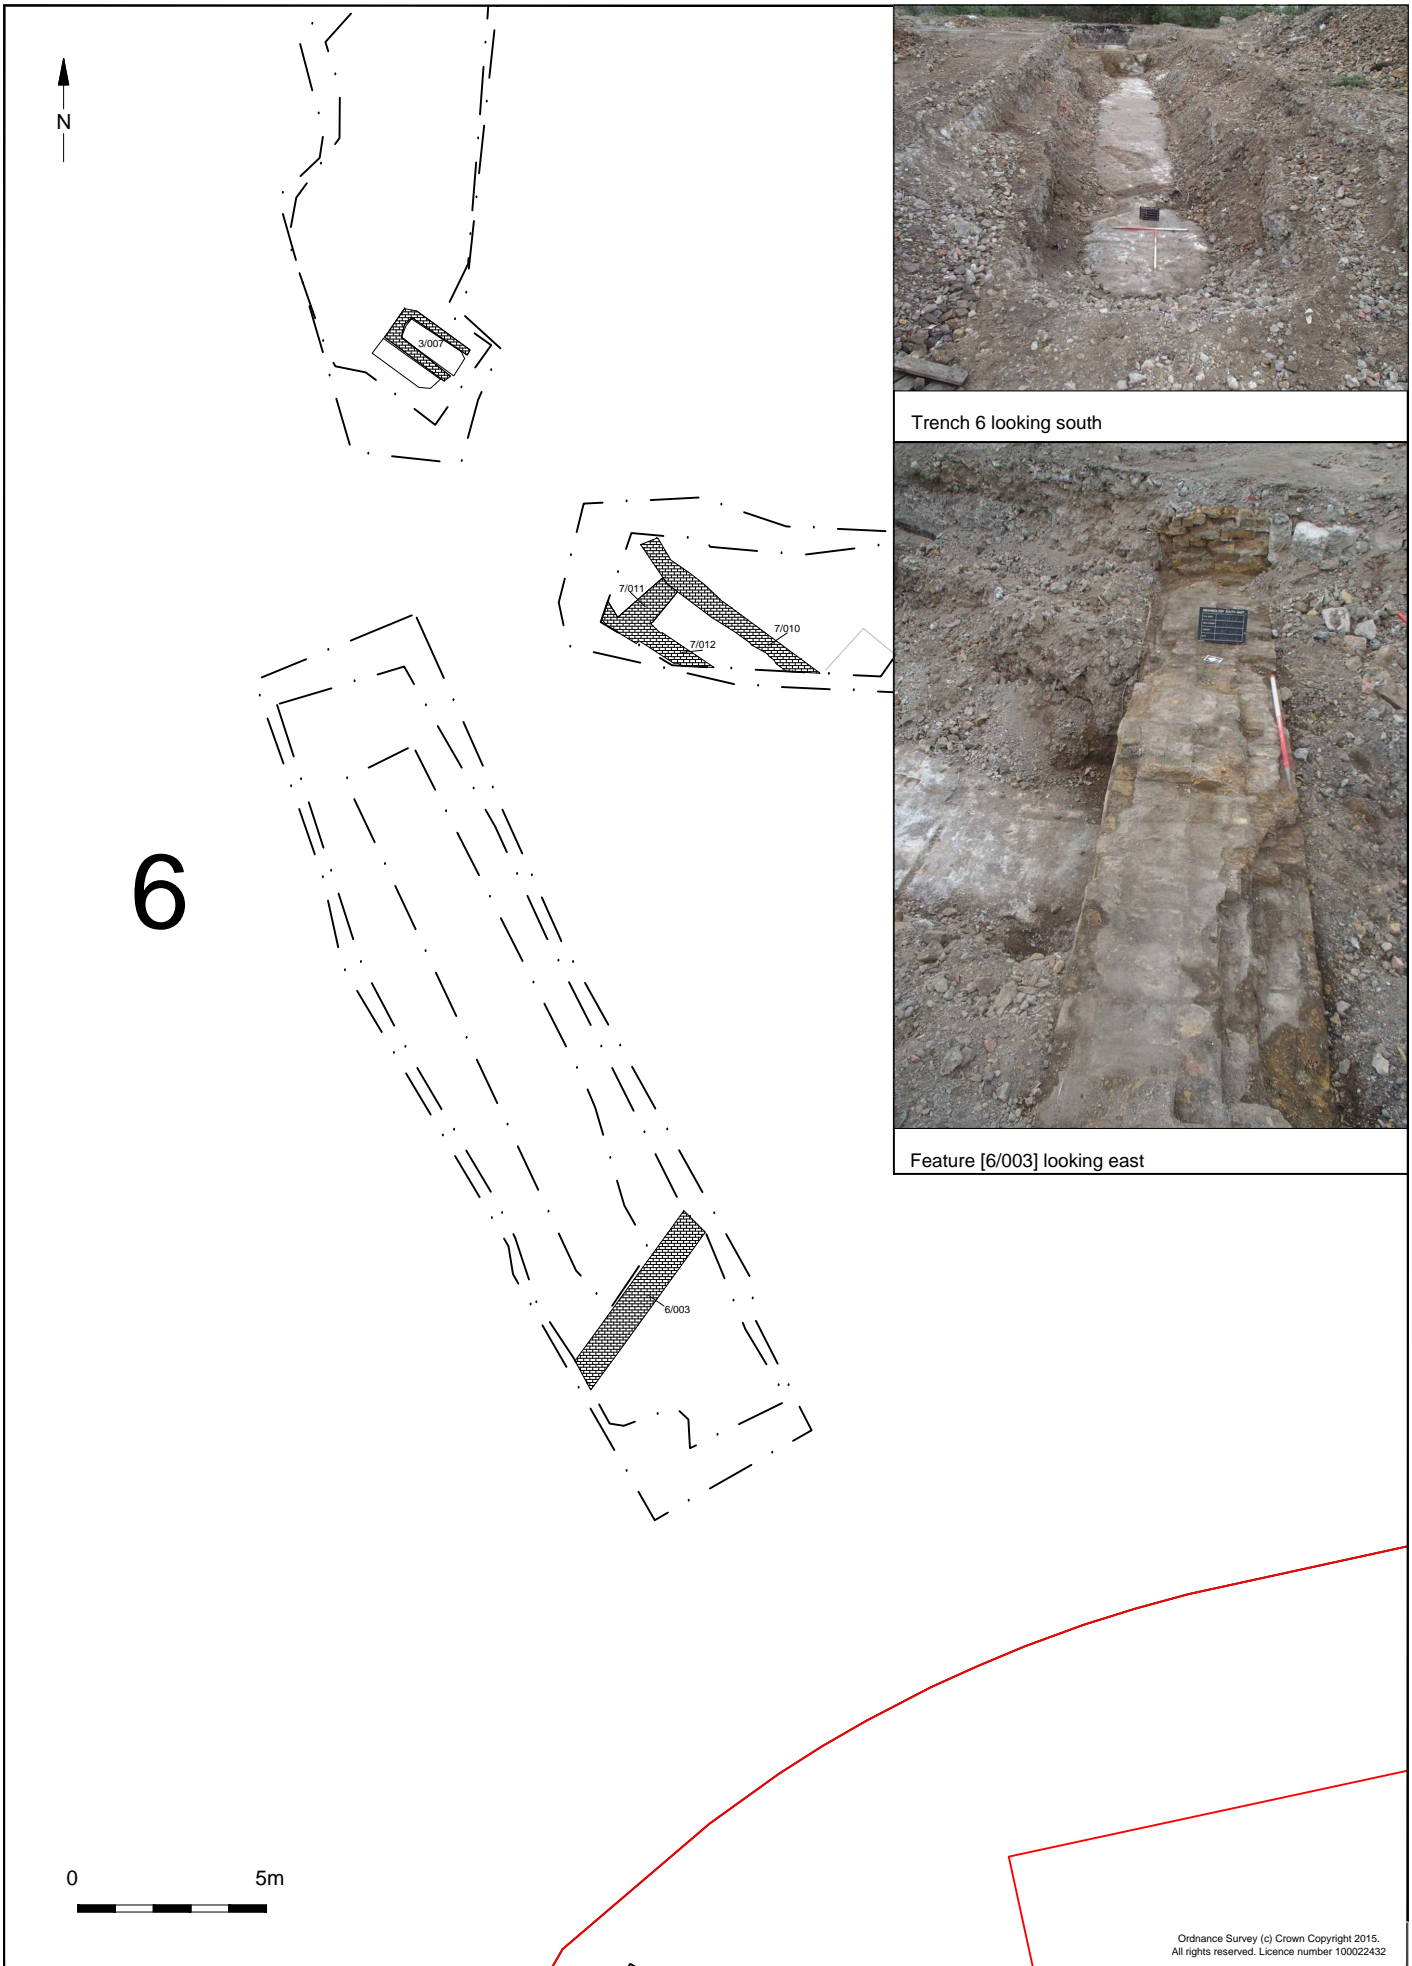
© Archaeology South-East		Former Sittingbourne Mill		Fig. 7
Project Ref: 170107	May 2017	Trench 6 plan and photographs		
Report Ref: 2017194	Drawn by: JC

4.6.1 Trench 6 was located on a northwest-southeast alignment and measured 30m x 5m in length. A single external wall was observed beneath two layers; a concrete slab [6/001] in the southern end of the trench and a layer of demolition rubble [6/002].

Trench 6 looking south

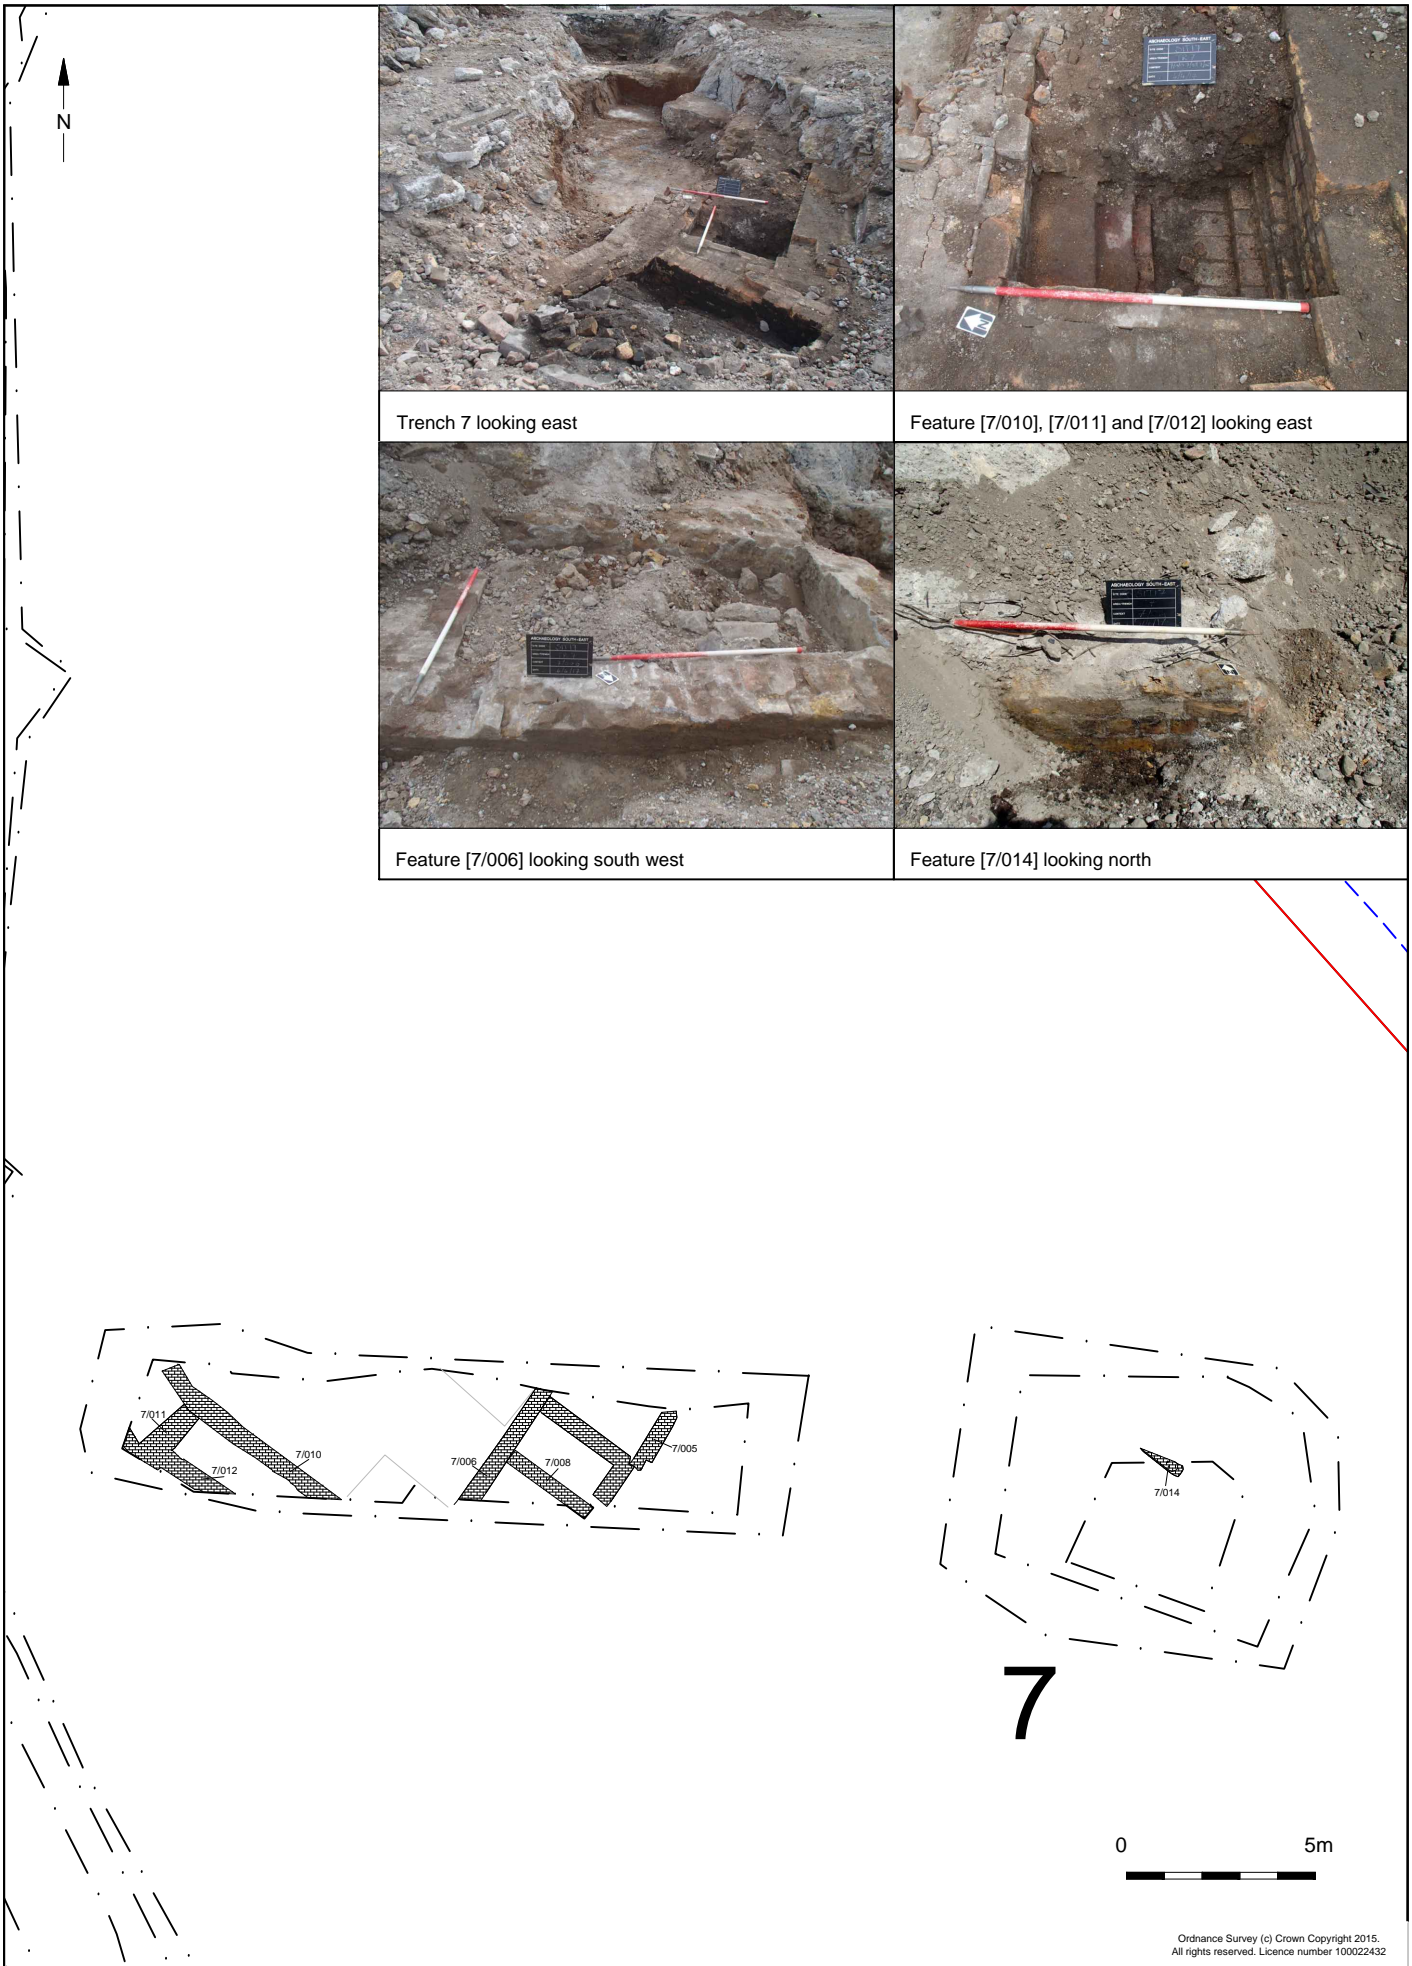
© Archaeology South-East		Former Sittingbourne Mill	Fig. 8
Project Ref: 170107	April 2017	Trench 7 plan and photographs	
Report Ref: 2017194	Drawn by: JC

- 4.7.1 Trench 7 was located on an east-west alignment and measured 30m x 5m in length, however, a break in the trench was necessary due to obstructions. Multiple walls and a possible flue were observed beneath two layers; a concrete slab [7/001] and a made ground layer of building rubble and concrete blocks [7/002] and [7/003]. [7/003] produced finds of post mid-19th century date.
- 4.7.2 At the western end of the trench a long chambered structure, possibly a flue or the base of a large chimney, was observed running on a northwest-southeast alignment. Consisting of three firebrick structures. [7/010] and [7/012] ran parallel with each other while stepping inwards to form a 'V' shape. Both were constructed with red brick in regular courses in an English bond.

- 4.7.5 Wall [7/006] was a large northeast-southwest running (possibly) external wall which formed a sub-square structure in the centre of the trench. Comprised of yellow brick in regular courses with an English bond it was similar to a large amount of brick structures on site, a layer of dark grey cement render [7/0007] was also observed coating the wall. Brick sampling of [7/006] provided a date between the mid-late 19th century until the early-mid 20th century. Its construction cut [7/017] and associated backfill [7/018] were imperceptible.

- 4.7.8 In the west of Trench 7 a possible floor surface [7/013] was observed covering the majority of the trench which lead into [7/010] and [7/006]. Comprised of a hard black, demolition material it is possible that it was a later phase of construction within the mill complex.

- 4.7.9 A heavily obscured wall on a northeast-southwest alignment was also observed in the section to the west of the break within the trench. [7/016] comprised of yellow and red brick in regular courses with an English bond. Sampling of [7/011] and [7/010] provided a date between the mid-late 19th century until the early-mid 20th century. The construction cut for [7/016] was not seen.

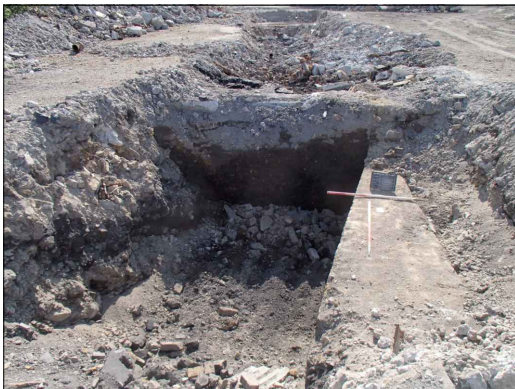
4.8.1 Trench 8 was located on a northwest-southeast alignment and measured 30m x 5m in length. Multiple walls and a plinth were observed beneath a concrete slab [8/001] and a mix of rubble, building debris and concrete [8/002]. Large modern concrete and steel foundations were present in the centre of the trench.

Trench 8 looking south

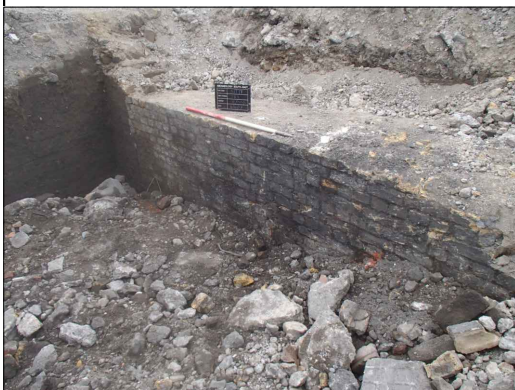
4.8.3 The deposit between walls [8/004] and [8/005] differ from the rest of the trench and made ground [8/002]. This was comprised of dark silty clay demolition rubble [8/003] with frequent inclusion of brick throughout. At the bottom of this deposit, a hard surface [8/006] was observed though no further work was taken to investigate it due to the depth the feature was encountered at.

Feature [8/005] looking south west

- 7.3.8 The other significant area of the mill was in Trench 8 and the location of the millpond. The area of the pond has been well documented from 1865 onwards to 1974 on the OS maps and upon excavation, a large retaining wall [8/004] and wedge shaped wall [8/006] were observed in the northern area of the trench. Both structures were likely part of a water channelling system that can be seen clearly on the 1938 OS map moving water from the southeast into the mill site (see Figures 16 and 19).

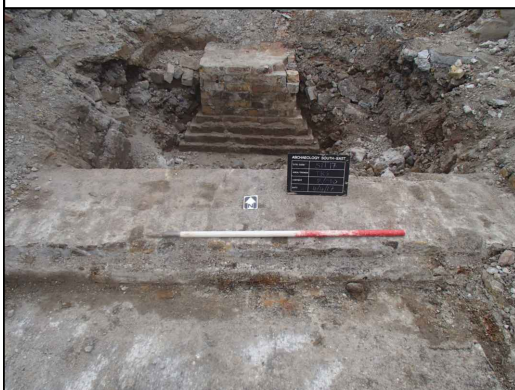
4.8.4 [8/007] was the base of a large plinth or pillar in the centre of Trench 8. It is possible that it was freestanding, though due to concrete foundations it was not possible to see the back of the plinth to confirm this. Constructed out of a mix of both yellow and red bricks it had an irregular coursing, which was most likely to accommodate the predetermined dimensions of the plinth. Brick sampling of [8/007] provided a date firmly in the mid-18th century marking it out as one of the earlier structures on the site. The base of [8/007] stepped down onto a large concrete footing [8/009].

4.8.5 A small heavily truncated east-west wall [8/010] south of [8/007] was observed higher than the plinth, [8/010]. It was comprised of yellow brick in regular courses in a Header bond. It appeared to be related to either [8/009] or [8/004] being roughly the same date. The base of [8/010] stepped down onto a large concrete footing [8/012] and sampling of the bricks has produced a date of late 19th-early 20th century. Its construction cut and associated backfill was not seen.

Features [8/007] and [8/010] looking north

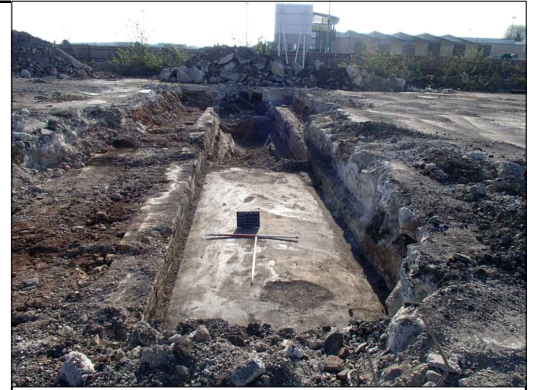
- 4.9.1 Trench 9 was located on a northwest-southeast alignment and measured 25m x 5m in length. Two parallel walls were observed beneath a layer of concrete slab [9/001] and a mixed layer of hardcore and crushed building material [9/002]. Large modern concrete and steel foundations were present in the northwest end of the trench.

Trench 9 looking east

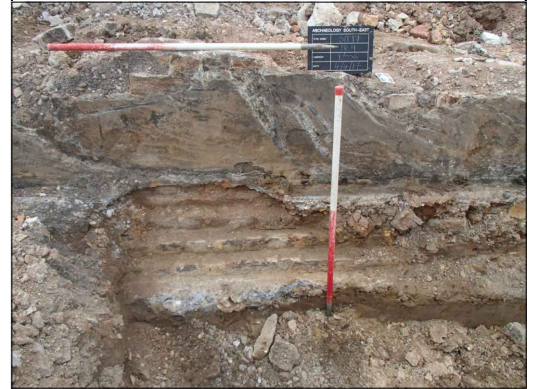
Feature [9/006] looking north

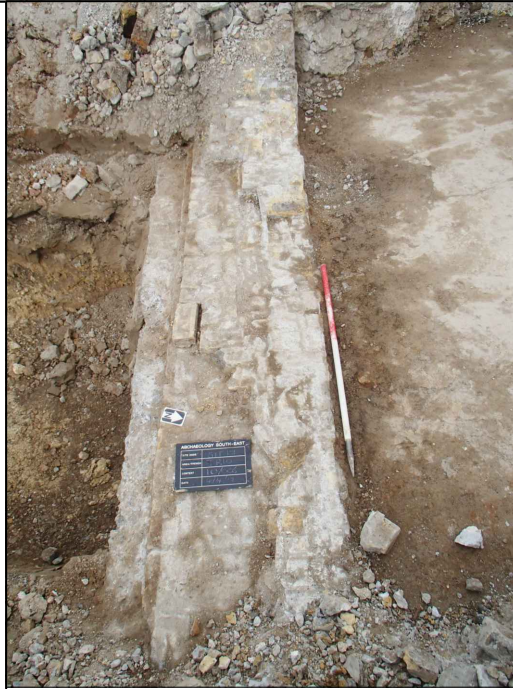
- 4.10.3 Wall [10/006] was a heavily truncated northwest-southeast aligned wall comprised of yellow brick in a Flemish bond with regular courses, a light grey concrete render [10/015] was also observed on its south facing side. At its base was concrete footing [10/005]. Sampling of the bricks has produced a date of late 19th-early 20th century. There was no sign of a construction cut or an associated backfill.

Feature [10/006] looking west

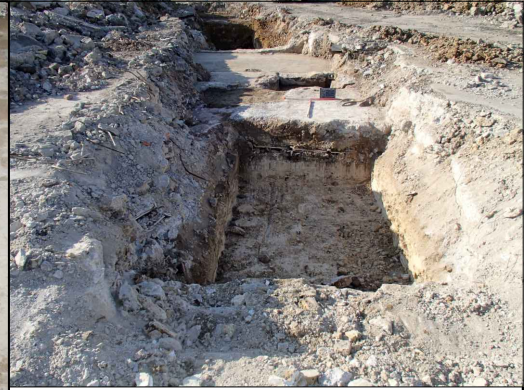
- 4.10.1 Trench 10 was located on a north-south alignment and measured 30m x 5m in length. Multiple walls were observed beneath two layers; a concrete slab [10/001] and a made ground layer of building rubble and concrete blocks [10/002]. The natural comprised a superficial clay head deposit with fragments of chalk [10/004].

Trench 10 looking south

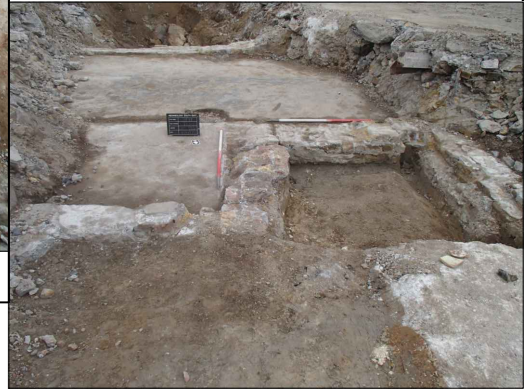
- 4.10.4 Four truncated and distinct walls were observed within the centre of the trench: [10/008] on a north-south alignment, [10/009] on a northwest-southeast alignment, [10/010] on a north-south alignment and [10/011] on a northeast-southwest alignment. Formed into a sub square structure it is possible all were contemporary with each other with sampling suggesting a date of late 19th-early 20th century. No concrete footings or construction cuts for these walls were observed due to the later inclusion of concrete surfaces [10/005] and [10/007]. All other walls were bare brick face except for [10/011], which was covered in a hard grey cement render [10/016]. All walls were built of either red or yellow brick with regular courses in a Flemish bond (where visible).

Features [10/008] to [10/011] looking south

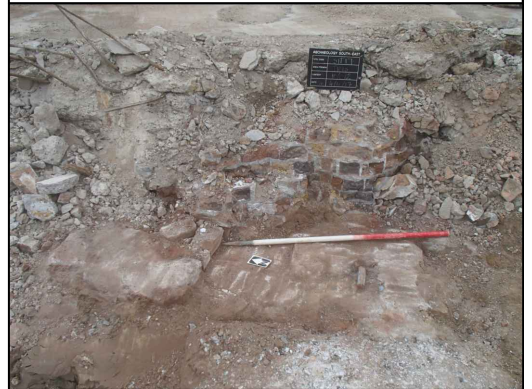
- 4.10.6 Wall [10/012] was a small, truncated wall on a north-south alignment observed in the trench section. Comprised of a red brick in regular courses in an English bond it is likely it relates to walls [10/008], [10/009], [10/01] and [10/011] or possibly an earlier phase of development in the south of the mill site. Brick sampling produced an earlier date of around the mid-18th century that suggests the latter option is more likely. No construction cut was observed.

Feature [10/012] looking east
