**Archaeological Watching Brief Report  
Deal Water Supply Works,  
St. Richards Road, Deal, Kent**

**NGR: 636356 150913  
(TR 36356 50913)**

**Permitted Development  
ASE Project No: 170616  
Site Code: EAL 17  
ASE Report No: 2017300  
OASIS ID: archaeol6-289164**

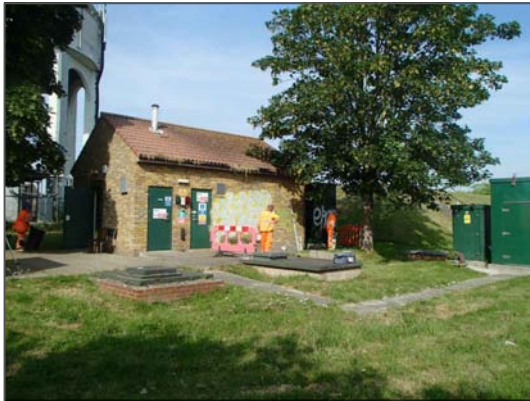
© Archaeology South-East		Deal Water Supply Works, St. Richards Road, Deal, Kent	Fig. 3
Project Ref: 170616	July 2017	Photographs of monitored work	
Report Ref: 2017300	Drawn by: AR

- 4.2.1 The recorded stratigraphic sequence was straightforward. It consisted of a mid-greyish brown silty clay topsoil/made ground, context [001], which directly overlay the 'natural' chalk, context [004], seen in a sondage within the excavation area. At the south-eastern end of the excavation area, the surface was a layer of reinforced concrete, context [002], laid on a sub-base of gravel, context [003] which overlay the topsoil/made ground, context [001]. The excavated area was heavily disturbed by the laying of services leading to and from the adjacent building, as well as by substantial roots from a nearby tree,

- 4.2.2 The absence of any subsoil layer and the depth of the topsoil/made ground strongly suggests extensive earthmoving/landscaping within the confines of the excavated area, and arguably of the works compound in general.

- 4.2.3 No archaeological features or deposits were encountered, and no artefacts were recovered from the topsoil.

general view of monitored area, looking south west

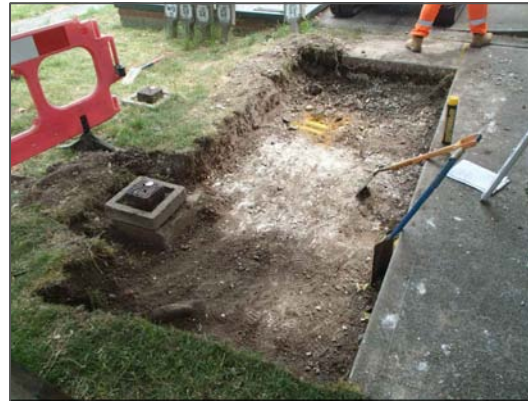
Excavation area, looking south east
