**8 GROVE HILL ROAD
ROYAL TUNBRIDGE WELLS, KENT**

Historic Building Record

**ASE Project No: 170486
Site Code: GHR17**

**ASE Report No: 2017389
OASIS id: archaeol6-295932**

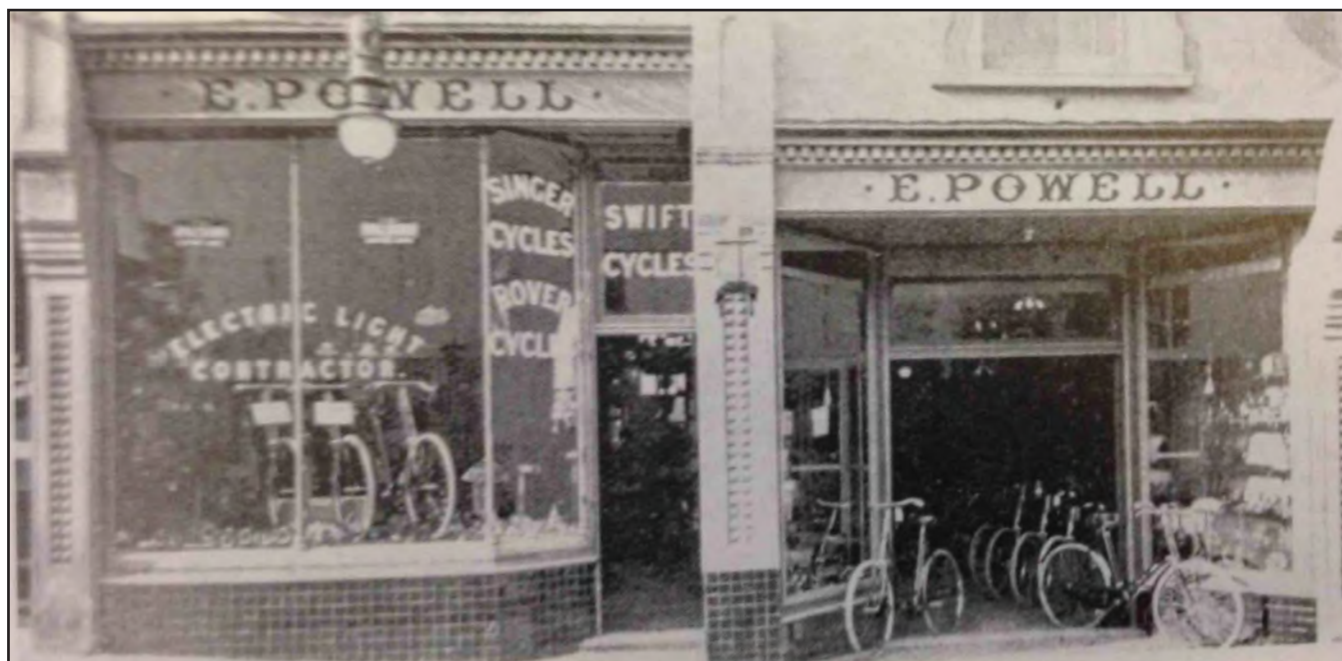
© Archaeology South-East		8 Grove Hill Road, Royal Tunbridge Wells, Kent	Fig. 8
Project Ref: 170486	September 2017	Ordnance Survey map of 1909	
Report Ref: 2017389	Drawn by: HS

- 5.7 The site remains relatively consistent on the Ordnance Survey map of 1909 (Figure 8), except for the construction of an additional outbuilding joining No. 12 to its pre-existing outbuilding. No. 8 remains unchanged. A pair of historic photographs show the site at this time as viewed from Grove Hill Road. The first photograph (Figure 9) was taken in 1907 and is of Nos. 10 and 12, which was occupied at this time by Edwin Powell, electrical, motor and cycle engineer. The shop front displays, complete with set-back glazing, nail-head moulded pilasters and console detailing are similar to those viewed on the existing frontage of No. 8. The second photograph (Figure 10) gives an oblique view of the street frontages of all the site structures as viewed in 1911. Particularly notable is the north elevation of No. 8, which together with No. 6 forms a pair of matching gables each with oculus detailing. It also shows shop signage, which is useful in identifying that by this date, the front part of No. 8 was in use as a shop.

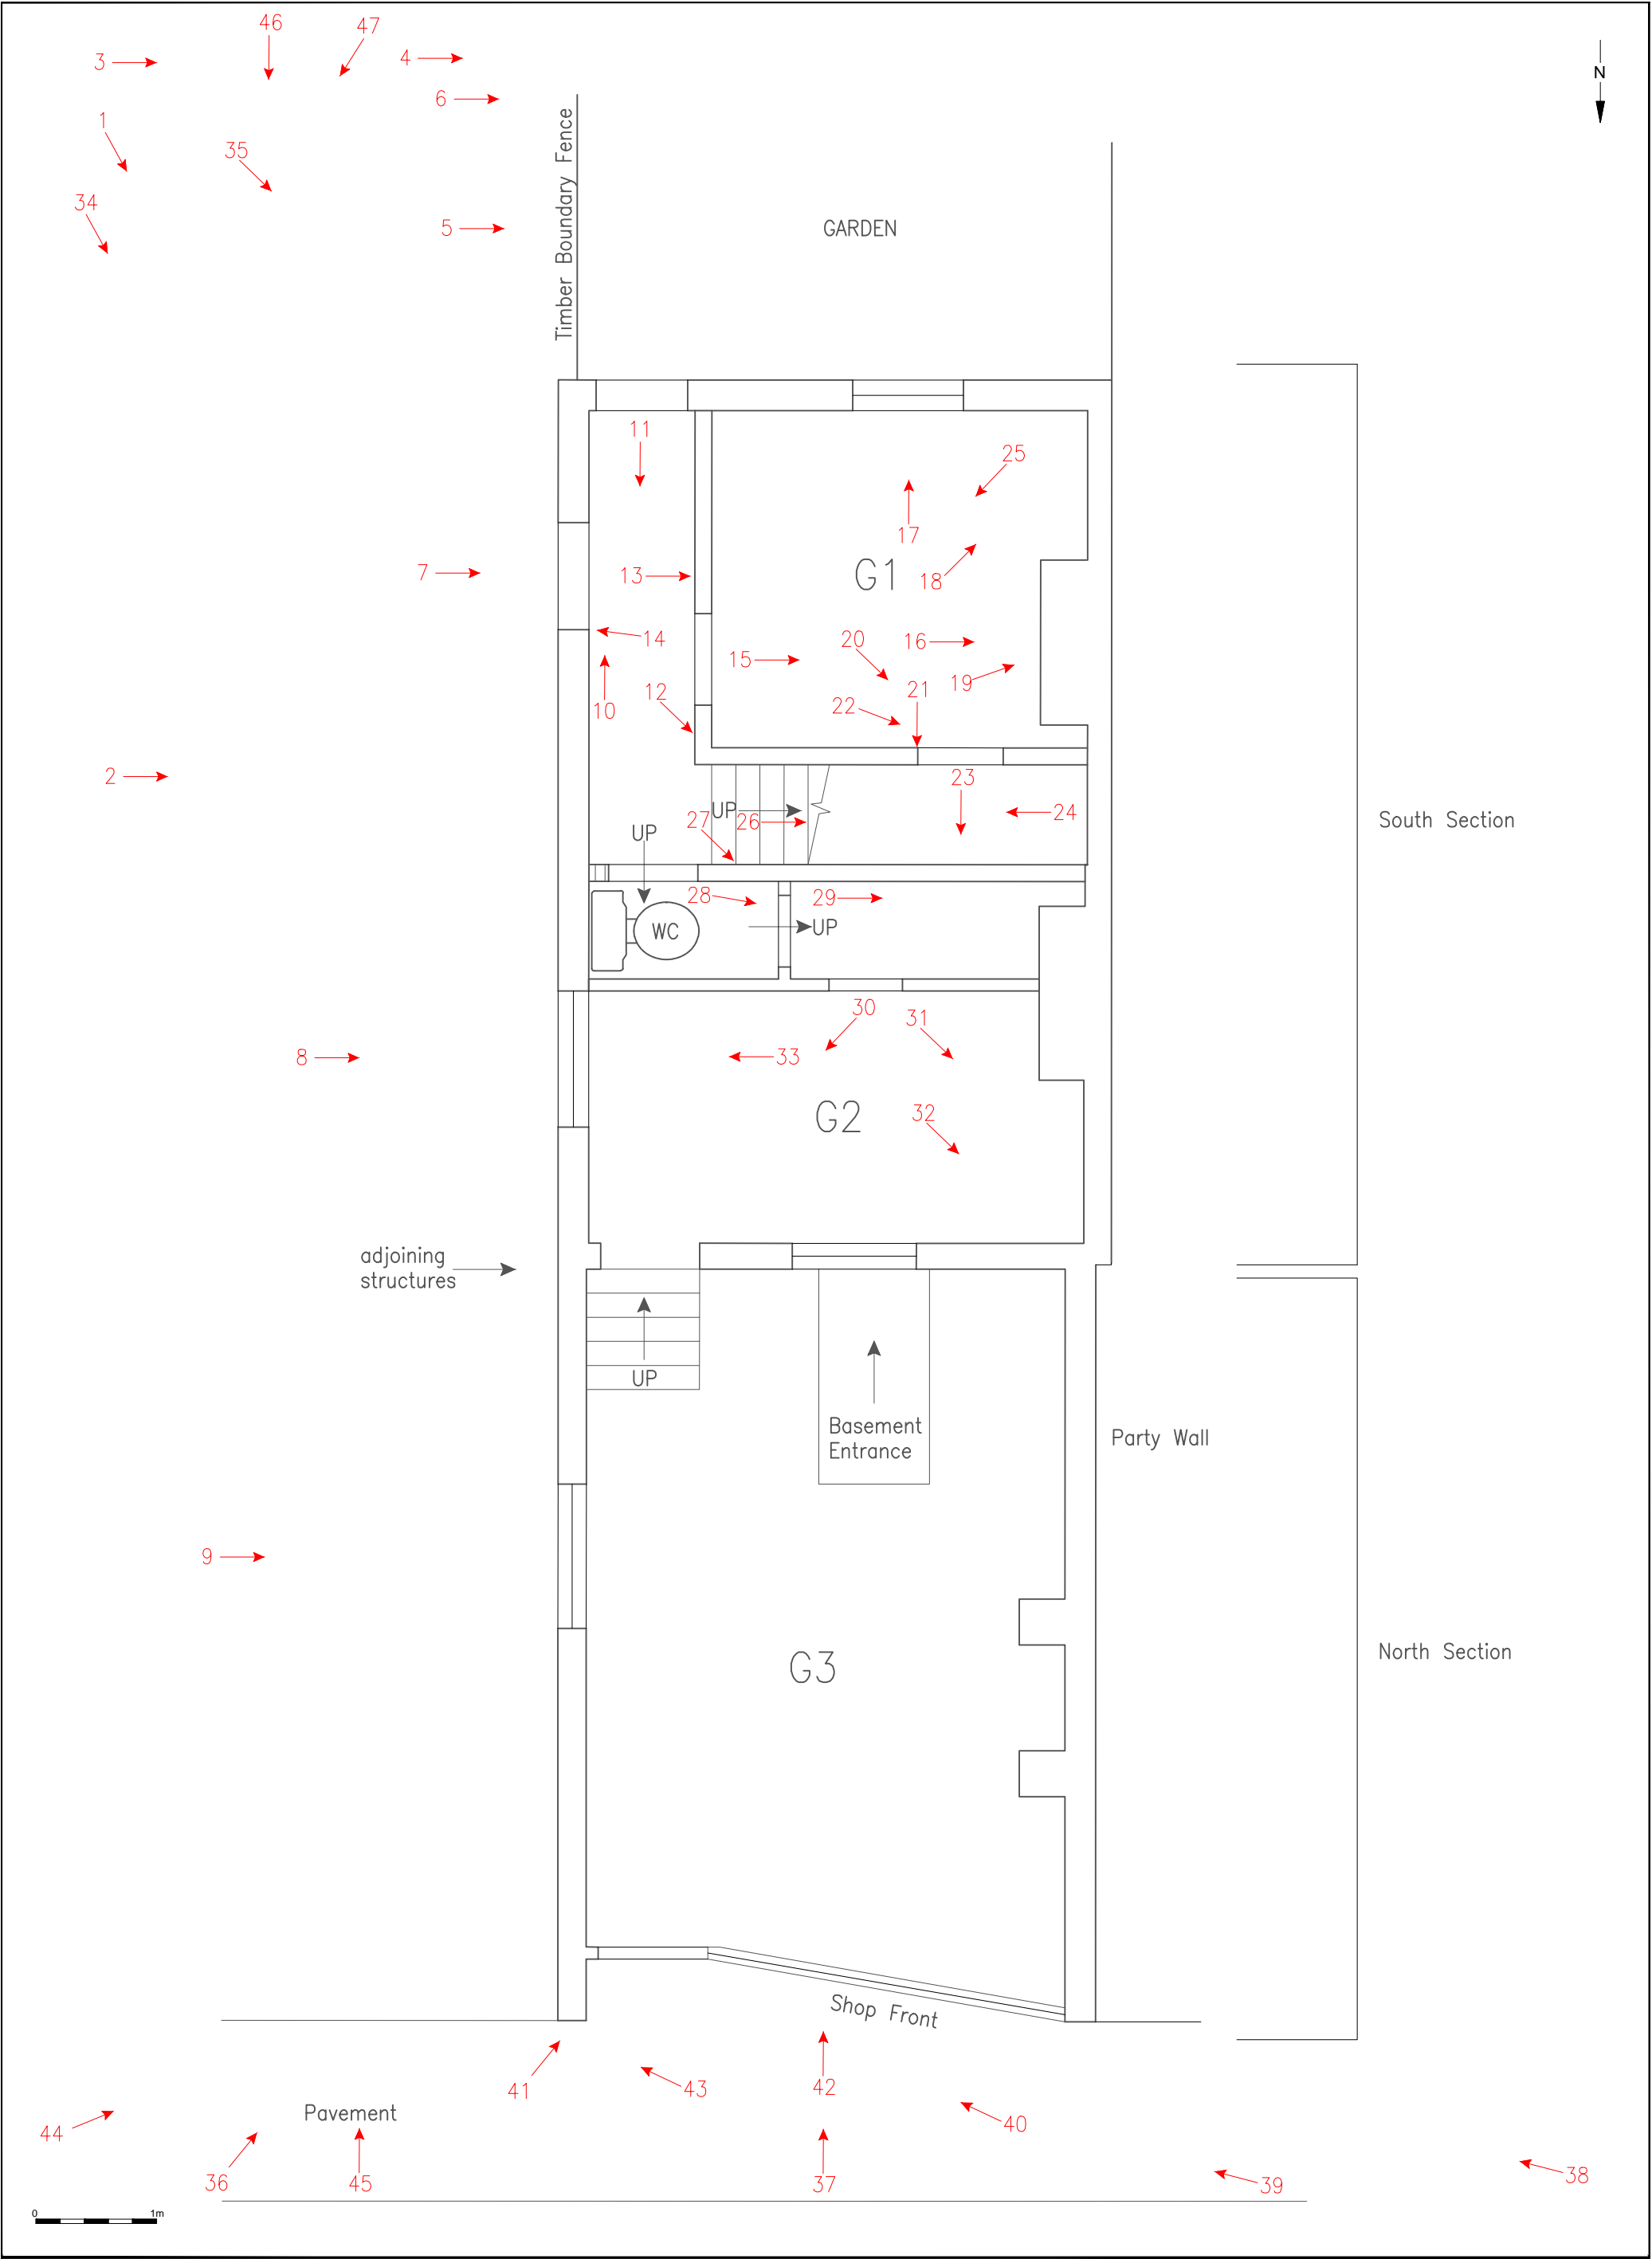
© Archaeology South-East		8 Grove Hill Road, Royal Tunbridge Wells, Kent	Fig.14
Project Ref: 170486	September 2017	Existing ground floor plan (scale 1:50)	
Report Ref: 2017389	Drawn by: HS	(Source: vkhp-consulting 2011; Ref.804611/01)

- 6.9 Internally the building is divided into north and south sections (Figure 14). The north section comprises retail space to the front of the building (G3) and a single room above at first floor level (F3). The south section comprises a single room to the north (G2) which has been partitioned on its southern side to a house a small WC. This room has been joined to the north section via a single doorway within the north wall, served by a small flight of steps to accommodate the change in floor levels. Below this room is the basement (Figure 15), accessed via a former stairwell beneath the suspended timber floor of the retail space to the north. The rear area of the southern section comprises an access corridor served by the east and south entrances, which provides access to a staircase to the first floor, a single living room with understair cupboard (G1), and the WC. The first floor was inaccessible during the time of the visit due to safety concerns, however floor plans provided by the client (Figures 16) indicate that when the plans were produced in 2011 the south section comprised two equally sized rooms (F1 and F2) both served by the central staircase. The room to the north (F2) had been subdivided with the insertion of a lightweight stud partition to create corridor access to the room situated above the retail space (F3) located within the north section of the building. The rooms were each heated by a fireplace situated against their western walls. The creation of the corridor to the north section, had resulted in the separation of the fireplace originally serving F2 from the remainder of the room.

- 6.10 The south section of the building comprises the earliest part of the structure, with both cartographic and constructional evidence dating it to the early 19th century (c. 1839). The principal entrance to this part of the building is situated within the east elevation. This opens out into the north – south aligned access corridor (Plate 4). The corridor floor has been stripped to expose the bare ground below and is set significantly lower than the external ground level. Regularly spaced brick sleeper walls set upon the ground originally supported a timber board floor above, fragments of which can be seen at the northern end of the corridor. The corridor has been created by the insertion of a timber studwork partition wall (measuring a width of 150mm) with lath and plaster coverings to the west. The adjacent wall to the east comprises plastered brickwork. All walls have multiple layers of wallpaper coverings, including the internal face of the door panels. The corridor terminates to the south with a ply-board doorway set within a relatively plain timber frame, which provides access to the garden and former rear lean-to (now demolished). A set of brick steps provide access to the rear doorway from ground level. The northern end of the corridor terminates with a plain internal doorway, only the frame of which remains *in situ*. Immediately to the west of the doorway is the staircase to the first floor, the opening of which is set within a plain slender timber frame, suggesting it housed a door at some point during the 20th century. South of the staircase is the inserted partition wall which houses a single doorway into the adjacent room. Nailed bare match-boarding covers the lower half of this slim section of wall (Plate 5), each board measuring between 110mm and 250mm. The doorway itself has lost its door but retains a timber sill and plain frame.

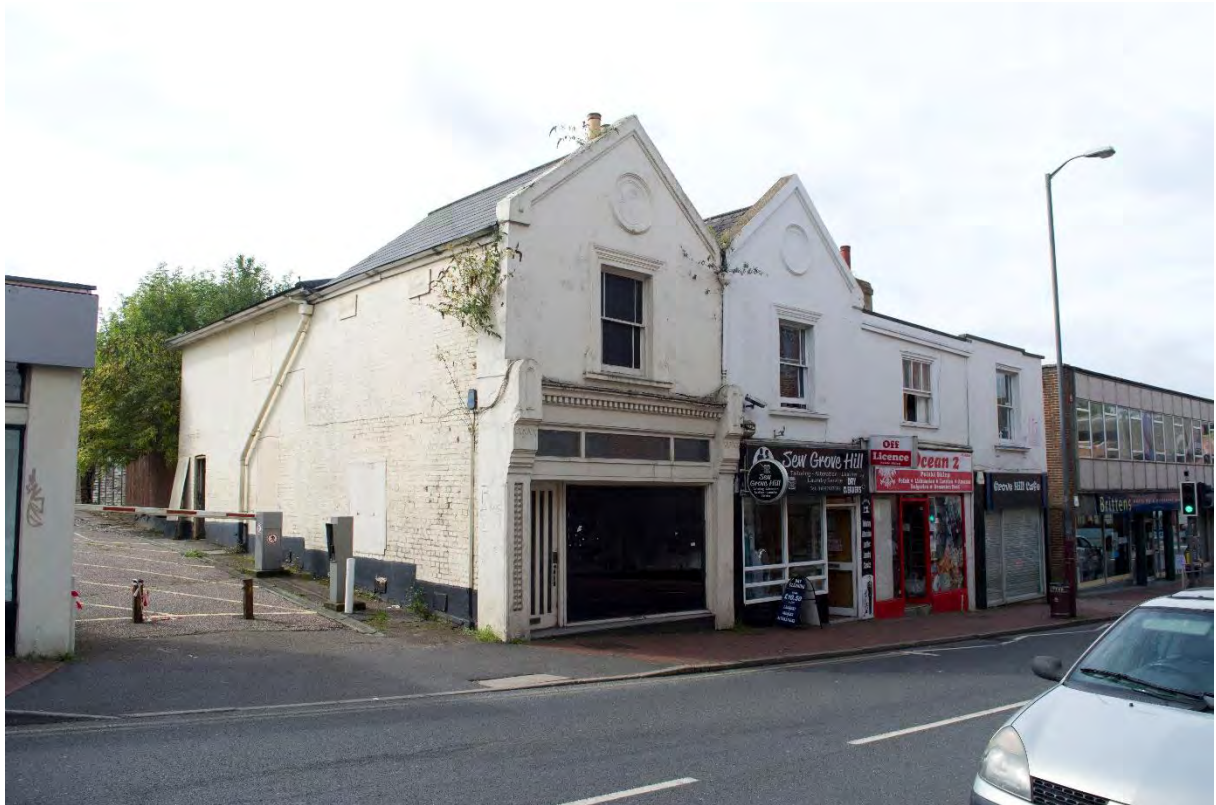
- 6.2 The principal (north) elevation (Plate 1) is cement-rendered and scored to imitate the appearance of ashlar masonry. It incorporates an original shop front at ground

floor level indicating the building's original purpose. The majority of the space is filled by a substantial full-height plate glass display window with transom light and an inset doorway. Both the window and doorway are modern, as is typical of shop fronts which are commonly the most vulnerable part of a shops architecture (Morrison 2003, 41). The display window is angled inwards towards the doorway which is situated to the east. Although the design is overtly modern, historic photographs of the neighbouring properties (Figure 9) indicate that they also had variations of inset plate glass displays, flush façades being an uncommon feature in shop front displays at least until the mid-/late 20th century (Morrison 2003 47). The photos illustrate the way the availability of relatively inexpensive sheet and plate glass by the 1850s and 1860s, had revolutionised shopfront design. Prior to this date, wholesale use of large glass panes would have been uncommon, with a preference for open fronts with cloth or shutters used as an alternative (Morrison 2003, 42).

Plate 1: View of the building's principal (north) elevation, facing south-west (36)

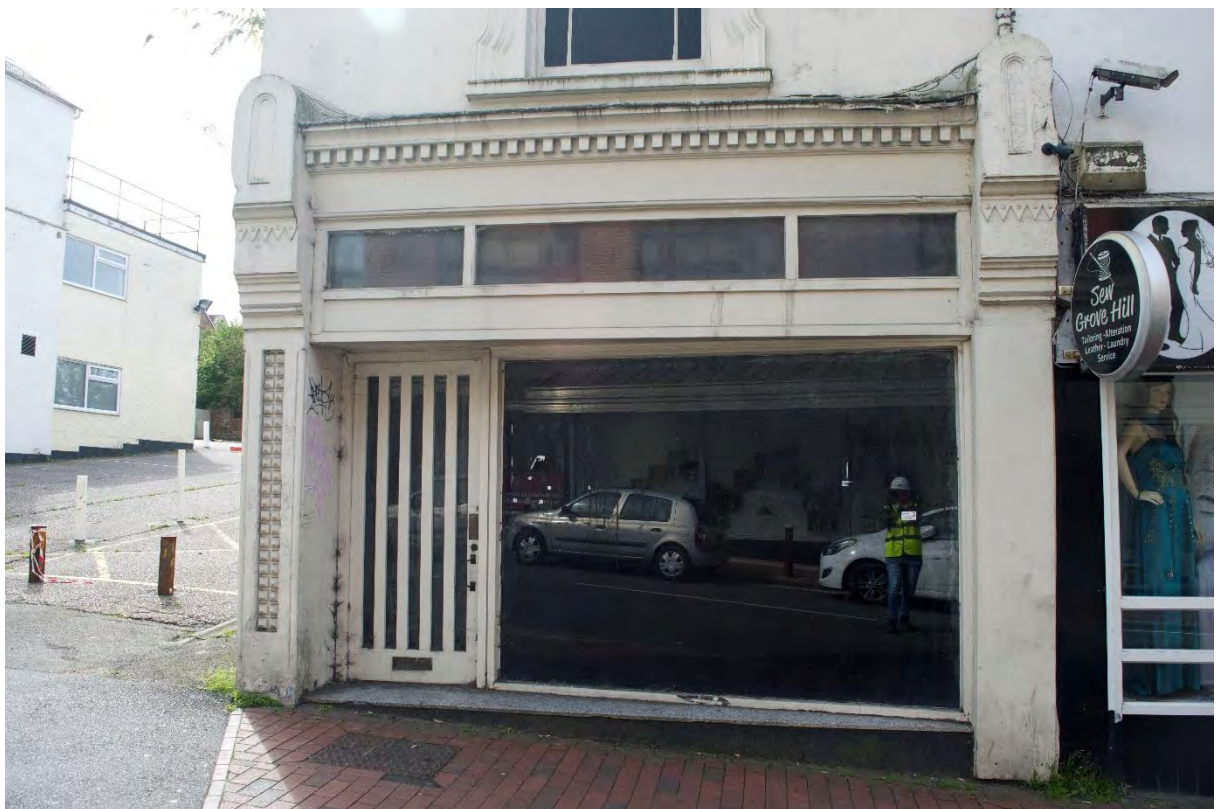
- 6.3 The display window (Plate 2) is set within cement-rendered pilasters, each decorated with bead-moulded edging and nail-head incision panels; the decorative panel on the western pilaster has been covered with modern ply-board. Both pilasters are topped with ornate consoles, decorated with arched-head incisions, and each are supported on stepped brackets displaying saw-tooth banner moulding. Above the modern transom light is a slender fascia topped by a cornice set with a continuous dentil relief. The architectural features are all characteristic of the mid-/late 19th century. Earlier shop-front designs post-dating the 1840s tended to favour 'the Palladian or Italianate styles but before long prominent classical columns were ousted by simpler pilasters, and full entablatures gave way to fascias that terminated in consoles.' (Morrison 2003, 49-50). Historic photographs of No. 10 and 12 Grove Hill Road (Figure 9) identify that the shop-front surround of No. 8 has stayed relatively consistent since the turn of the 20th century, with many features including pilasters, consoles and cornice detailing, mirroring that described. The neighbouring properties have used their entablatures as name fascias (in this case E. Powell), a common use after 1762 when a law was enacted in London prohibited the hanging of signs (Morrison 2003, 42). Despite this, a historic photograph of Grove Hill Road (Figure 10) clearly indicates the combined use of both name fascias and hung signs on both No. 8, and Nos. 10-12.

Plate 2: Detailed view of the building's shop front, facing south (40)

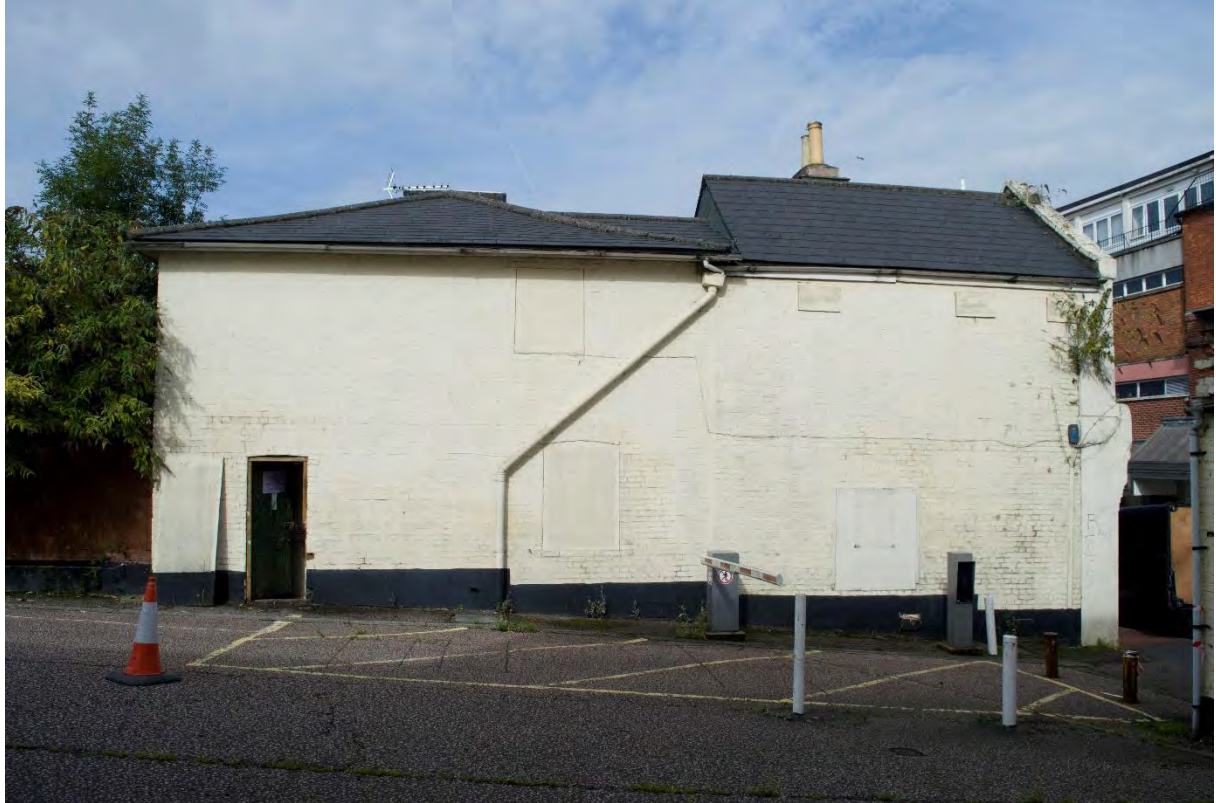
- 6.5 The building's east elevation (Plate 3) is constructed in painted English-bonded brickwork, the absence of render is typical on non-principal elevations and expected in this case due to the elevation's former outlook onto a narrow alley pre-1960. The building's phased construction is particularly evident on this side, as evidenced by a closed straight joint between the north and south halves of the structure. The straight joint matches the change in roof structures, in addition to a noticeable change in floor level, sloping to the north. The north half of the elevation has a single inserted window set off-centre to the south at ground floor level, with flush cement lintel. A series of narrow ventilation grilles have been additionally inserted at ground and eaves level. All openings form modern insertions as evidenced by the truncated surrounding brickwork, matched with cement patch repairs. It is likely that the window was inserted following the demolition of the terraced buildings to the east

c.1970s when additional natural light would have become available. The nature of the window and grilles is uncertain due to their external boarding.

Plate 3: General view of the east elevation, note the inserted window and door openings, facing west (2)

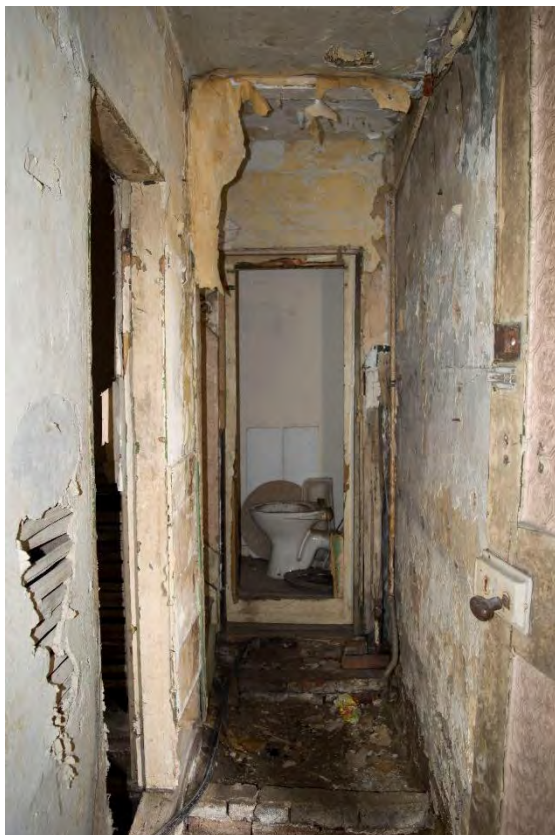
Plate 4: View of the north – south aligned corridor within the south section of the building, facing north (11)

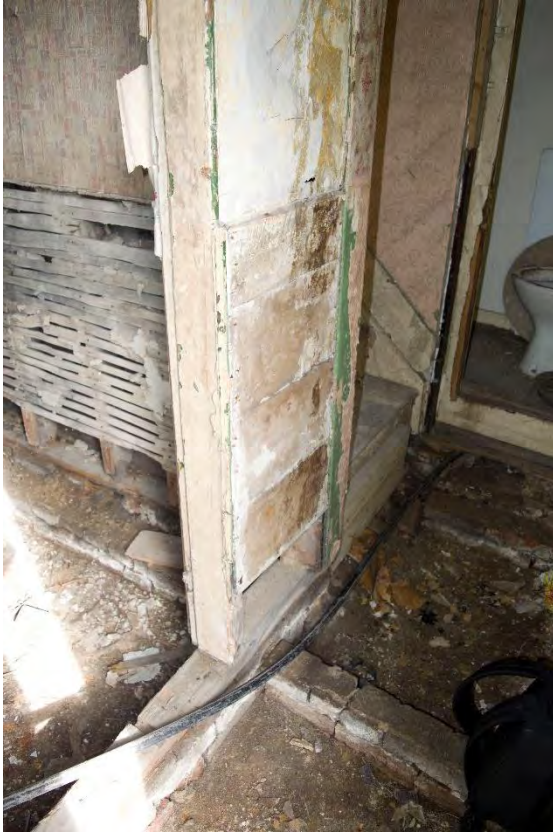
Plate 5: Detail of the match-boarding covering the partition wall to the west of the corridor within the south section of the building, facing north-west (12)

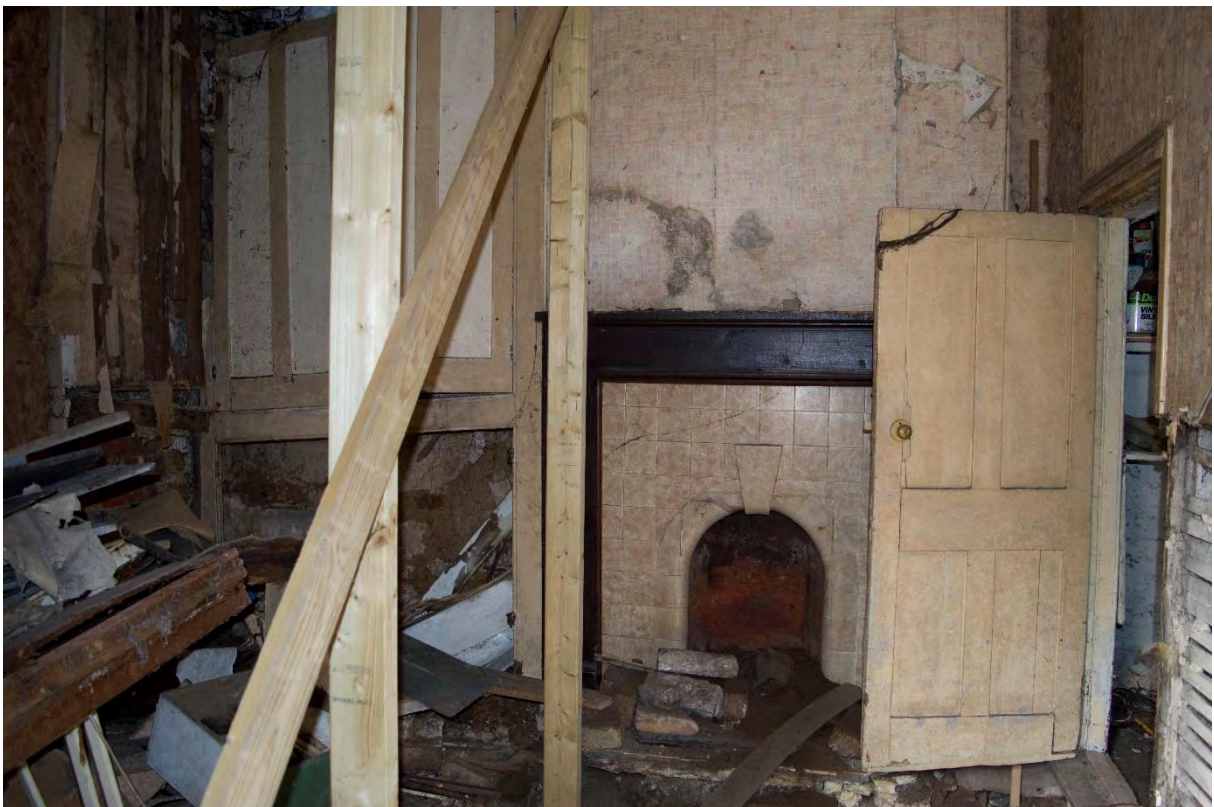
- 6.11 To the west of the entrance corridor is the remainder of what would have formed the original building's rear room (G1) (Plate 6). It has been sub-divided to accommodate the corridor along its eastern side, which was presumably done in conjunction with

the insertion of the eastern external doorway following the structure's expansion. It now forms a relatively small square plan. The floor has been stripped in a similar way to the adjacent corridor, but a small number of timber boards are retained within the north-west corner of the room. The ceiling comprises a lath and plaster covering, made visible due to failed sections of plaster. A modern softwood frame interrupts the central space and has been inserted to provide additional support to the floor above. A large window opening within the south elevation originally lit the room, this has now lost its window and is currently boarded. Framing the window are areas of retained vertically laid match-boarding terminating at a shallow projecting timber dado rail, areas of which have been covered with wallpaper. The lower half of the wall has been stripped but fragmentary plaster covering indicates its former finish. The remainder of the room is dominated by a large chimneystack against the west party wall (Plate 7). The fireplace comprises an early/mid- 20th century tiled surround with keystone detailing and rounded edging, with a 19th century cast iron inset and hearth. The mantle is of stained timber, relatively plain and dates to the mid-/late 20th century. Due to the location of the staircase, the chimneystack is set off-centre to the north. The southern alcove is filled with a fitted cupboard which appears early 20th century in nature with shallow bead-moulded trims and recessed panelling. Only the upper cupboard doors survive, the lower pair having been affected by rot and removed. The north wall comprises a timber stud partition with a lath and plaster covering (Plate 8) which encloses the staircase beyond. A single slender door at the west end of this wall gives access to an understair cupboard. The door comprises four recessed panels, each decorated with embossed wallpaper. The frame is slender with a moulded top, a notable feature includes a spring latch fixing (Plate 9), the style of which is characteristic of the 18th and early 19th centuries (Hall 2005, 59). The wall itself is covered with multiple layers of wallpaper on its upper half, the earliest of which has a hessian scrim underlayer which indicates a hanging process typically recorded from the 19th century onwards (Rosoman 2009). The lower half of the wall (not affected by stripping) is clad with vertically-laid painted match-boarding which terminates at the doorway with a bead-moulded trim and is topped by a slim projecting timber dado rail. The understair cupboard has a painted brick wall to the west which supports two ephemeral timber shelves. The remaining walls are covered with a combination of wallpaper and match-boarding as elsewhere. The floor comprises orange brickwork set on the natural ground (Plate 10). The stair has been additionally supported by the insertion of modern softwood framework on its underside.

Plate 6: View of the southern ground floor room within the south section (G1), facing west (15)

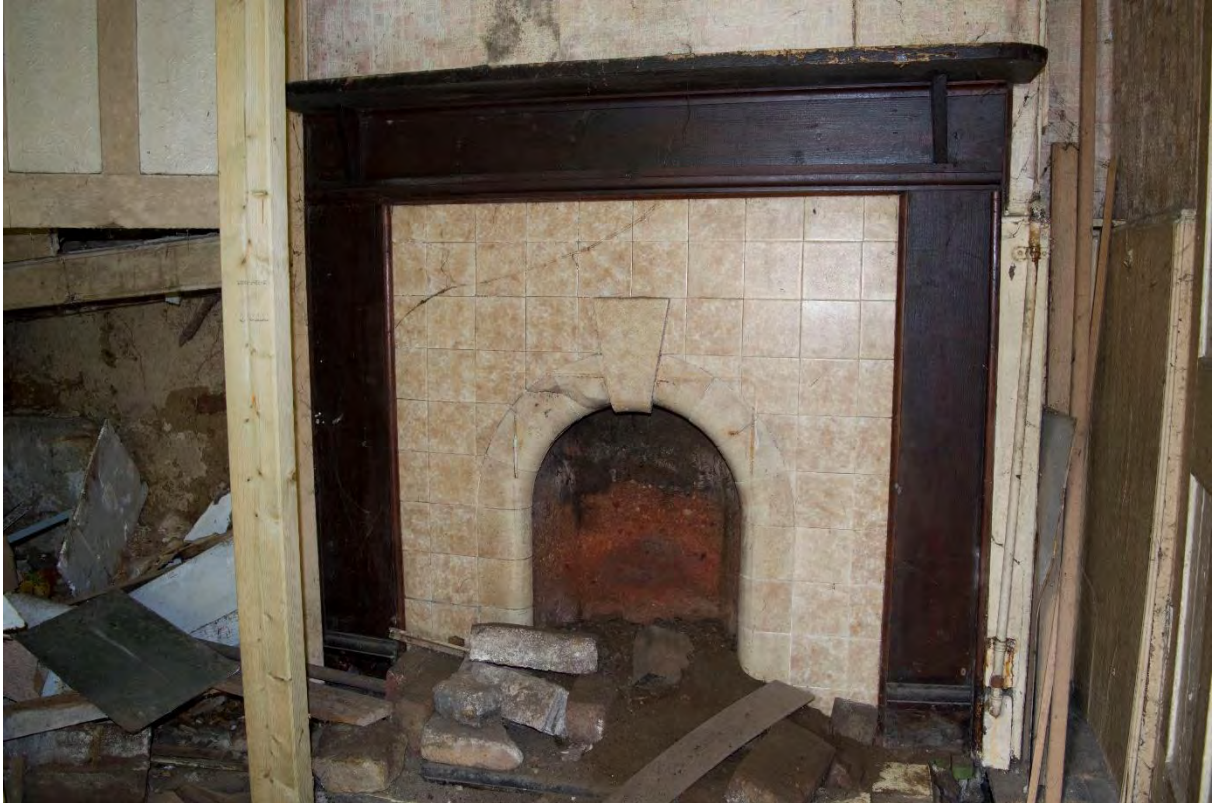
Plate 7: Detail of the fireplace within G1, facing west (19)

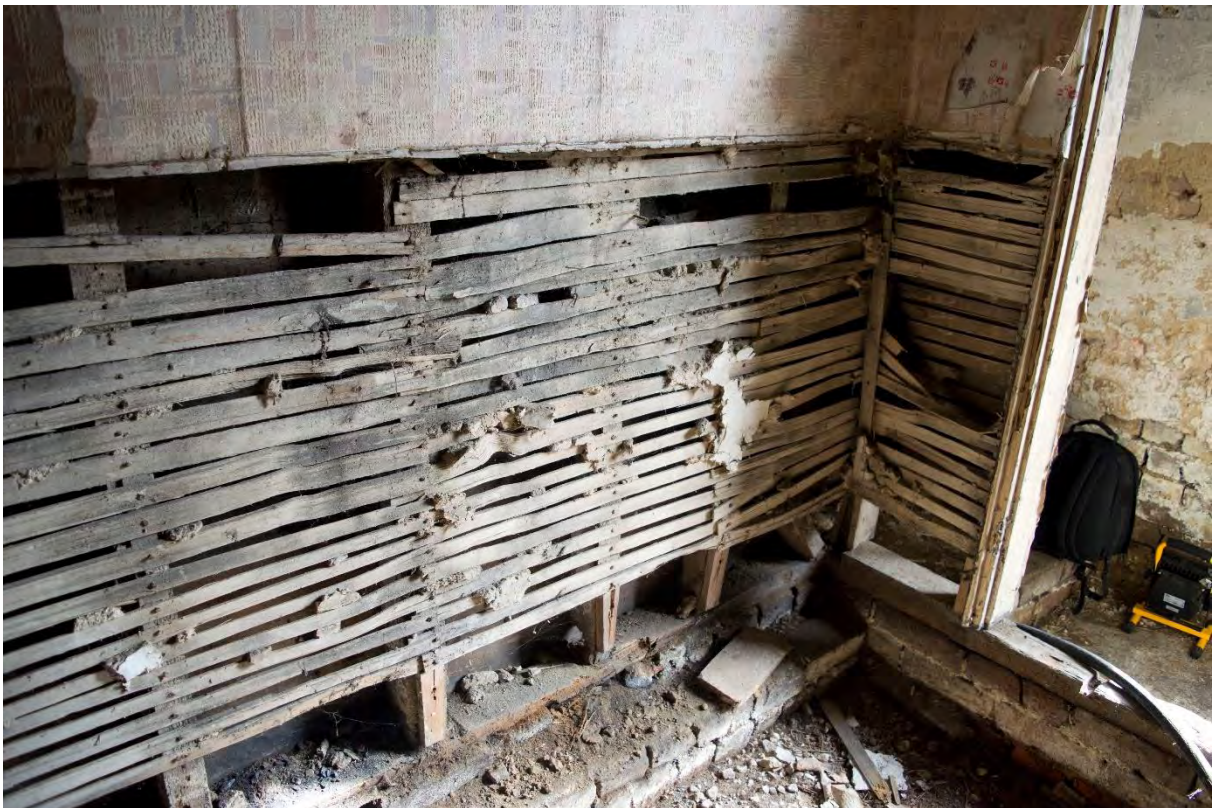
Plate 8: Detail of the partition wall enclosing the southern side of the staircase (G1), facing north-east (25)

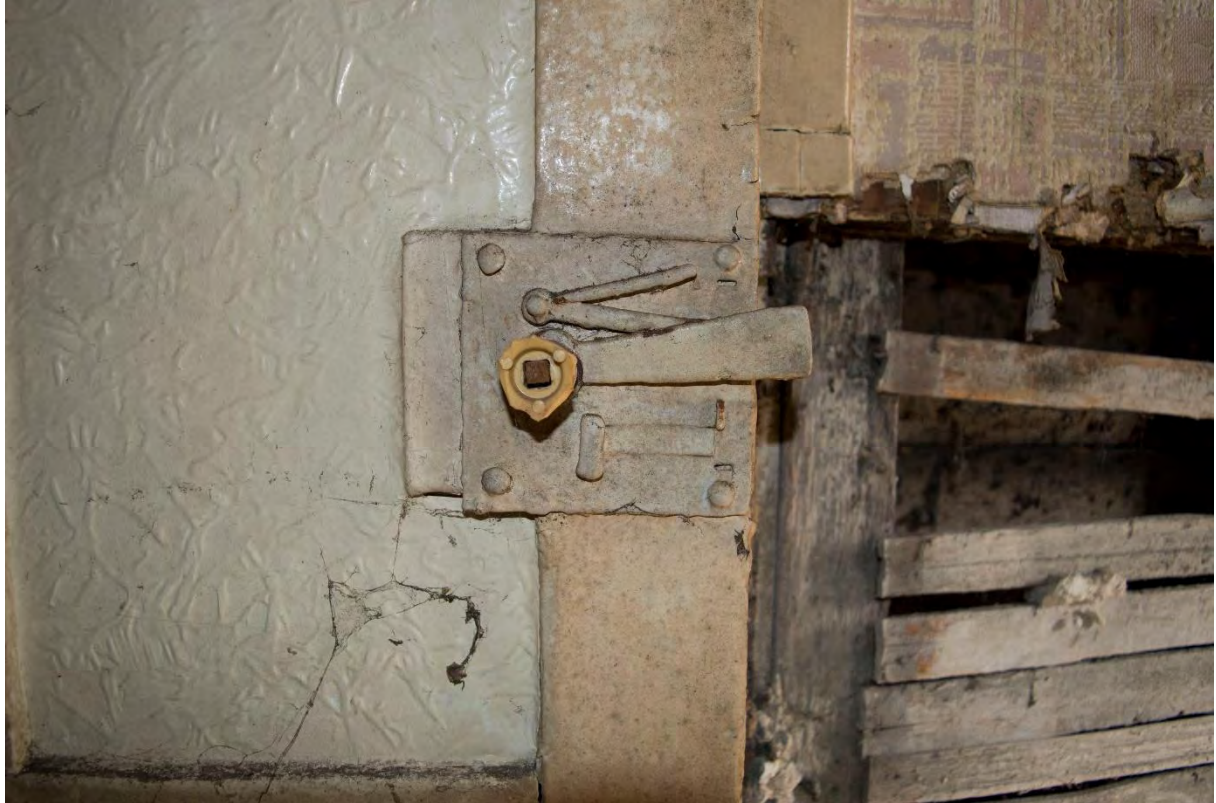
Plate 9: Detail of the spring catch fixing on the understair cupboard door (G1), facing north (21)

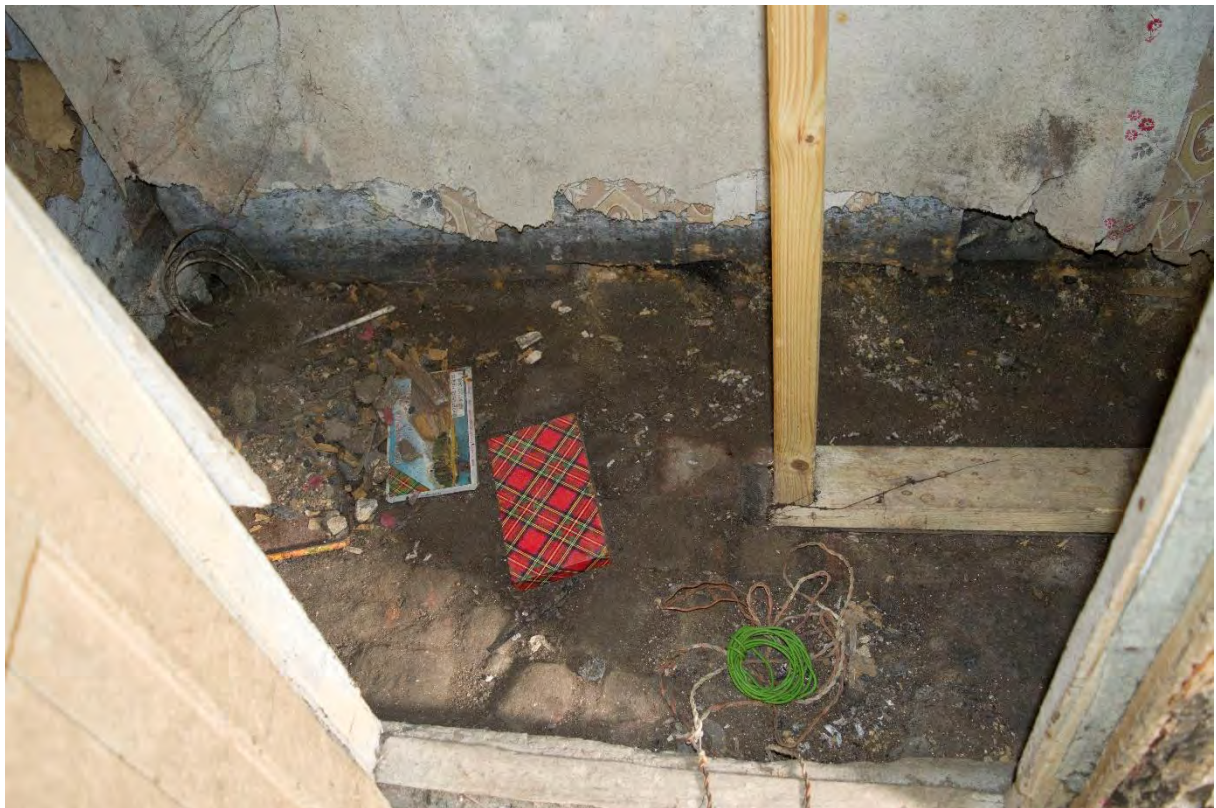
Plate 10: Detail of the brick flooring within the understair cupboard (G1), facing north (23)

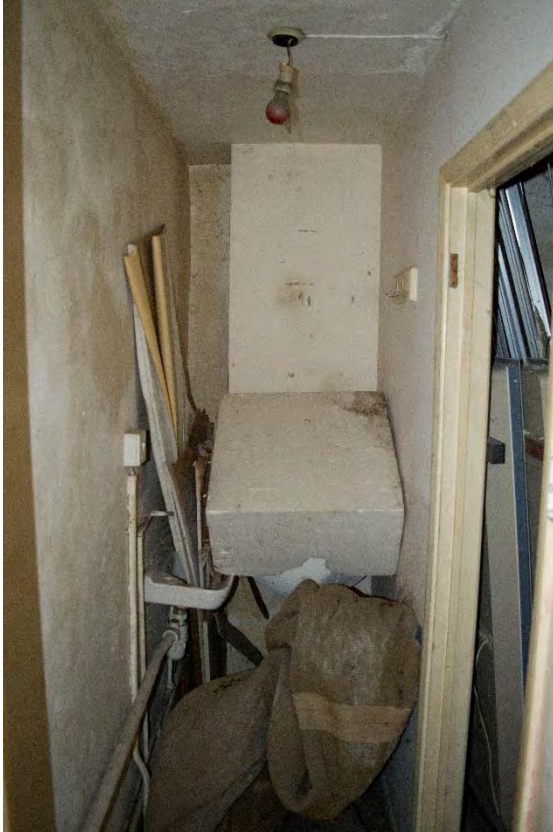
Plate 11: View of the narrow WC created along the southern wall of G2, note the truncated chimneystack, facing west (29)

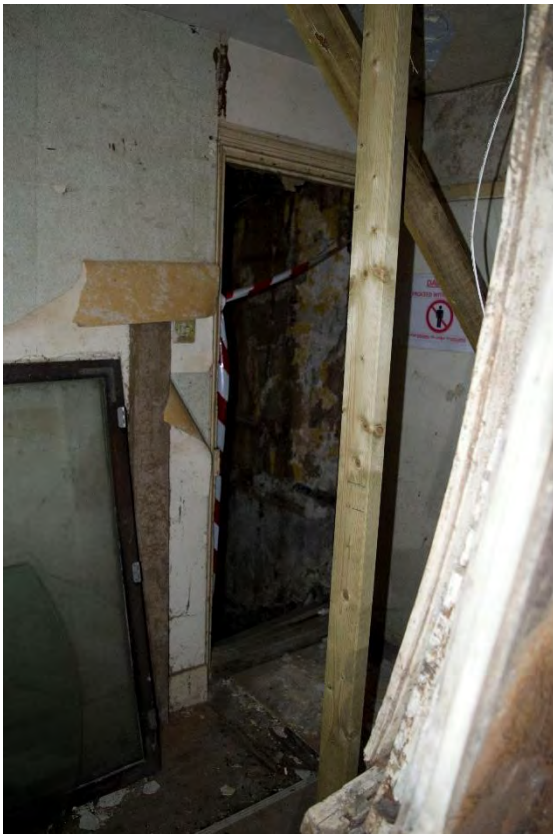
Plate 12: View of entrance into the north section of the building, G2, facing north-east (30)

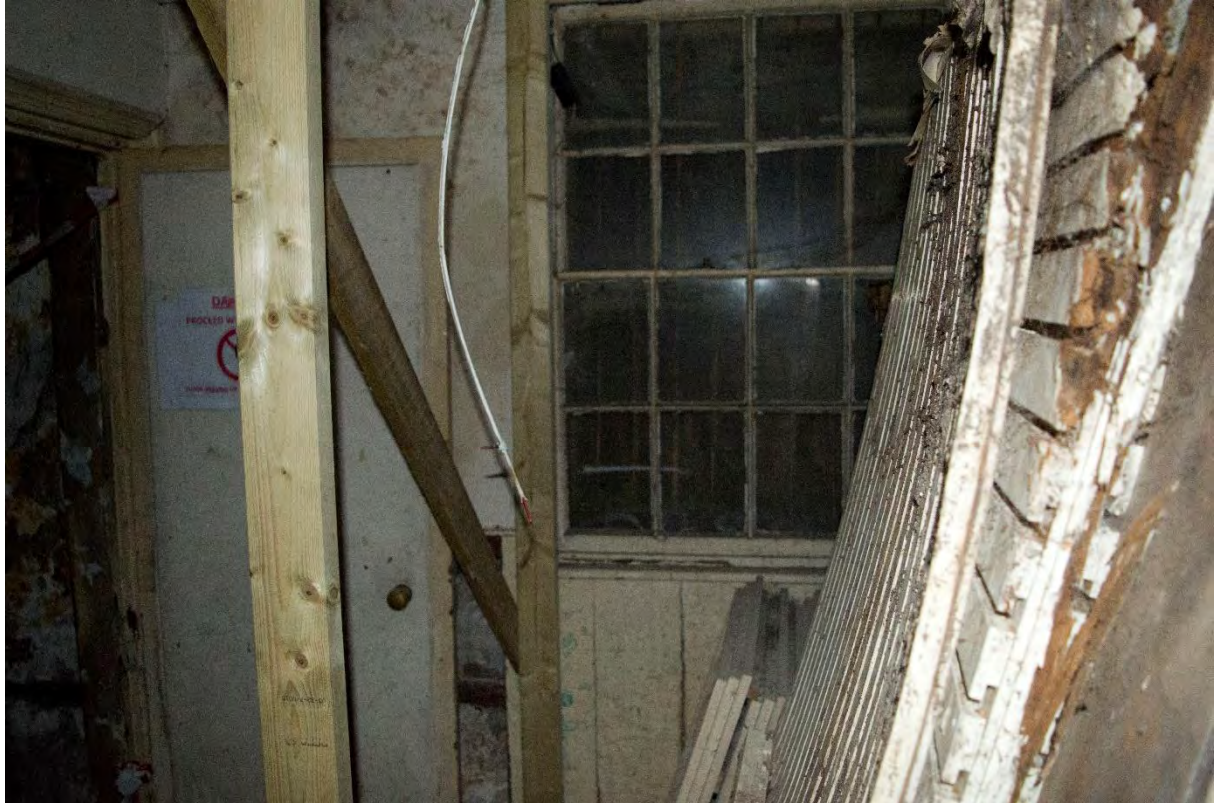
Plate 13: Detail of the inserted window within the east elevation of G2, note the match-boarding below, facing east (33)

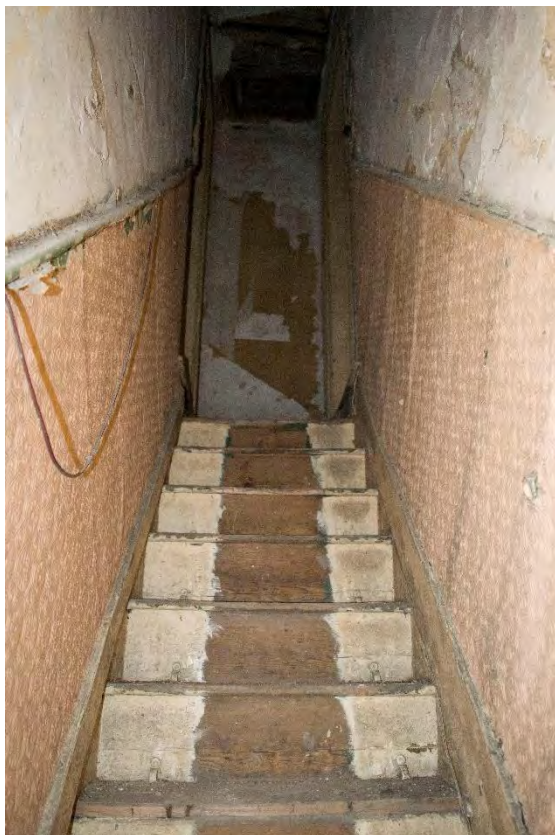
- 6.16 The stairs (Plate 14) are situated towards the centre of the south section of the building. They comprise a relatively narrow straight flight which rises from east to west, formed of with timber risers and treads, set within a closed string. A continuous run of metal stair rods (Plate 15) and an area of unpainted timber, indicate that the centre of the stair was carpeted at some point during its history. The stair opens up at first floor level onto a small landing with doorways set at a higher level to the north and south. The north and south walls enclosing the stair are clad with match-

boarding on their lower half which terminates in a rounded timber dado rail. The upper halves are plastered and covered with wallpaper. The match-boarding has been subsequently covered with paint and wallpaper since its insertion.

Plate 14: View of the staircase situated towards the centre of the south section of the building, facing west (26)

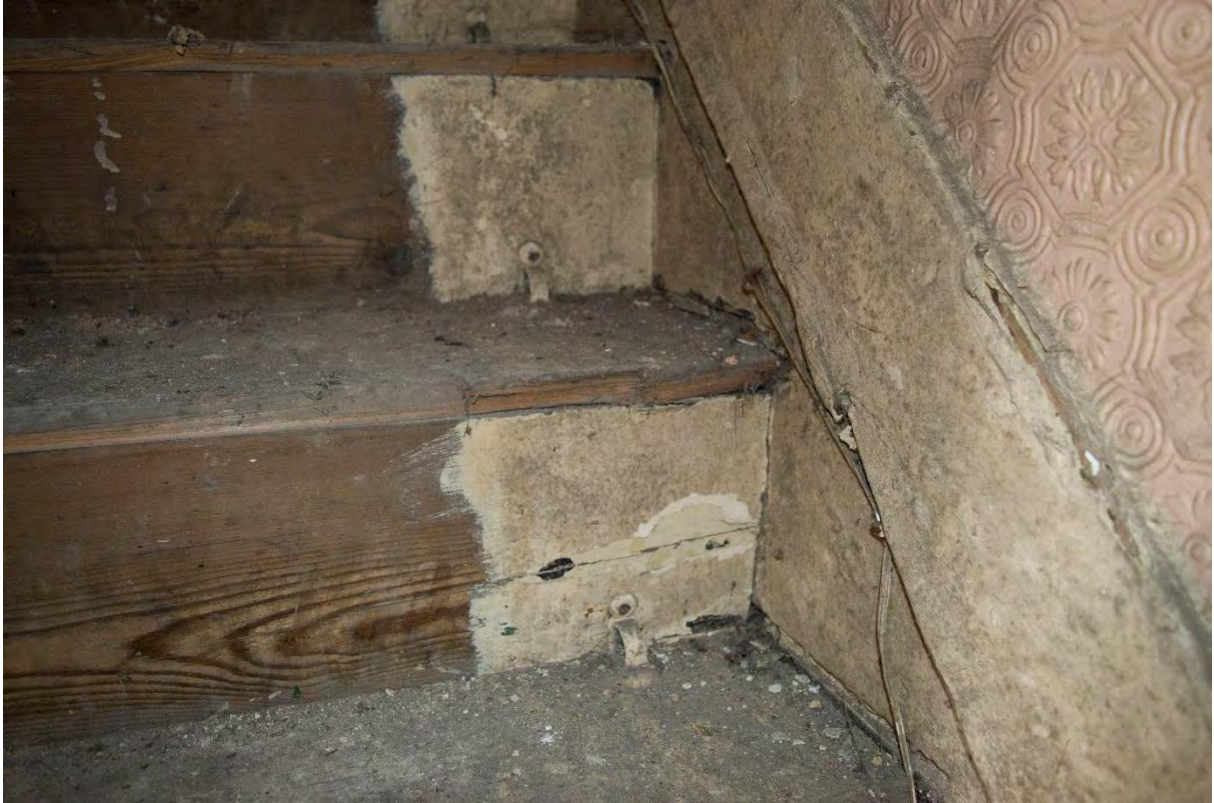
Plate 15: Detail of the treads, risers and stair rod fixings, facing north-west (27)
