**FURNACE MILL AND OASTHOUSE, HOOK GREEN,
LAMBERHURST, KENT, TN3 8LH**

**HISTORIC BUILDINGS RECORD
& HISTORIC BUILDINGS WATCHING-BRIEF**

Historic England Level 3

ASE project no: 180066

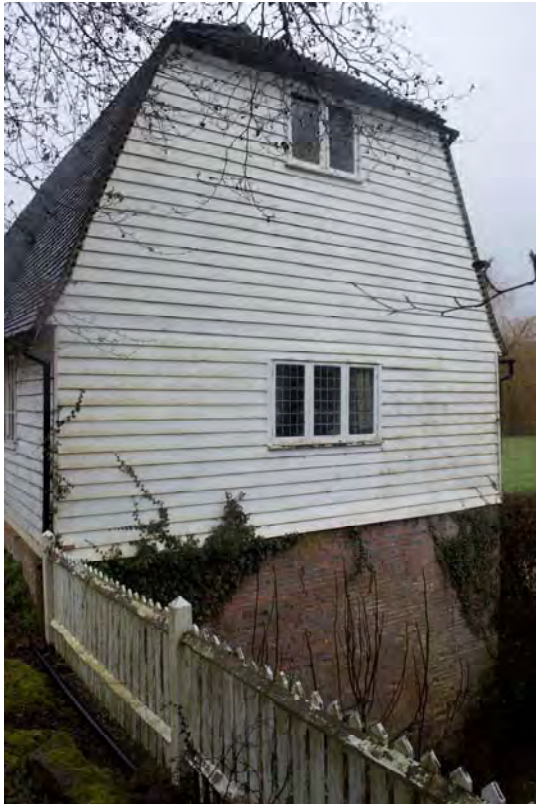
- 6.6 The south elevation of the building overlooks the pit for the waterwheel (Plate 3). A three-light casement is situated at first floor level and a two-light casement at second floor level, within the gable of the half-hipped roof terminal. Both are modern replacements although an undated historic photograph shows they occupy pre-existing openings (Mills Archive ref. JSPB-24379, not reproduced; via <https://catalogue.millsarchive.org/view-from-road-furnace-mill-lamberhurst>). The water wheel itself has been lost; however, the massive timber wheelshaft which connected the waterwheel to the internal gearing for the millstones, remains *in situ*, albeit much-decayed. It enters the building through a square opening with timber lintel (Plate 4). The mill had an overshot waterwheel, driven by water entering at the top and turning it by the weight of the water in its buckets (Mills Archive). This is reflected in the higher ground on the western side of the wheel pit, where there is evidence for low brick walls which channelled the water to the wheel pit (Plate 5). Historic maps suggest that the water came to the mill via a leat from the River Teise to the north, seemingly terminating in a mill pond to the north of the farm. Water from the pond was channelled below ground along the eastern side of the farmhouse, before appearing as the head race on the western side of the mill (Figs. 4 & 5). Once it had entered the wheel pit the water flowed into a tail race running beneath the track to the farm before bearing south to run perpendicular to the track, then east to discharge into the River Teise.

Plate 3 The south elevation of the mill (FMI18-0015)

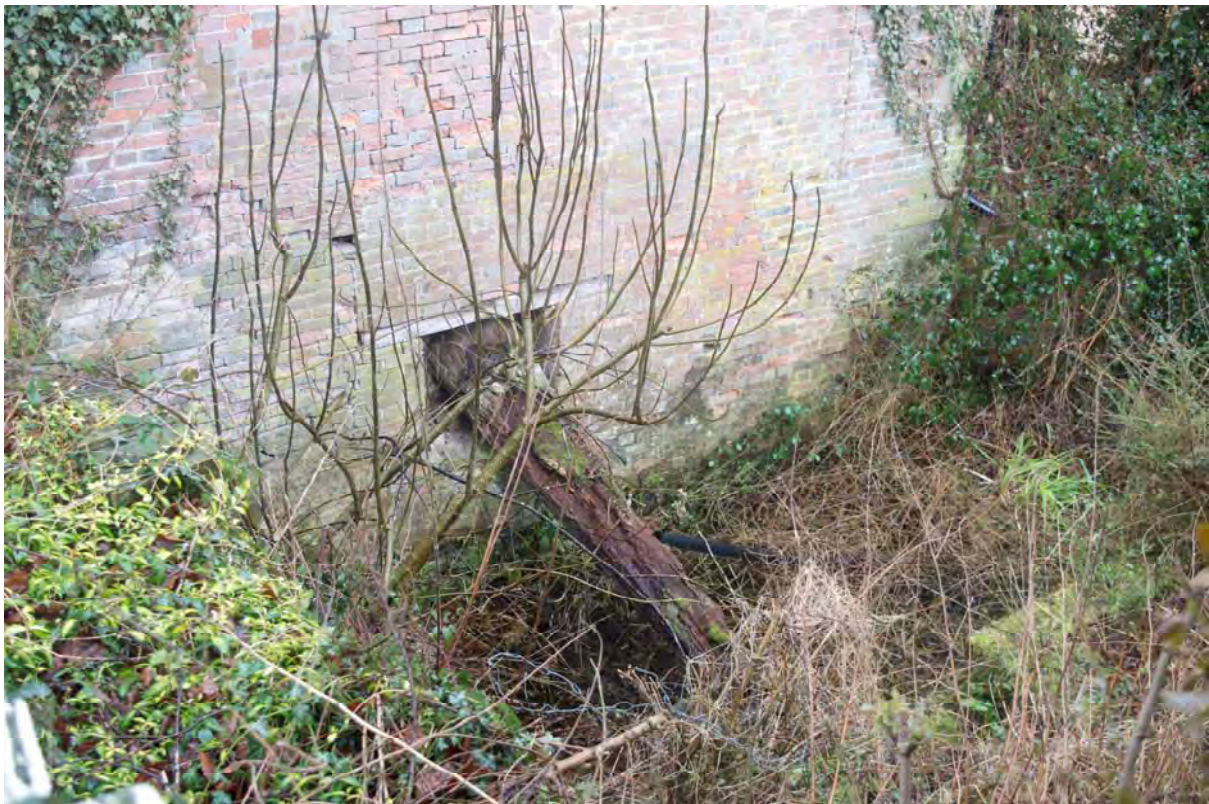
Plate 4 Detail of the timber wheelshaft. Note the coursed stone to the left-hand side (FMI18-0014)

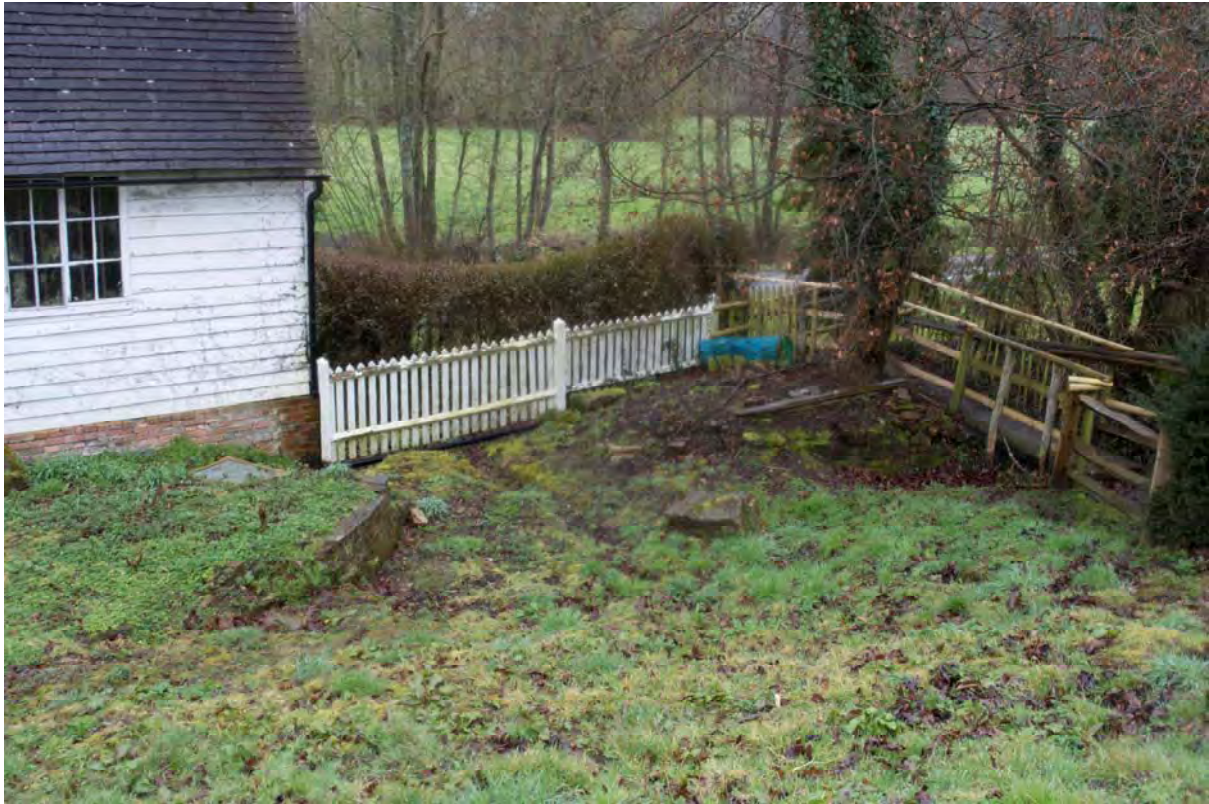
Plate 5 Remnants of brick walls which channelled water to the wheel pit, facing south-east (FMI18-0007)

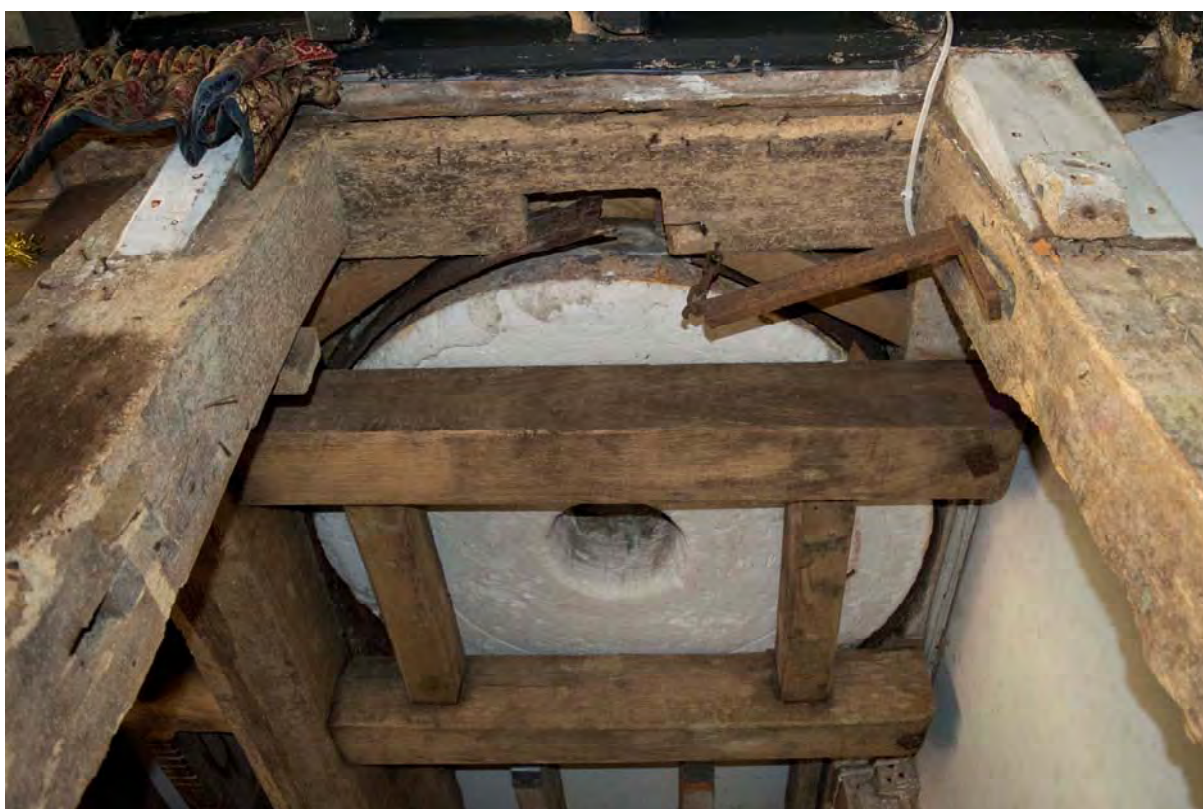
Plate 8 The underside of one of the millstones which remains *in situ* within the southern bay of the mill. Note the adjoining iron fixture (FMI18-0109)

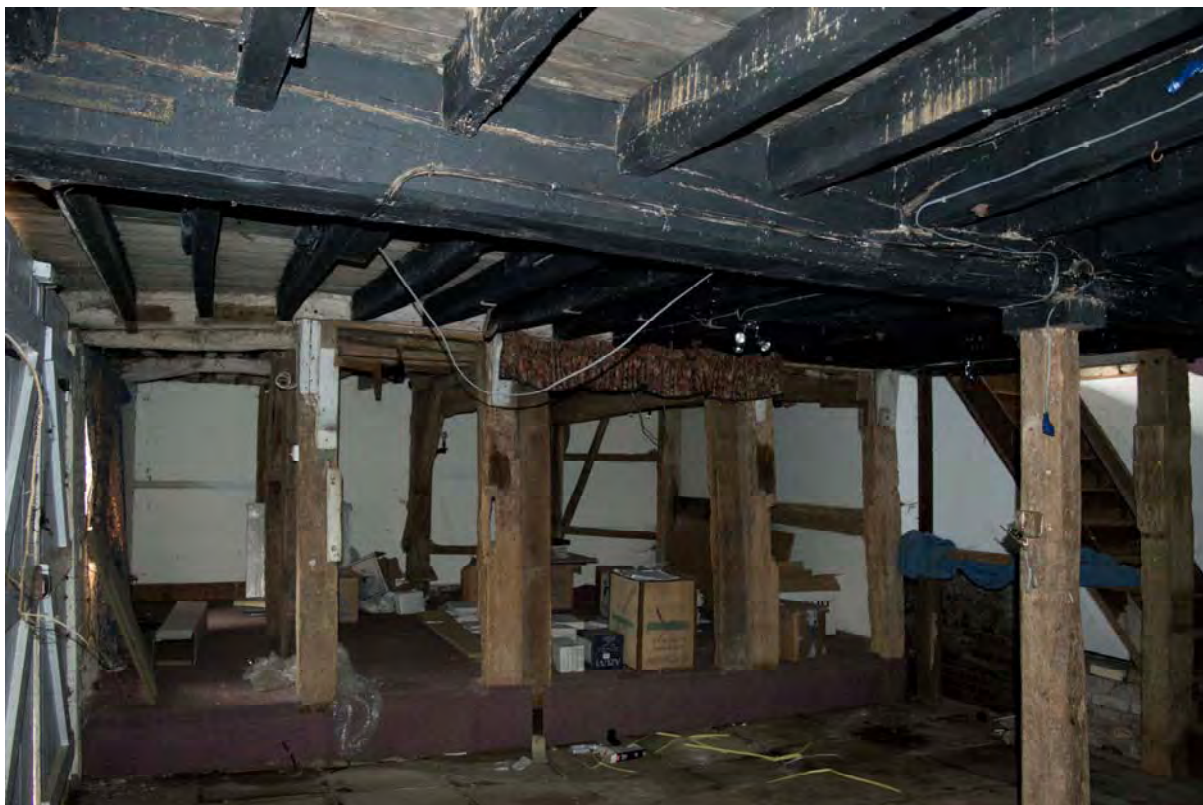
Plate 9 Ground floor of the mill, facing south, showing the hurst which supports the millstones (FMI18-0101)

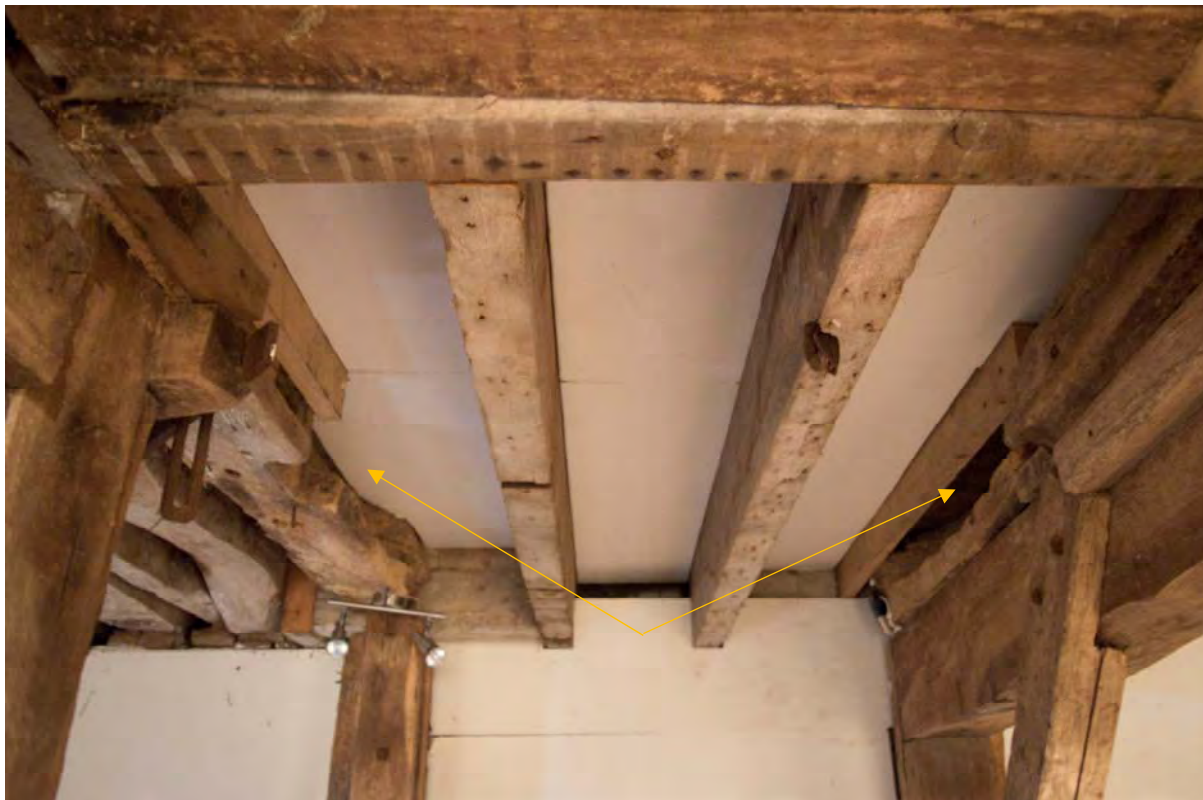
Plate 10 Curved recesses in the girders of the hurst indicating the site of one of the removed pairs of millstones (FMI18-0154)

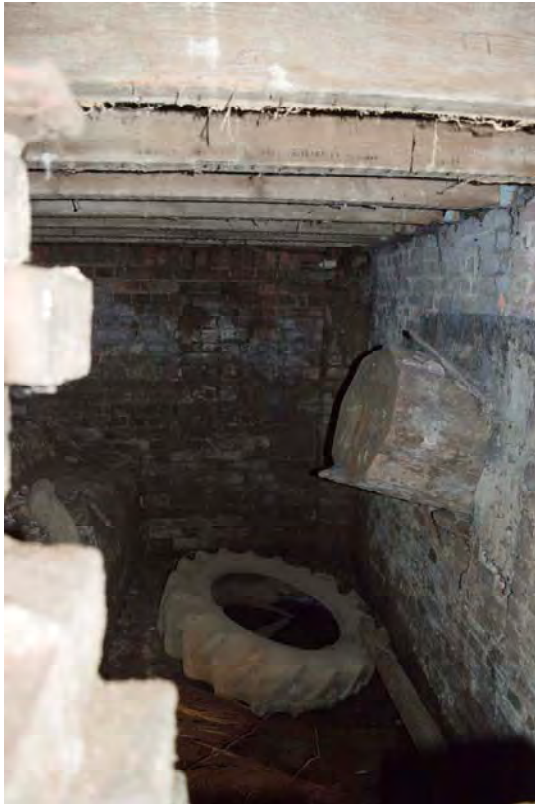
Plate 11 View of the wheelshaft and inserted timber floor, viewed from the passage along the western side of the hurst (FMI18-0123)

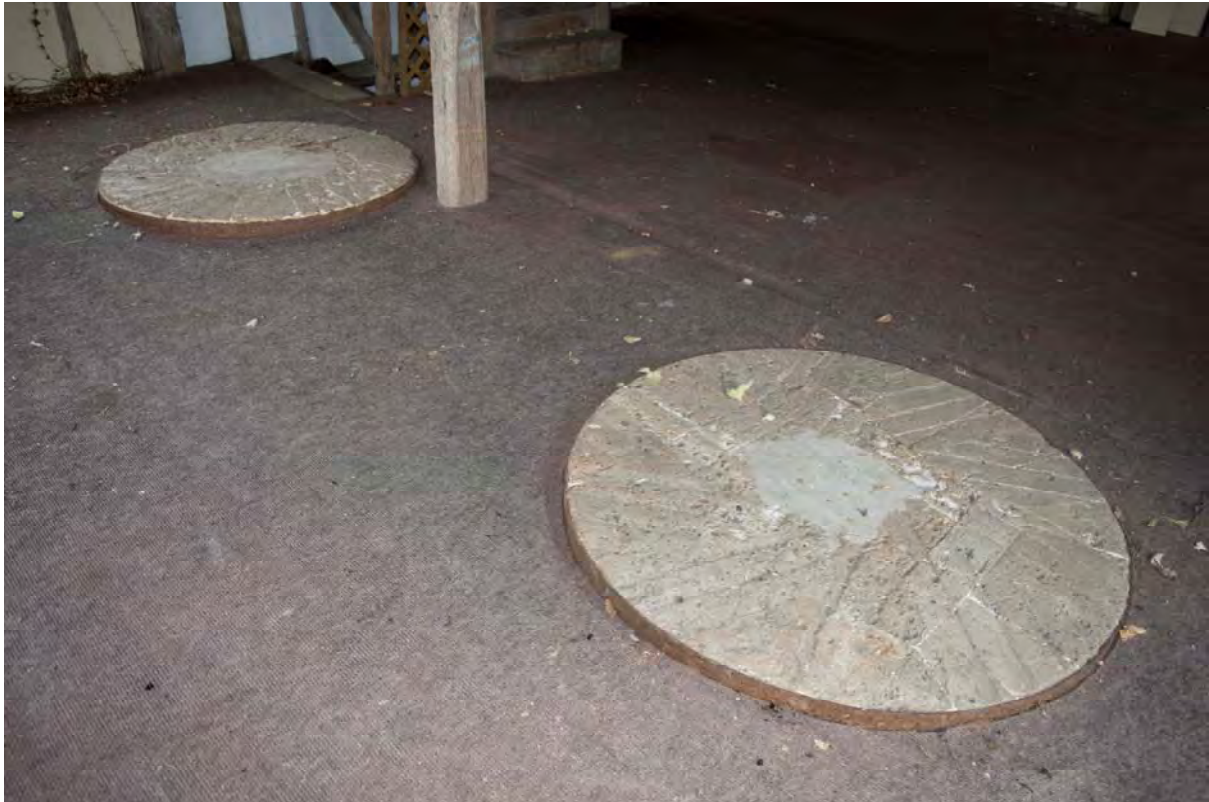
- 6.13 The first floor is accessed via a staircase on the western side of the central bay. The stair itself is a replacement straight flight of simple softwood tread and riser construction but is nevertheless historic. It occupies the original stair trap; however, whether it replaced a stair of similar form or a steeper ladder stair is unknown. The first floor itself is known as the stone floor. It is of three open bays, and the stationary bedstones of two of the pairs of millstones remain visible within the southern bay; the turning upper stones, known as runner stones, have been removed (Plate 14). Both the remaining stones are 'French' stones, that is, they are formed of blocks of stone bound with an iron hoop (Plate 15).

Plate 15 Detail of the two surviving bedstones (FMI18-0080)

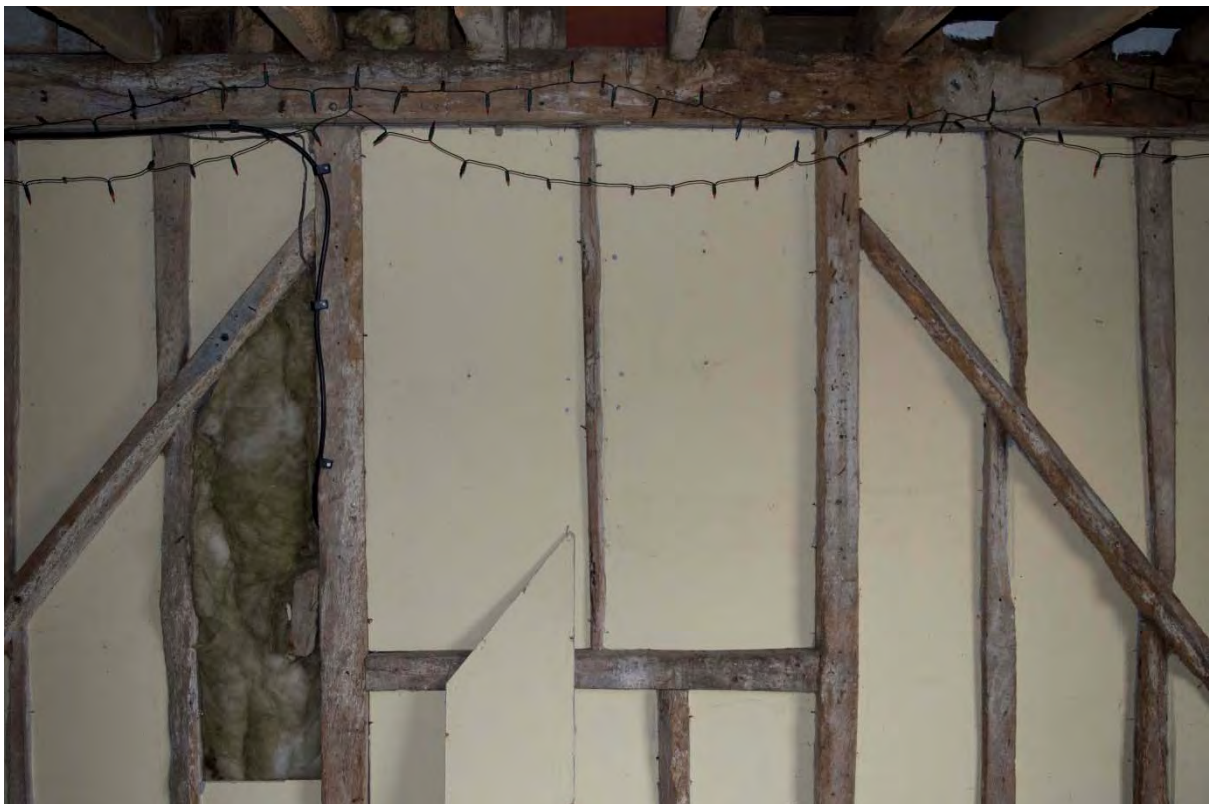
Plate 18 Blocked first floor window within north wall (FMI18-0097)

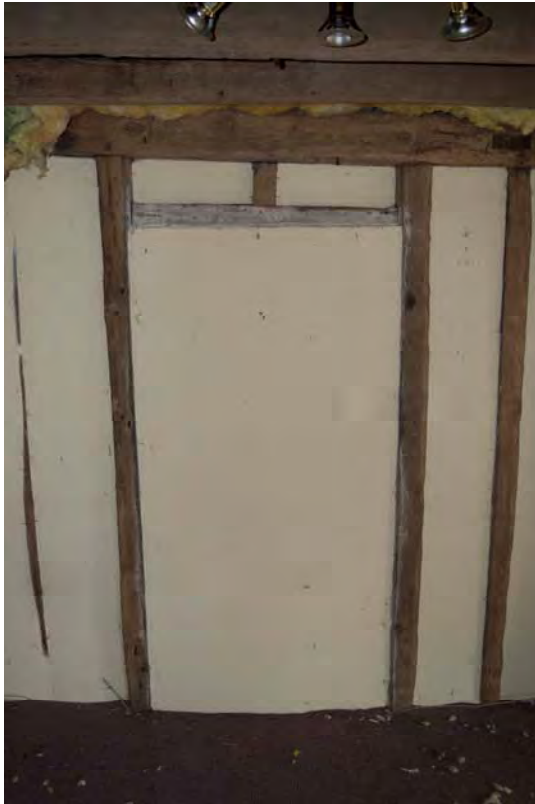
Plate 19 Blocked first floor loading door within east wall (FMI18-0094)

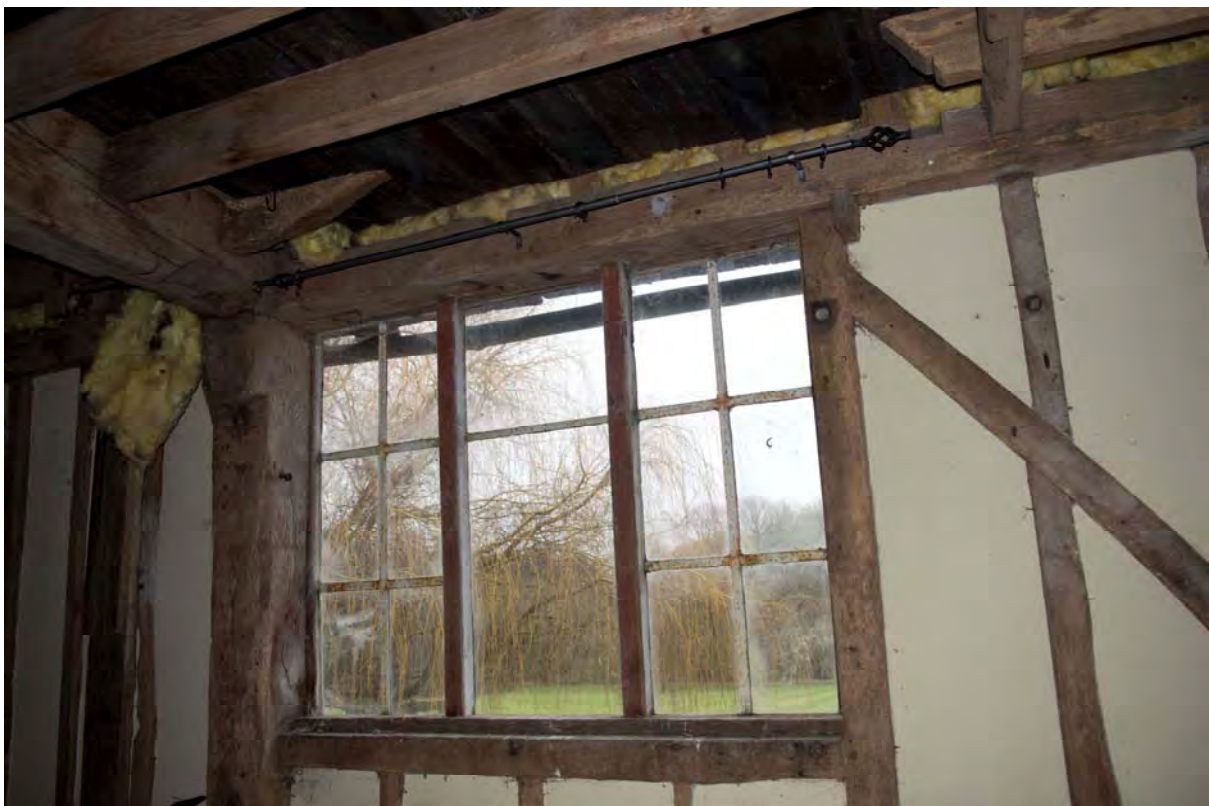
Plate 20 Truncated first floor ceiling joist on the east side of the southern bay (FMI18-0088)

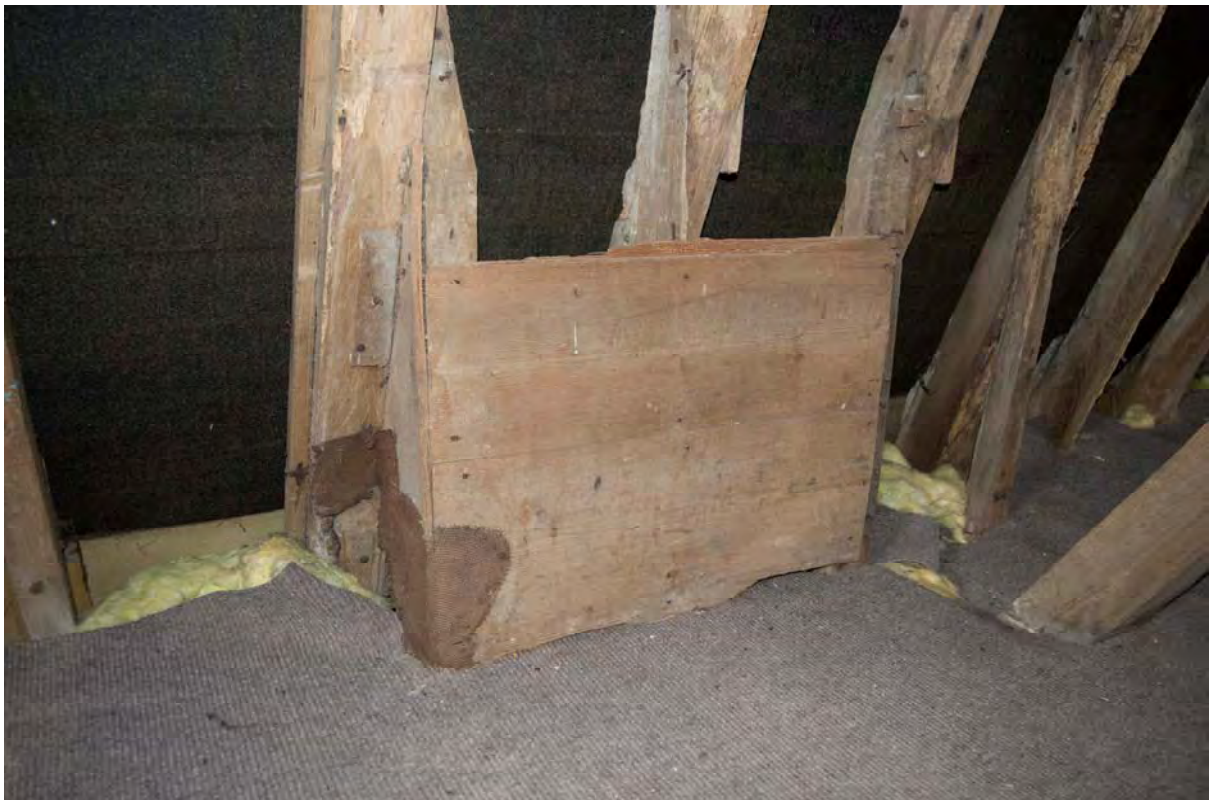
Plate 22 Remnant of horizontal boarding relating to grain bins, on the east side of the central bay at second floor level (FMI18-0066)

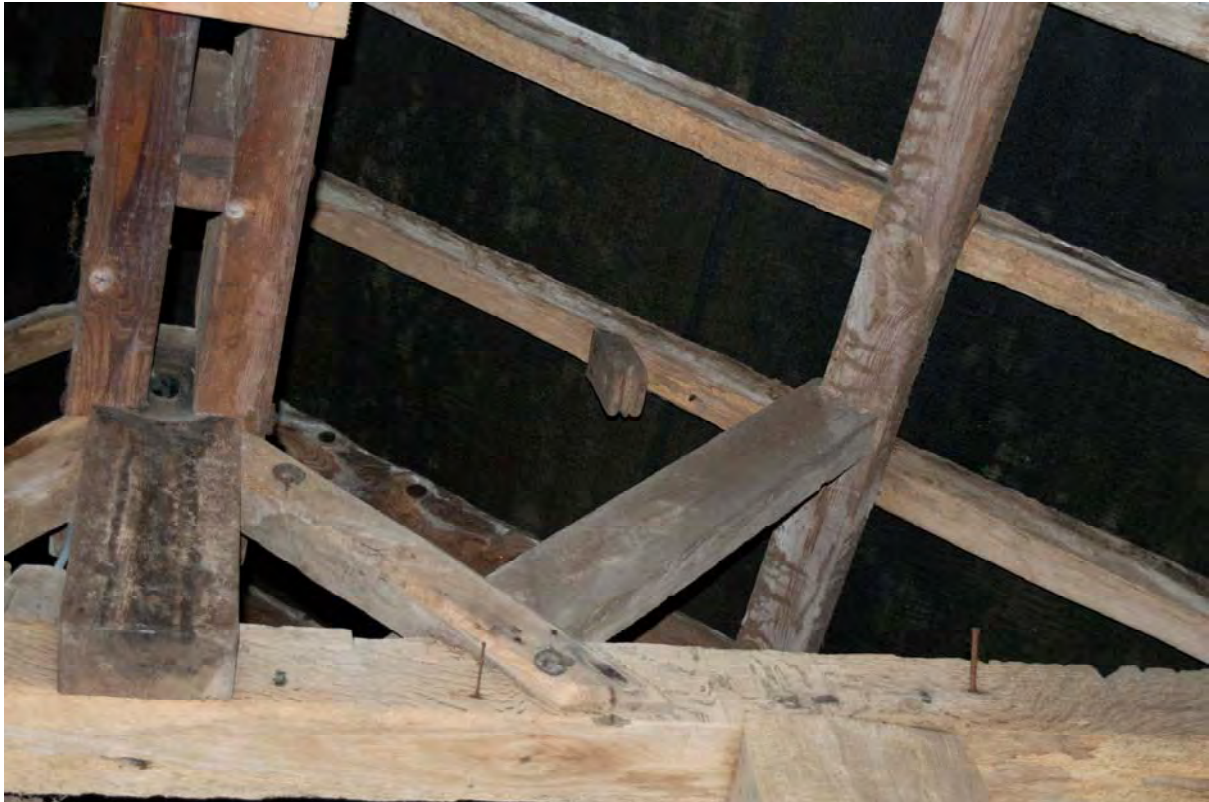
Plate 25 Detail of the arrangement of the support for the sack hoist wheel. Note the timber pulley fixing attached to the rafter (FMI18-0125)

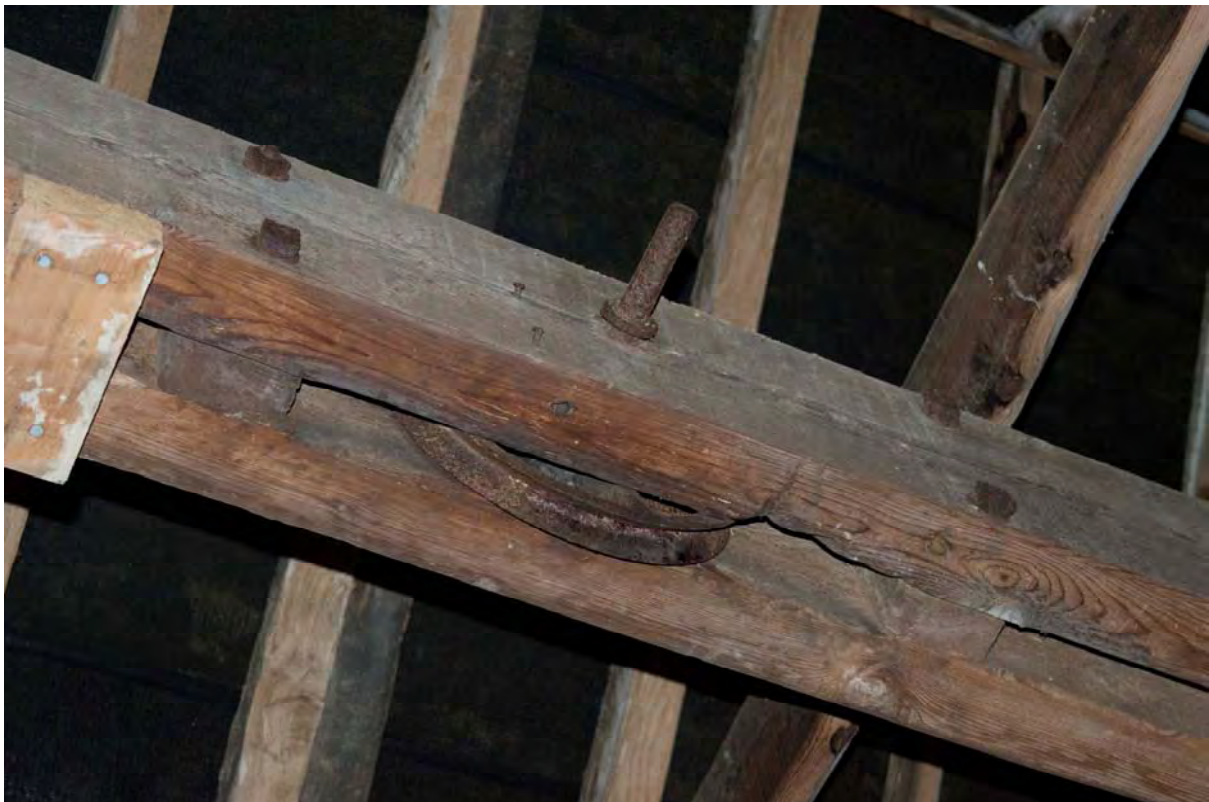
Plate 26 Iron wheel for the sack hoist (FMI18-0124)

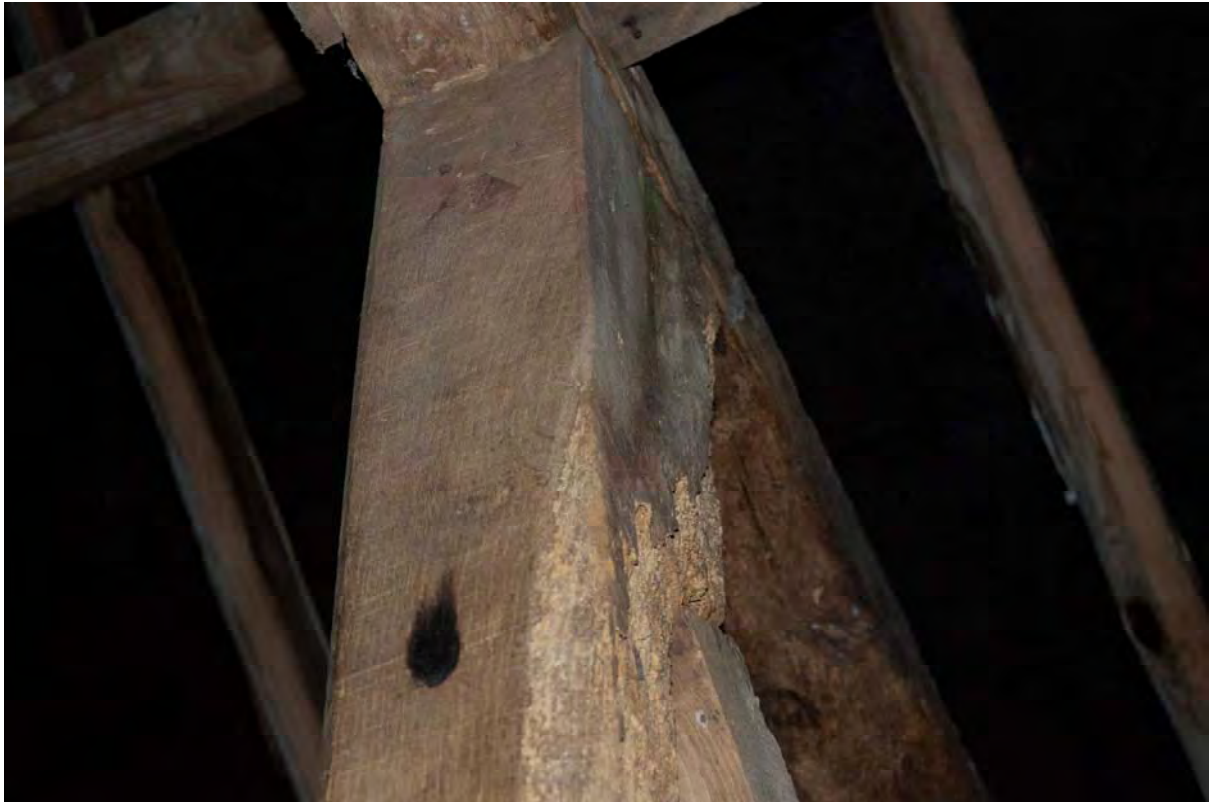
- 6.23 Of interest are a number of marks which can be identified on the queen studs. One of these appears to be an inverted W mark, formed by overlapping Vs (Plate 27). Such marks are thought to be 'apotropaic' or ritual marks, which were used to protect a building from evil spirits, witches or their animal familiars. Openings such as doorways, windows and particularly fireplaces were seen as danger points that needed protection (Hall 2005). In addition, several clear flame-shaped burn marks are visible. Such marks are now thought to be deliberate, possibly ritual marks rather than accidental damage (Dean and Hill 2012). Together, these marks suggest that superstition concerning the protection of the building and the grain processed there, was alive and well during the course of the building's use as a mill.

Plate 27 Possible apotropaic mark, formed by two inverted, overlapping Vs, with flame-shaped burn mark below (FMI18-0126)

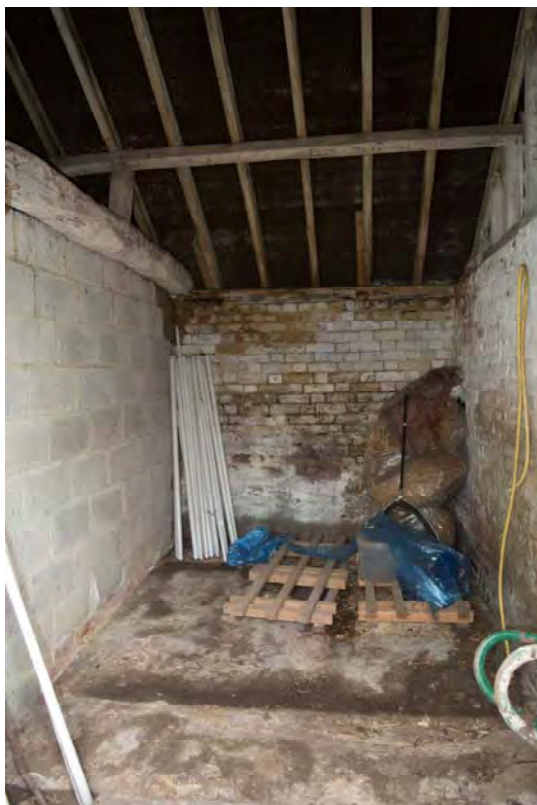
Plate 29 Interior of the stables on the north side of the mill, facing west, showing inserted breezeblock partition between the central and southern stables. Note the drainage channel in the floor (FMI18-0142)

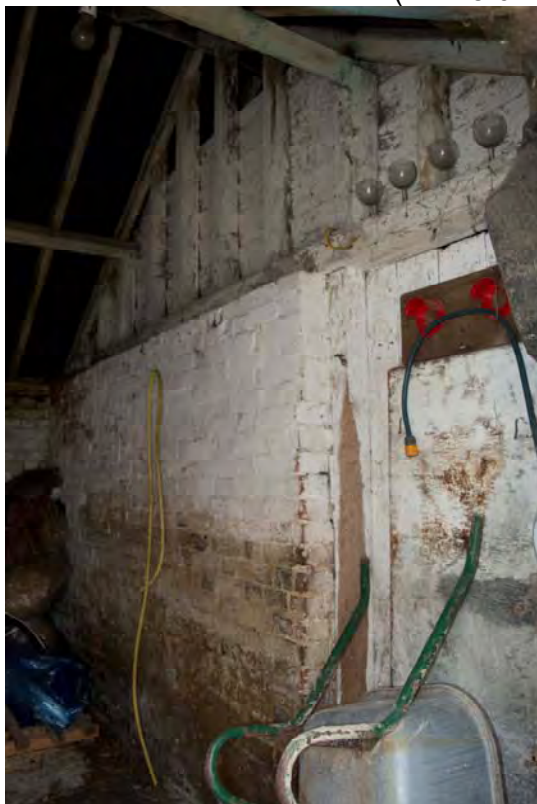
Plate 30 Interior of the stables on the north side of the mill, facing west/north-west, showing the original brick and stud partition between the central and north stables (FMI18-0143)

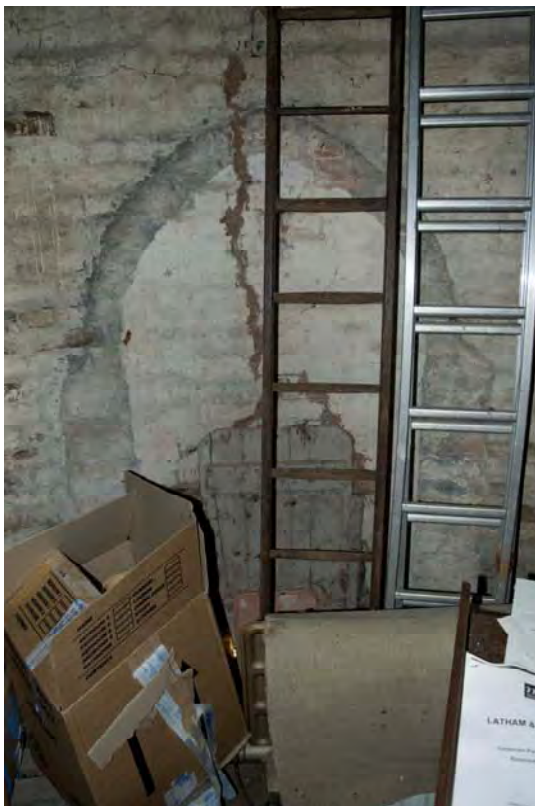
Plate 42 Scars around the probable stoking hole/fuel door to the north-west of the roundel (FMI18-0048)

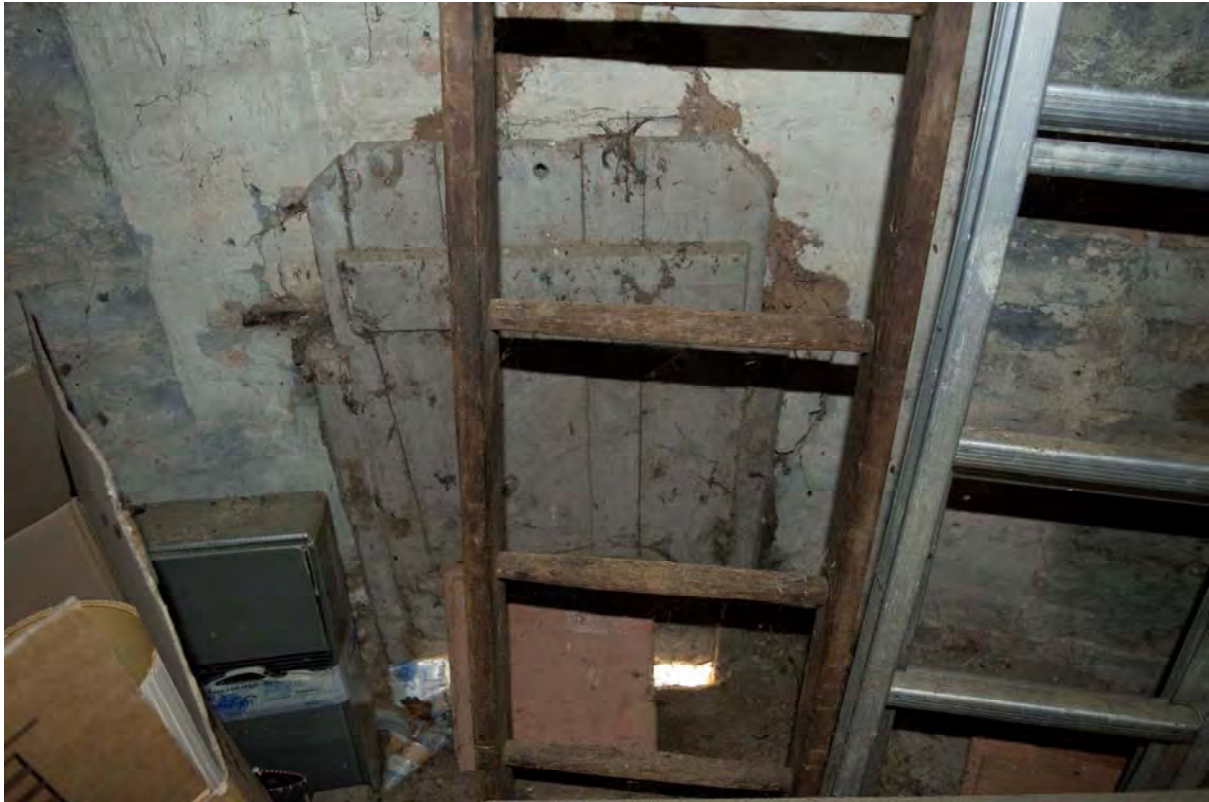
control draught to the kiln (Plate 43). The small draught holes to either side also have vertically-sliding timber shutters. The drying floor which would once have been situated above the kiln has been removed and replaced although the twin girders carrying the existing floor are chamfered and may be contemporaneous with the construction of the oast. The joists themselves are staggered and incorporate reused material including whitewashed joists and some with nail holes and stripes characteristic of once having been clad with a lath and plaster finish (Plate 44). The girders and the ends of the joists are set into the external brickwork of the roundel with a modern mortar of cementitious appearance. The joists are overlaid with a mixture of modern and reused boards with a whitewash finish, with unpainted stripes from the position of joists in their original setting. Originally, the drying floor would have comprised joists overlaid with timber or metal slats and covered with a coarse horsehair cloth, or possibly perforated tiles (Jones & Bell 1992).

Plate 43 Vertically-sliding timber shutter to the probable stoking hole/fuel door (FMI18-0049)

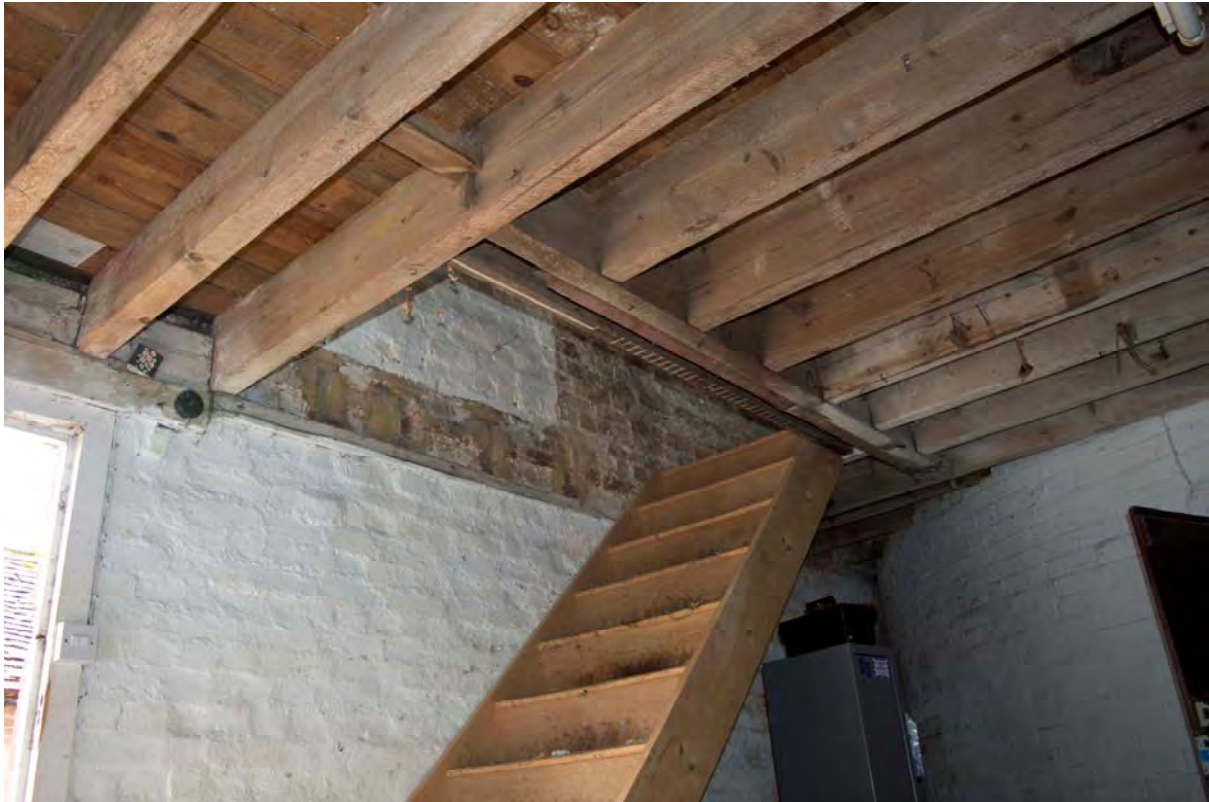
Plate 45 The existing stair to the first floor, which occupies the original stair trap. Redundant joist mortices appear to be for a later alteration. (FMI18-0056)

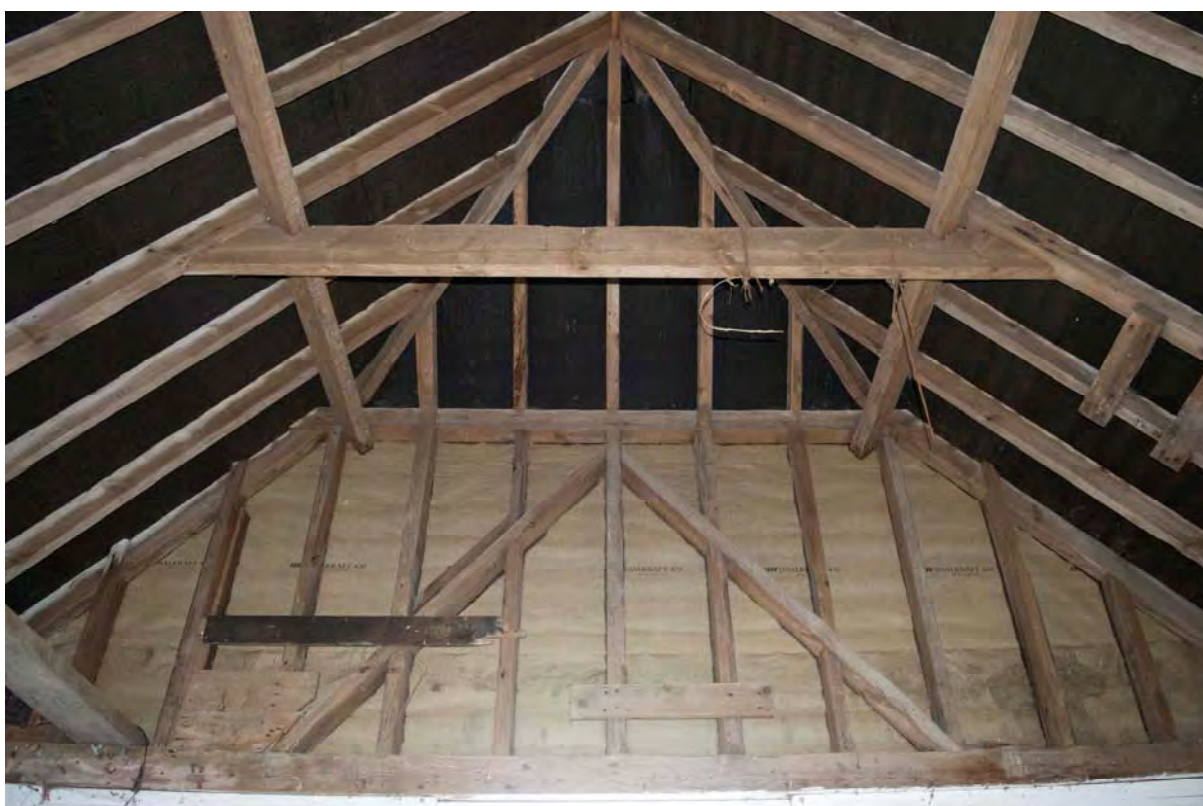
Plate 48 Detail of the half-hipped roof terminal to the south-east of the storage. Note the pair of horizontal timbers nailed to the rafters, to the right-hand side (FMI18-0035)

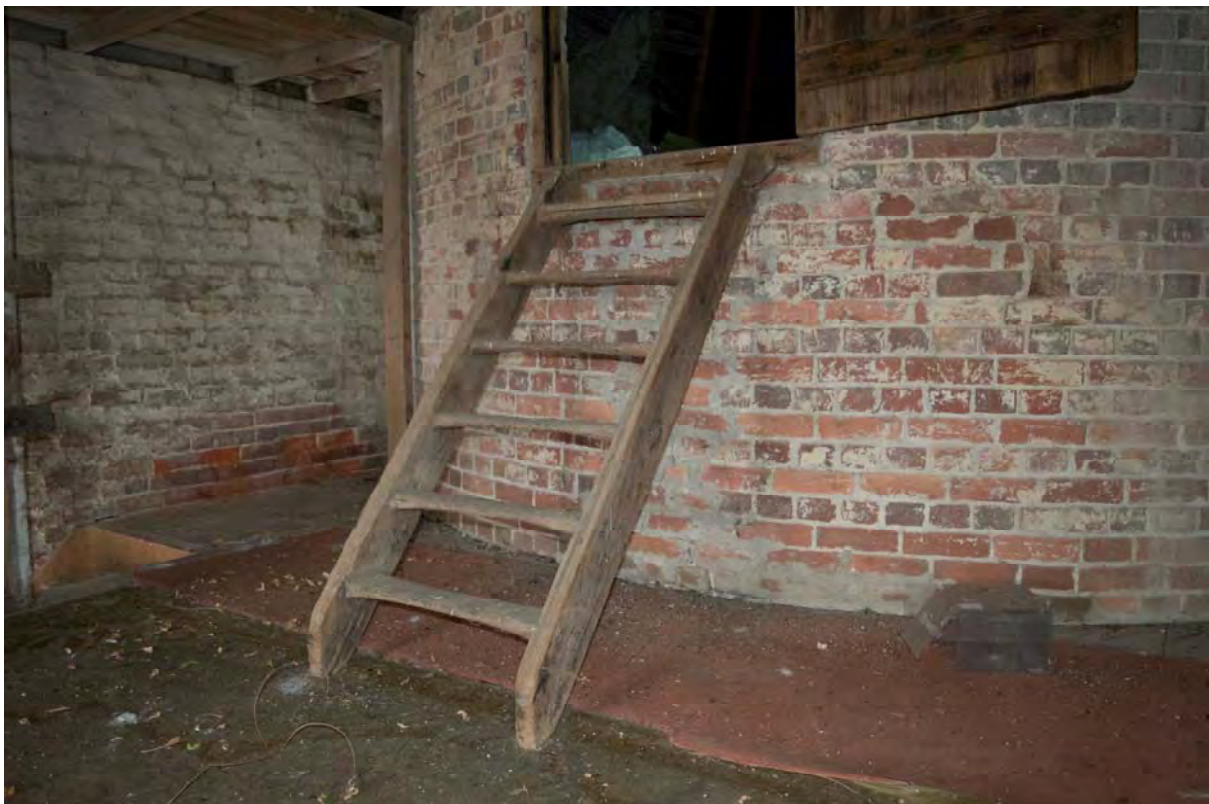
- 6.39 The drying floor in the upper part of the roundel is accessed from the first floor of the stowage via a raised doorway reached by a short timber ladder stair (Plate 50). The stair is fixed to the timber threshold of the doorway with iron hooks. The treads are worn to both sides and scars for fixings at the base of the stair suggests it has been turned upside-down. The threshold and the head of the doorway on the interior side are curved to match the shape of the roundel. The door itself is ledged and formed by bead-moulded planks, with an upright iron handle with expanded ends, and tapered round-ended strap hinges. Remnants of a hessian seal are nailed to the door and frame. 'BAGS TO BE PUT IN' is scratched onto the door on the stowage side (Plate 51).

Plate 50 The ladder stair to the drying floor of the roundel (FMI18-0037)

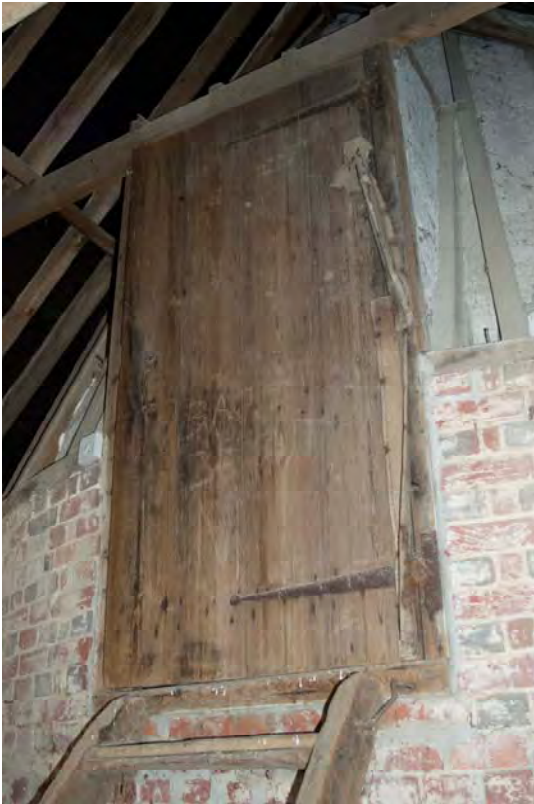
Plate 51 The first floor door to the roundel (FMI18-0038)

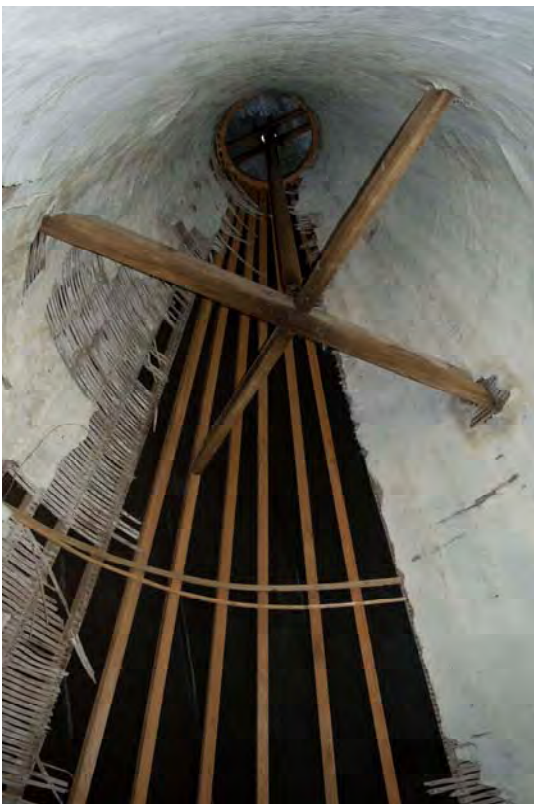
- 6.40 The conical roof of the roundel is formed by rafters resting on a curved wallplate above the brickwork. A number of rafters on the western side have been replaced with modern softwood; the remainder are faced with a lath-and-plaster finish. The roof is braced with two intersecting timbers forming a cross-piece supporting the cylindrical pivot of the cowl (Plate 52). The latter is seemingly of timber; however, due to the height of the pivot, it was not possible to confirm this with certainty. The top of the roof, beneath the cowl, is flat and covered with lead, and the pivot exits this covering through a circular hole framed by two slender timbers.

Plate 52 The interior of the conical roof of the roundel, showing the cross-piece and the cylindrical pivot of the cowl (FMI18-0042)

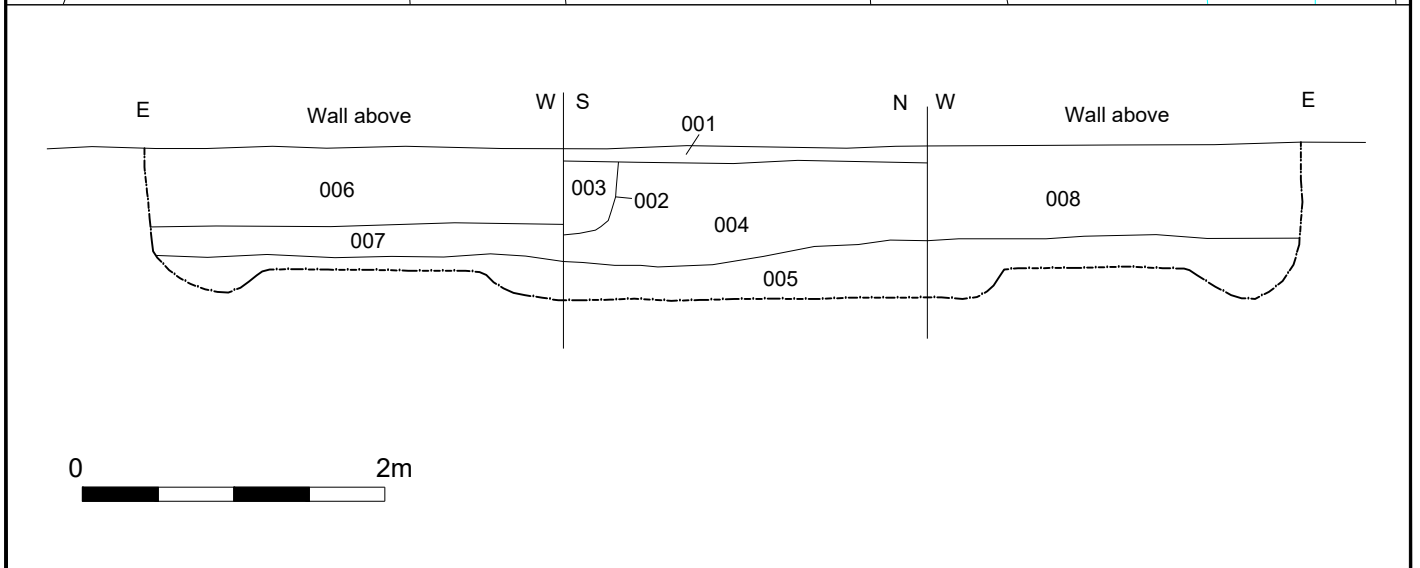
© Archaeology South-East		Furnace Mill and Oasthouse, Lamberhurst, Kent	Fig.A4.1
Project Ref: 180066	June 2019	Watching Brief- excavated footings in cart shed	
Report Ref: 2018110	Drawn by: SC

2.1 The observed excavations comprised a single trench at the entrance to the cart shed, 2.4m square. The excavation was undertaken with a mini-digger using an 0.8m ditching bucket to a depth of 1m.

2.2 Natural [005] deposits of sandy clay with sandstone consistent with the Tunbridge Wells Sand Formation were uncovered at a depth of 0.6m and excavated by a further 0.5m to reach the depth required by the foundation. Above this, made ground deposits [004] including mixed CBM and infrequent pottery and clay pipe fragments were observed, consistent with the mid-19th century date of the cart shed. The wall of the mill, on the southern side of the excavation has a foundation consisting of a single course of sandstone blockwork [007] with lime mortar at its base and six courses of brickwork [006] consistent with the wall above. The cart shed wall, to the northern side of the excavation has a foundation of three courses of sandstone blockwork [008] with lime mortar. It is possible these blocks ([007] and [008]) are reused from an earlier structure. A foundation trench [002] from the mill wall was observed running east – west, to the depth of the brickwork. This was filled with redeposited made ground
