REPORT FOR AN ARCHAEOLOGICAL WATCHING BRIEF AT STONE ACRE, COPT HILL ROAD, IGHTHAM, SEVENOAKS, KENT TN15 9DT

Archaeological Watching Brief

Report reference: DAS 0021-21

Planning Reference: TM21/01606/RD

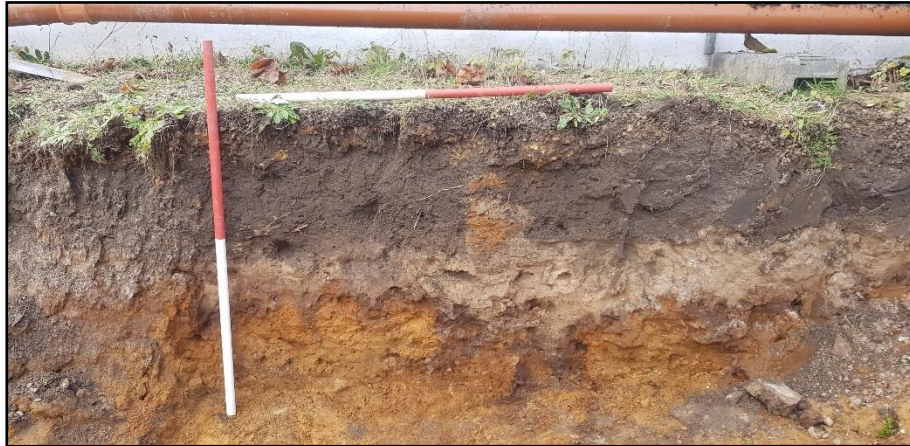
(Fig 14 – Looking West at Section 4)

5.12. Section 4 illustrates Soakaway 1, a rectangular pit approximately 2.0m x 2.5m x 2.0m depth, situated 20.0m south of the main trench area. 0.2m of 1001, a dark brown sandy topsoil sits above 0.4m of 1002, a soft, mid-brown sandy clay subsoil. 1002 sits above 1003, an undetermined depth of loose orange/brown sandy silt, thought to be the superficial geology.
