ARCHAEOLOGICAL WATCHING BRIEF AT ST MARY'S CHURCH, HUNTON, KENT ME15 0RR

Planning Reference: 19/504235/FULL

DAS Site Code: SMH20-WB

Report Number DAS 010/20/SMH20

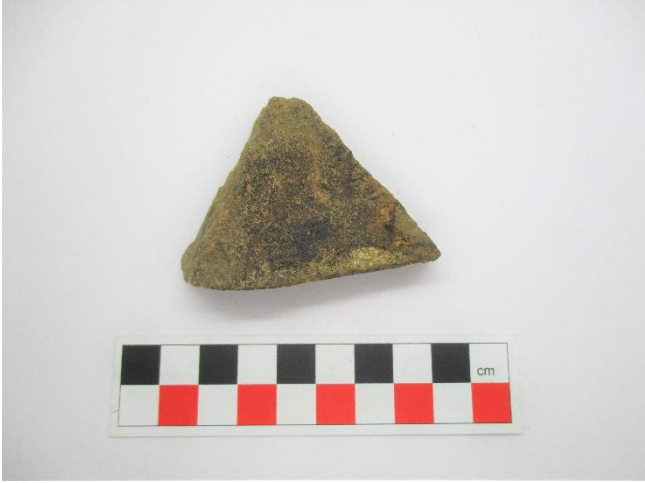
<p>13.7</p> <p>1007 – Shaped igneous rock fragment, probably granite, that has been subject to fire or burning.</p>

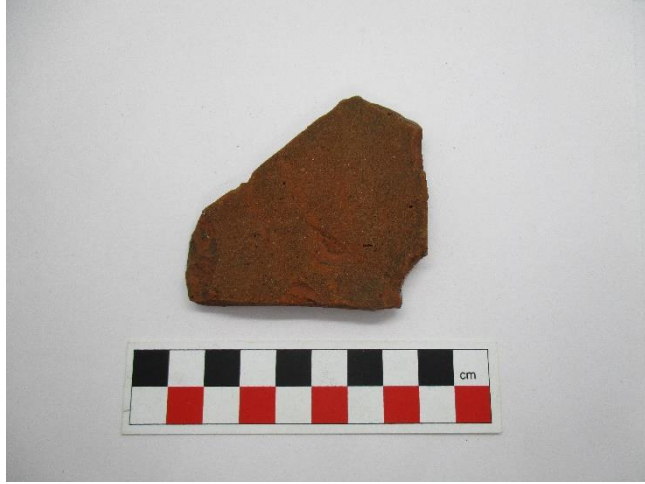
<p>13.8</p> <p>1007 – Post-medieval Kentish peg tile c.1800 – 1900 AD</p>

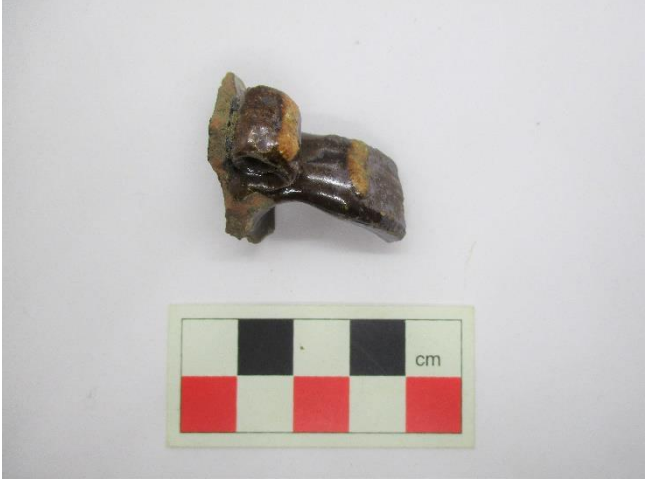
<p>13.9</p> <p>1007 – Handle from brown glazed earthenware posset pot or cup c.1750 – 1850 AD</p>

6.9. 0.1m of topsoil 1001 sits above 0.15m to 0.3m of 1002, loose brown sandy loam subsoil. 1002 sits above 0.15m of 1005, a loose brown sandy loam containing modern building debris. Under 1005 is 1006, up to 0.3m of a moderately compact sandy clay, probably the fill of a post-medieval midden (1007), containing refuse consistent with domestic settlement; pottery suggests a late eighteenth or early nineteenth-century date (see **13.1 - 13.3 & 13.9**). 1007 is cut into the natural (1003) (See **12.2 & 12.3**).
