REPORT FOR AN ARCHAEOLOGICAL WATCHING BRIEF AT TOWN FARM SHAMBLE, HIGH STREET, BRENCHLEY, TONBRIDGE, KENT TN12 7NH

Archaeological Watching Brief

Report reference: # DAS 0018-21

Planning Reference: 21/00706/FULL

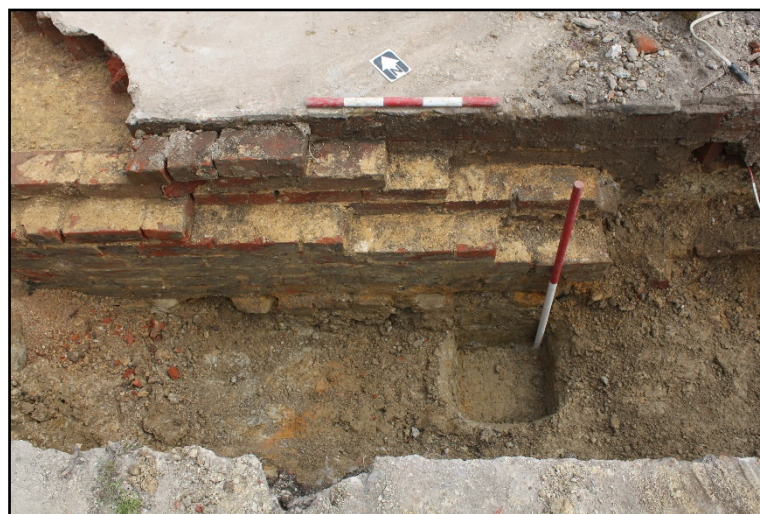
5.7. Section 1 illustrates (Figs 9 & 10) a minimal spread (up to 0.05m) of 1001, 0.1m of 1001, a loose mid-brown sandy clay in patches around the site; likely a recent deposit because of the landscaping/demolition that has taken place in preparation for the development work. 1001 sits above 1002, 0.05m of a concrete floor surface, likely in use after c.1945 AD. 1002 sits above 1005, an earlier brick floor surface, probably associated with the Georgian/Victorian period(s) of use as a slaughterhouse. 1005 sits atop of 1004; the

underlying brick Flemish bonded walls of the original structure. 1004's foundation cut, 1021, would've been cut into the superficial geology (1008), an orange mottled grey silty clay, though the cut is difficult to see in the groundworks. The initial foundation of 1004 is a poorly bonded course of header bricks. Surrounding the lower six to eight courses of brick is 1007, a dirty orange/brown sandy clay, which has the appearance of redeposited superficial geology filling the foundation cut and surrounding the lower courses of 1004. At the base of the sondage seen in Figs 7 & 8, the superficial geology 1008, an orange/brown mottled grey silty sand, can be seen.

(Fig 9 – Section 1 looking east)

(Fig 10 – Looking east at Section 1)

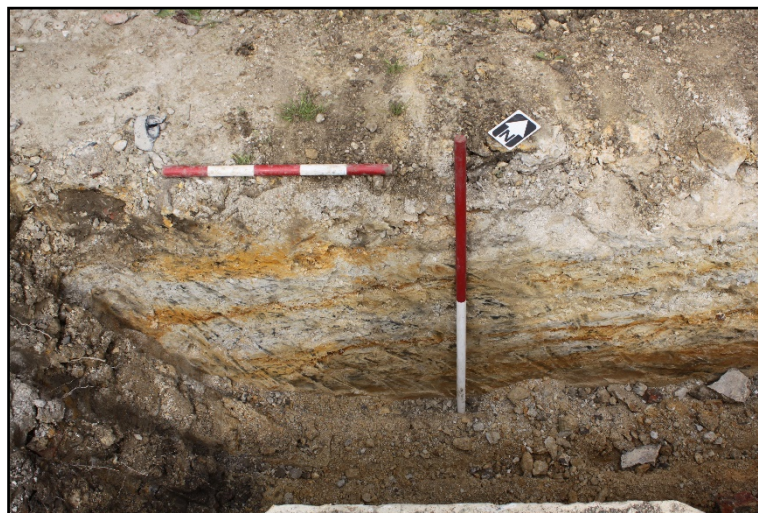
5.8. Section 2 illustrates (Figs 11 & 12) 0.05-0.08m of 1002 sits above c.0.2m of 1007, a dirty orange/brown sandy clay, which appears redeposited superficial geology filling the foundation cut surrounding the lower courses of 1004. Crucially, there is no evidence for 1004 or 1005 extending north. Therefore, although the modern concrete surface 1002 appears as an interior surface, it also surrounds the original building/slaughterhouse footprint. 1007 sits above an undetermined depth of 1008, an orange/brown mottled grey silty sand, believed to be superficial geology.

(Fig 11 – Section 2 looking north)

(Fig 12 – Looking north at Section 2)

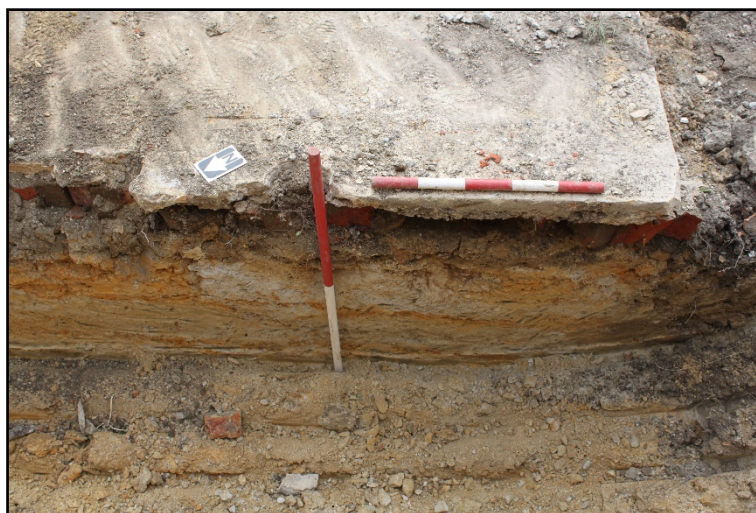
5.9. Section 3 illustrated (Figs 13 & 14) 0.05-0.08m of 1002 sits above 1005, an earlier brick floor surface, probably associated with the Georgian/Victorian period(s) of use as a slaughterhouse. Interestingly, there is no evidence of 1004 in Section 3, which implies that 1005 also skirted the outer perimeter of the building. Below 1005 is c.0.15m of 1007, a dirty orange/brown sandy clay, which appears redeposited superficial geology filling the foundation cut and surrounding the lower courses of 1004. 1007 sits above an undetermined depth of 1008, an orange/brown mottled grey silty sand, believed to be superficial geology.

(Fig 13 – Section 3 looking south)

(Fig 14 – Looking south at Section 3)

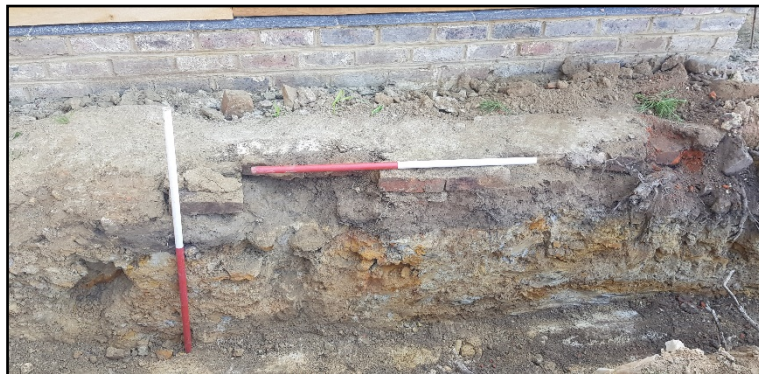
5.10. Section 4 illustrates (Figs 15 & 16) a continuity of stratigraphy on the site's east side. 0.05-0.08m of 1002 sits above 1005, an earlier brick floor surface, and indicates that

1005 extended east, perhaps to provide a floor surface for a lean-to, or similar timber structure, attached to the original building. No evidence of 1004 in Section 4. Below 1005 is c.0.2m of 1007, a dirty orange/brown sandy clay, which appears redeposited superficial geology filling the foundation cut and surrounding the lower courses of 1004. 1007 sits above an undetermined depth of 1008, an orange/brown mottled grey silty sand, believed to be superficial geology.

(Fig 15 – Section 4 looking east)

(Fig 16 – Looking east at Section 4)

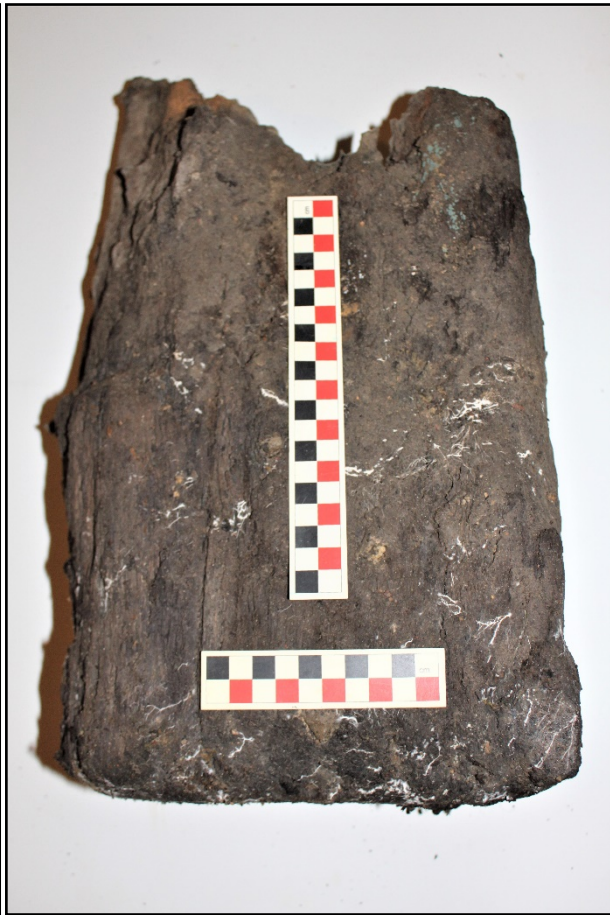
- 5.13. Figs 19 & 20 illustrate 1020, a large wooden post sunken upright into 1008 to the east of 1004 and likely formed a structural part of a lean-to, attached to the original building. 1020 appears to have been snapped off at below ground level, but not recently.

(Fig 19 – looking north at 1020 in-situ)

(Fig 20 – Building post 1020)

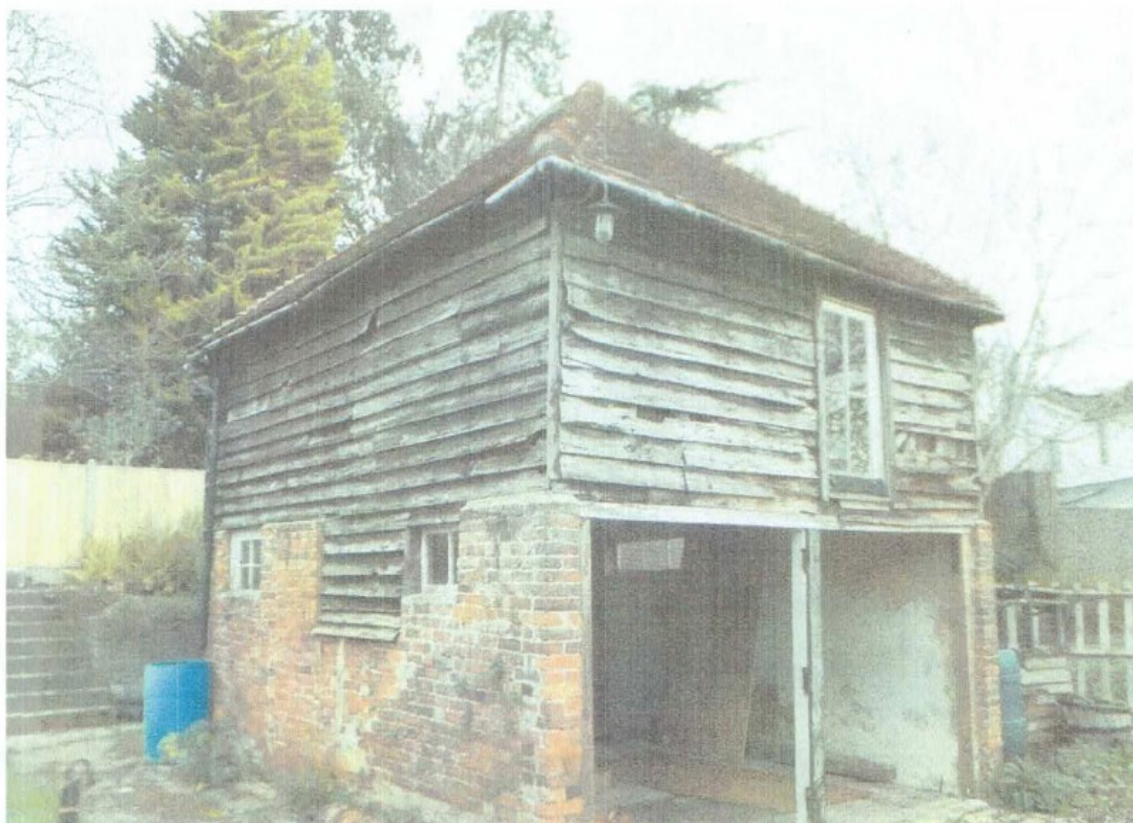
(1)

OVERALL LOOK OF BUILDING
DECEMBER 2020!

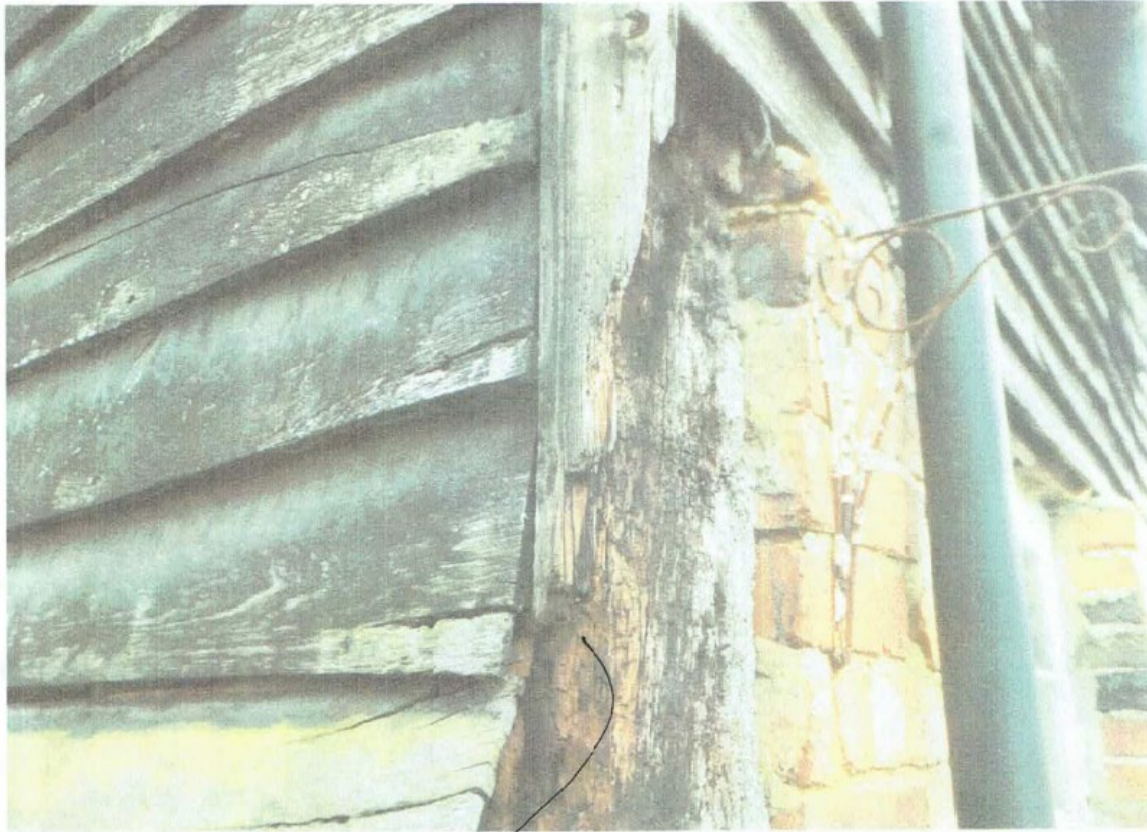
A

ROTTEN TIMBER
SPOKE WOOD AND
CHIPPING.
