REPORT FOR AN ARCHAEOLOGICAL WATCHING BRIEF AT THE GEORGE INN, CHURCH STREET, SHOREHAM, KENT

George Inn, Church Street, Kent
Archaeological Watching Brief
Report reference: # DAS 0016-21
© Darnley Archaeological Services
01 June 2021

Planning Reference: 20/03465 & 20/03466

DAS Site Code: TGS21-WB

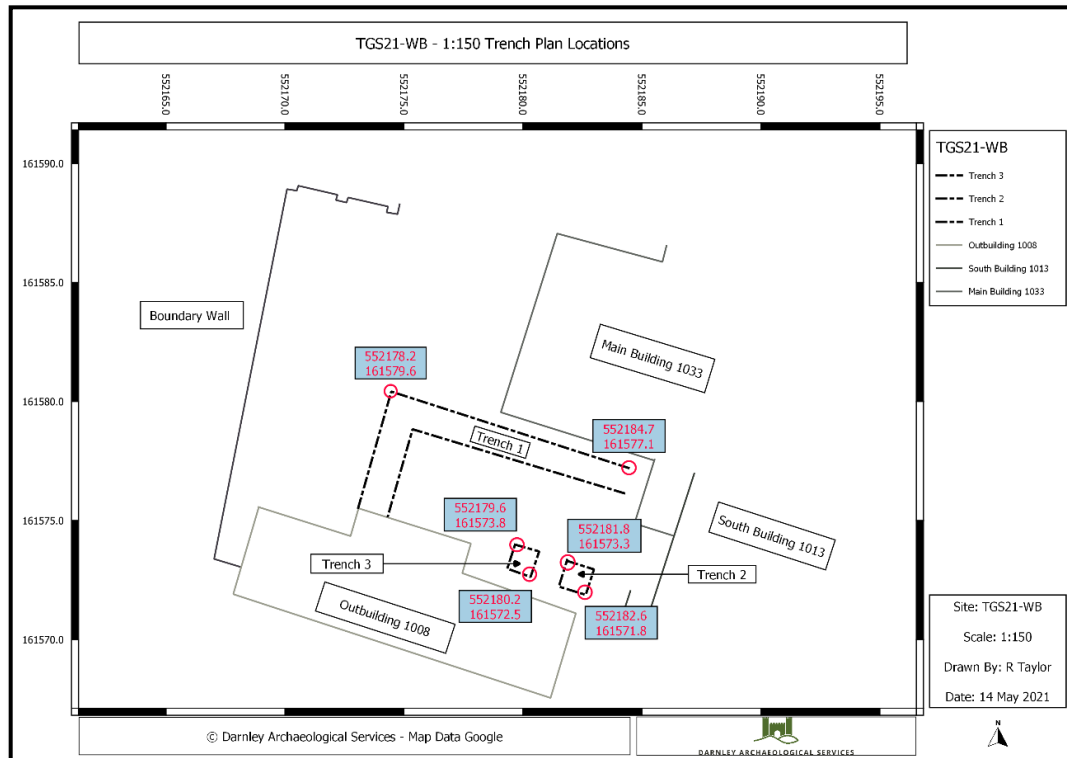
(Fig 5 – TGS21-WB 1:150 Trench Locations)

- 4.6. Excavation areas were set out according to the plans (Fig 5). Locations were recorded using GNSS.

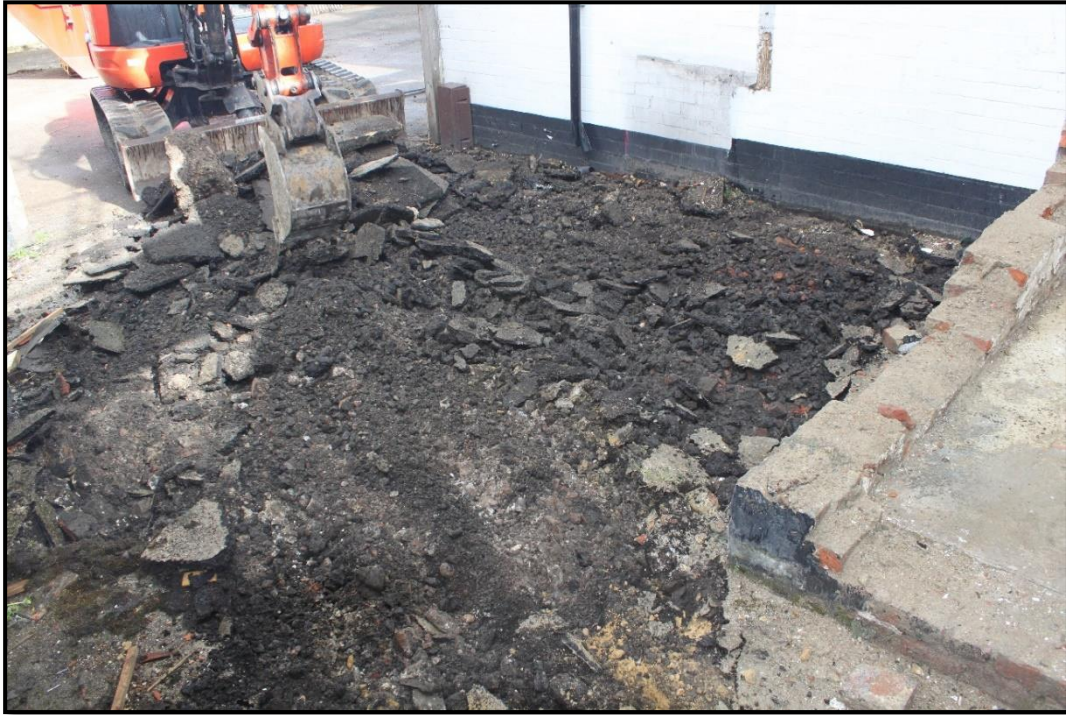
The initial work required removing 1001, a modern tarmac spread of 0.05-0.1m across the site.

(Fig 7 – looking northwest across the site at the removal of 1001)

1001 abuts toilet block 1004 to the north, concrete surface 1005 and south range of main building 1013 to the east, and outbuilding 1008 to the south. Toilet block 1004 appears to have been constructed c.1980 AD, placing 1001 at a similar or after the date.

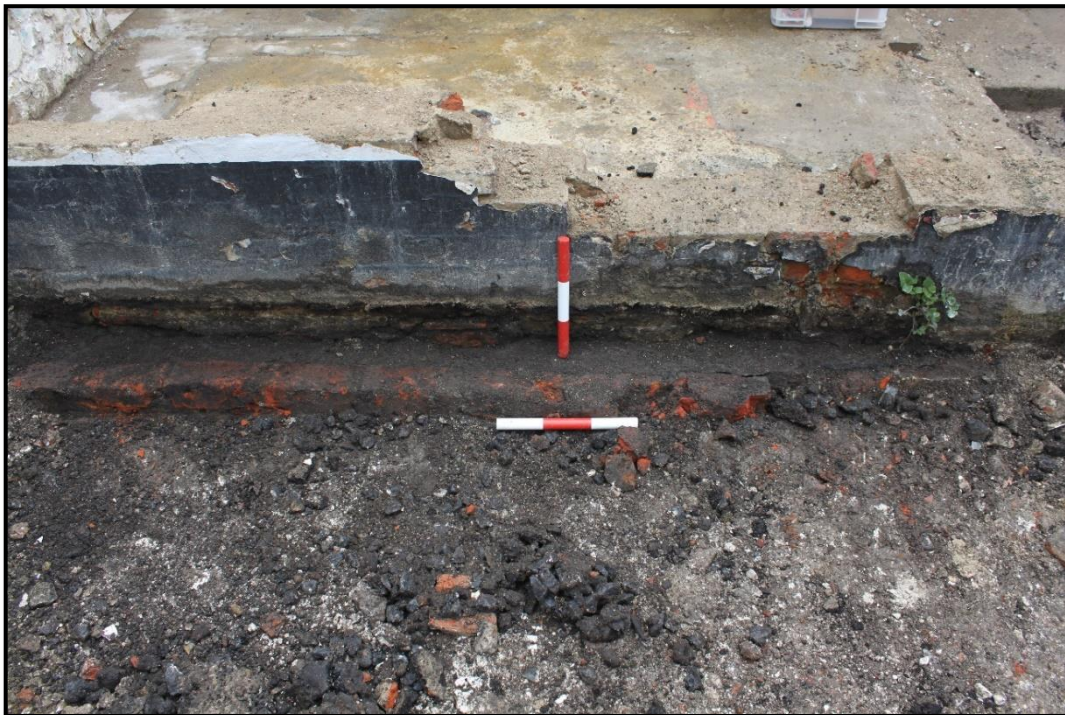
(Fig 8 – looking north at concrete surface 1005, laid atop of brickwork block surface 1006 with 1038 in the foreground)

Closer to the buildings, the gradual removal of 1038 for c.0.1m toward 1005 revealed 1006, a brickwork block surface, under 1001, that appears to head west toward building 1013 and under concrete surface 1005. A thin bitumen spread, 1009, was applied to the surface of the exposed brickwork of 1006 in front of 1005 (Fig 8).

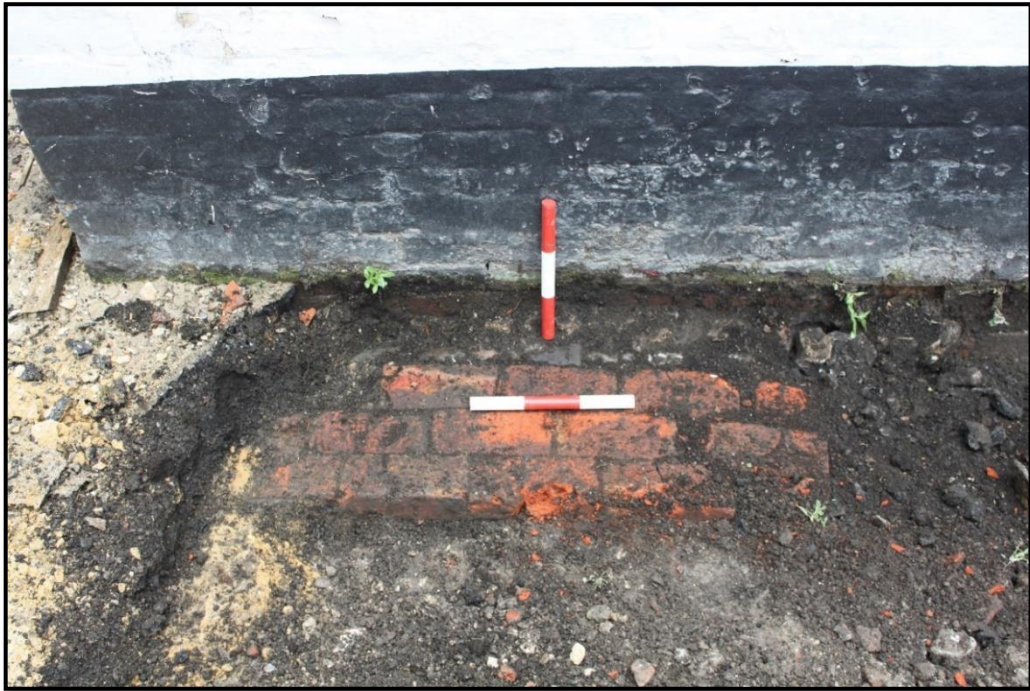
Removal of 1001 to the south, adjacent to outbuilding 1008, revealed a similar brickwork block surface 1007, which appears to sit on 1038 and likely the same as 1006.

(Fig 10 - looking south toward 1008 and brickwork block surface 1007 with 1038 in the foreground)

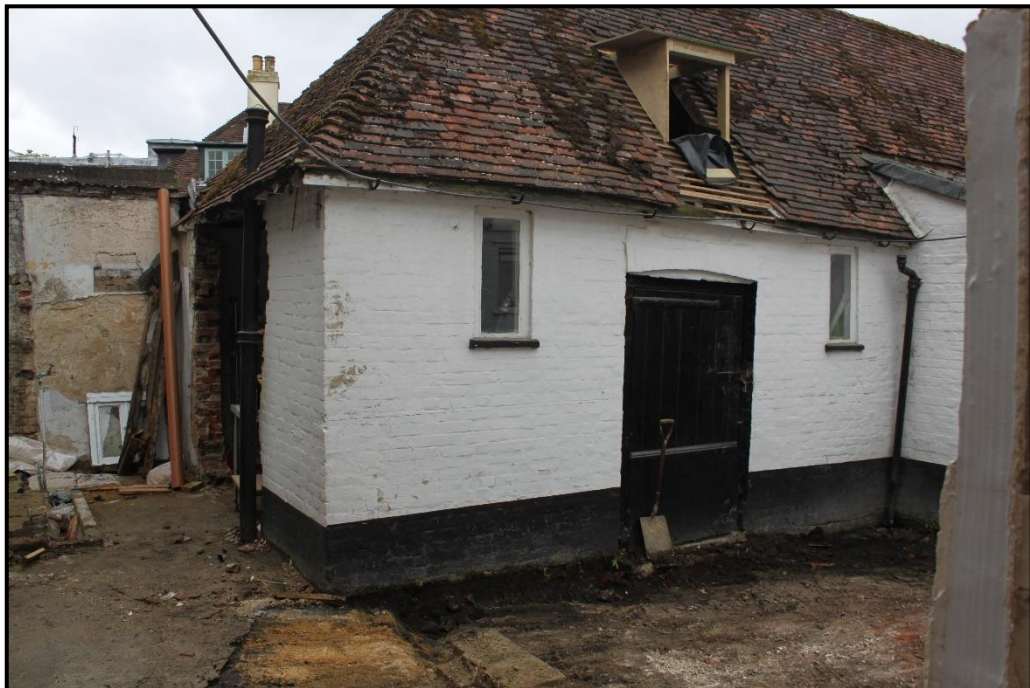
1008 has a separate listing of TQ 56 SW 173 as a Grade II Listed Building and believed to have been built as an 18th century coach building (Fig 11).

(Fig 11 - looking south at outbuilding 1008)

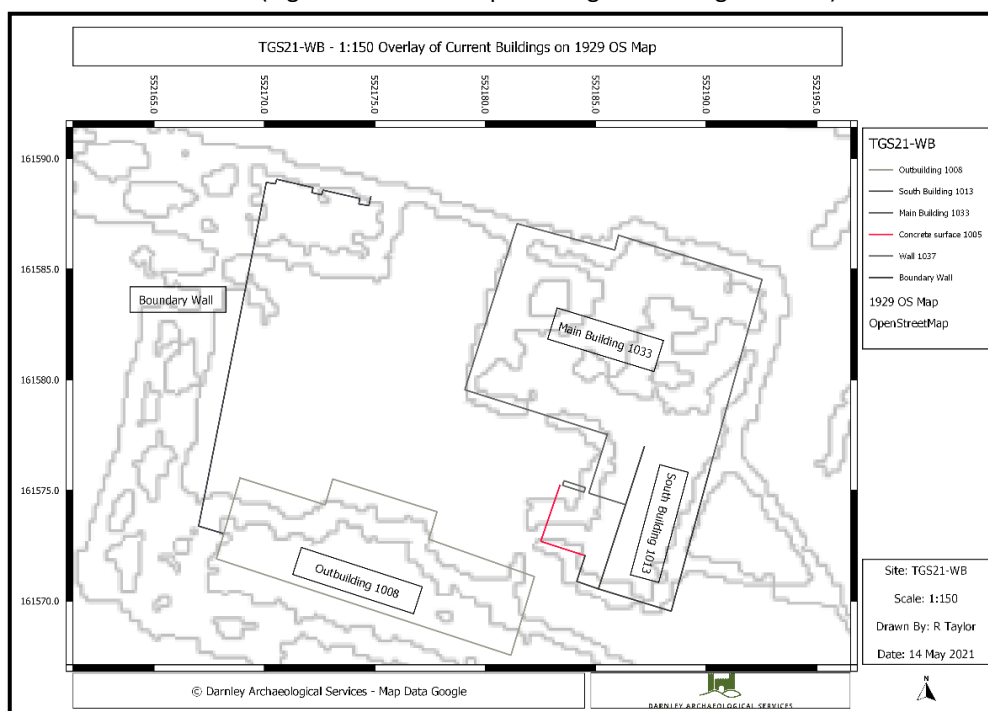
(Fig 13 - 1929 OS Map showing altered frontage to 1008)

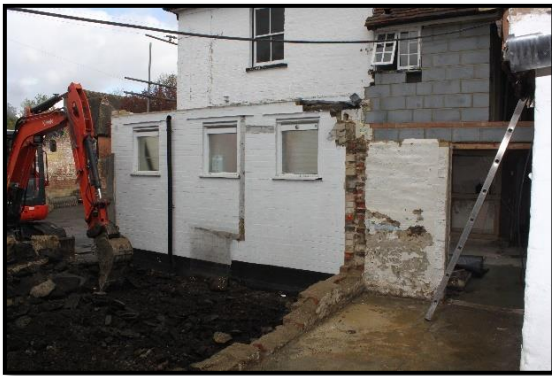
The next step was the demolition of toilet block 1004. The demolition exposed building fabric consistent with a dating of c.1980 AD. It revealed that 1004 was built onto a mid-Victorian extension 1041 onto the west of the original main building 1033.

(Fig 14 – looking northwest at 1004)

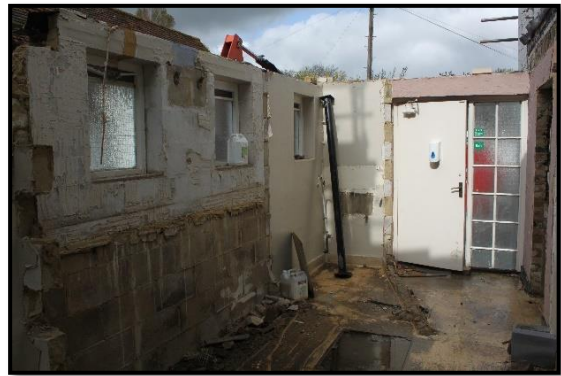
(Fig 15 - internal view of 1004 looking southwest)

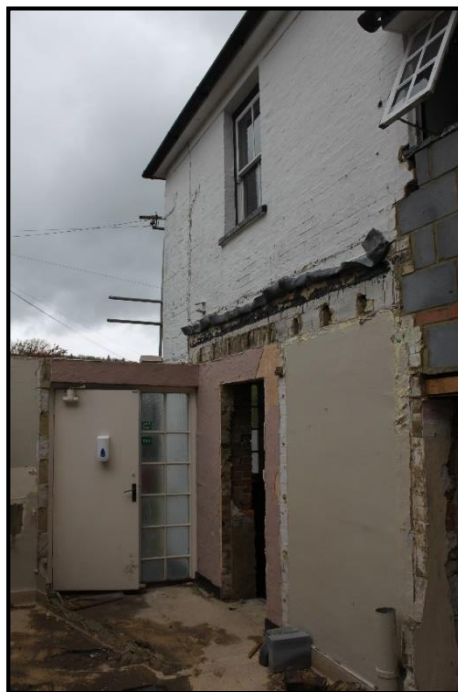
(Fig 16 – looking northwest at how 1004 is built onto 1041)

Fig 16 illustrates how the erection of 1004 incorporated a single course of brick (yellow) added to the exterior brick (red) of 1041. Following the demolition of 1004, concrete surface 1005 was removed. 1005 is a modern concrete floor approximately 0.1 to 0.15m in thickness. Upon removing 1005, a further concrete spread 1010 about 0.05m in thickness was revealed. 1010 appeared to cover 1006, the latter seemingly continuing east. As 1010 was removed, a sandstone slab was unveiled at a threshold of 1013. The slab and 1006 were set into 1042, a yellow sandy mortar about 0.05 to 0.1m thick.

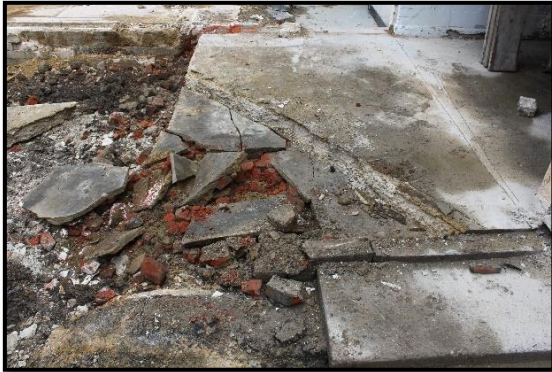
(Fig 17 – looking north at the removal of 1005)

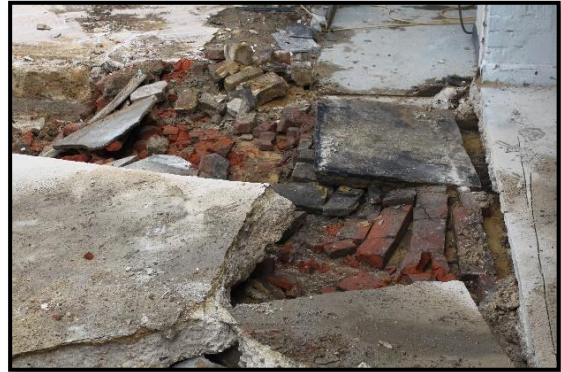
(Fig 18 - looking north at sandstone slab)

The revealed threshold raised questions about the age of 1013. 1013 is an aspect of the original L-shaped building erected in c.1550 AD. However, there has been conjecture about the age of 1013, mainly that it is a later addition to 1033. This appears in part true, and the newly revealed threshold indicates it predates 1006 and 1007 but maybe stratigraphically contemporary with the construction of 1008.

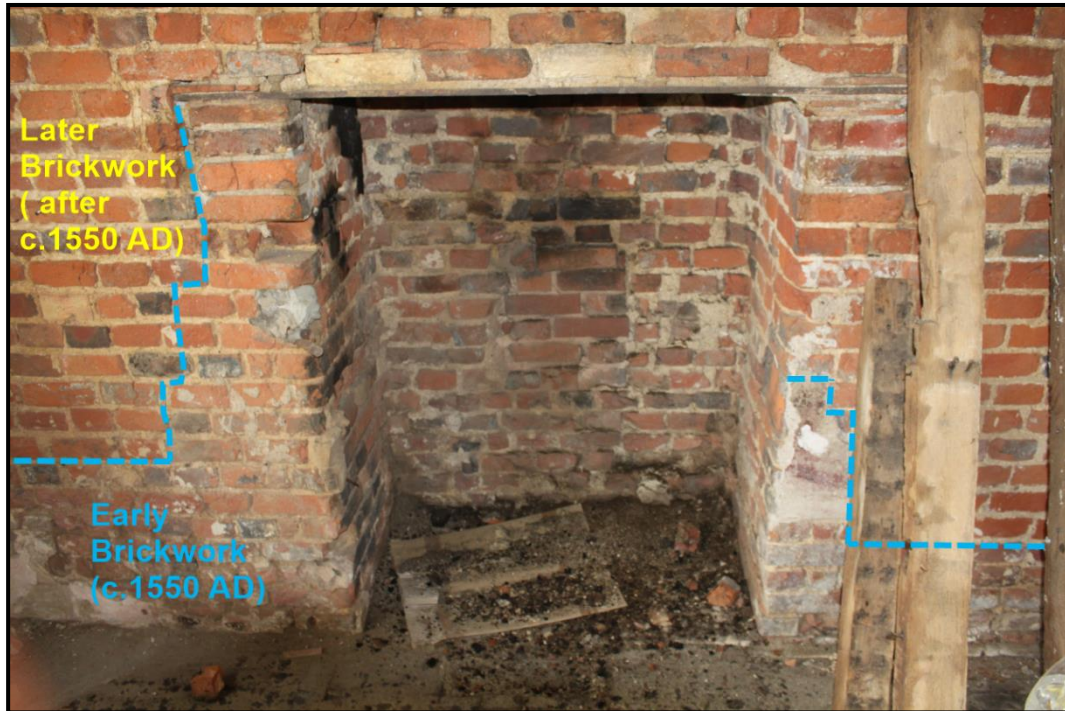
(Fig 19 – looking south at fireplace and brickwork in 1033)

An inspection of the existing internal beams and brickwork suggest a gable end to 1033, onto which 1013 was built later. Firstly, the dragon beam visibly ends at the gable end (see **11.2 & 11.4**). Secondly, there appear to be two phases of brickwork on the north-facing wall of 1013. The lower brickwork courses (presumably a platform for the gable end) is different to the more regular and orange brickwork above (Fig 19) but the same as the north-south, east-facing wall of 1033 (see **11.2**).

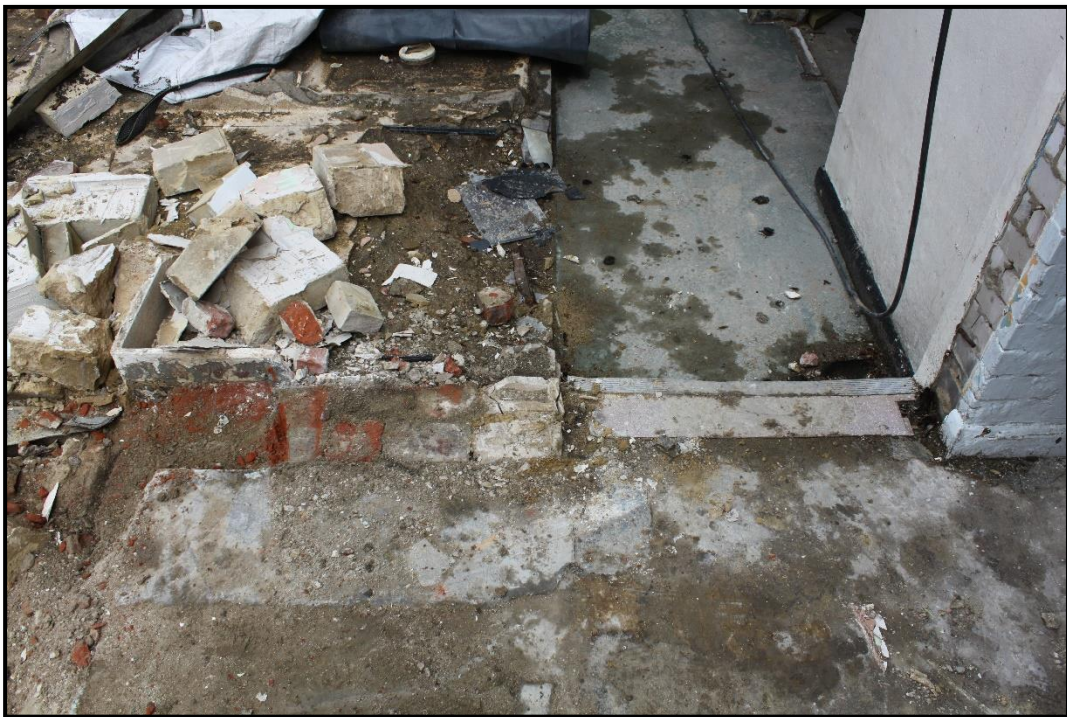
(Fig 20 – Wall 1035 visible projecting west from 1013)

The removal of 1005, 1010 and 1006 revealed a brick wall 1037 projecting west from 1013. This wall is thought to have turned south and returned to the southwest corner of 1013. 1006 was likely mortared to 1037 with 1042. 1042 sits atop 1038, which, in this area, was approximately 0.3m in depth. 1038 sits above 1003, a dark brown sandy clay with chalk flecks thought to be an early occupation layer. 1003 sits atop 1030, a buff sandy silt containing pulverised chalk and considered natural geology (head deposits), affirming the potential age of 1003.

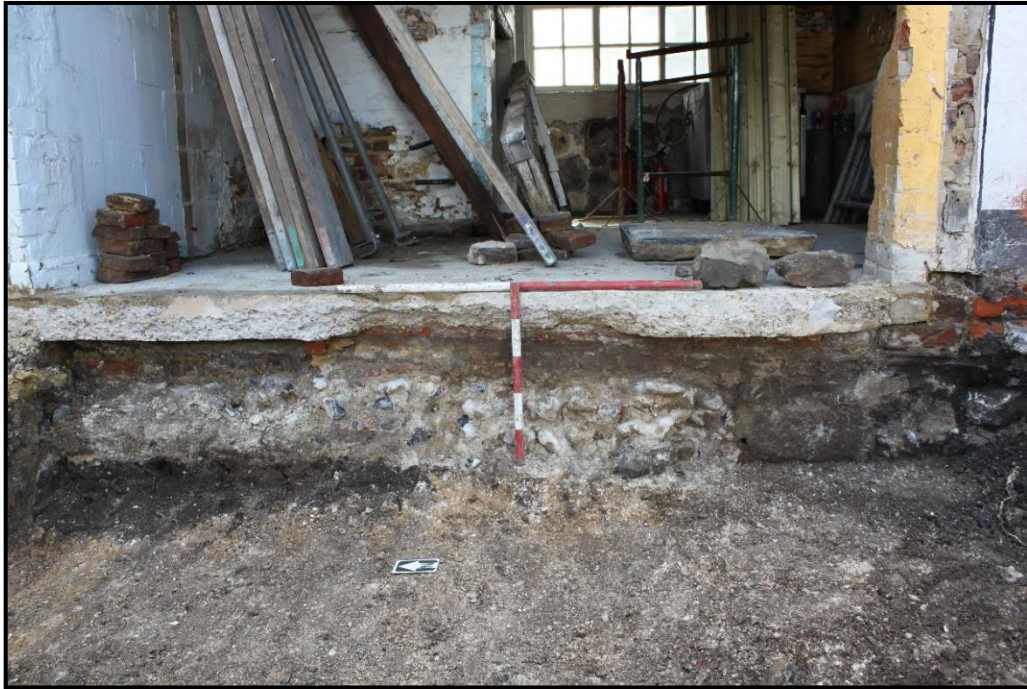
(Fig 22 – Looking east at foundations 1012 & 1015; brick courses can be seen above)

Under 1013, two distinct foundation courses were viewed. Firstly, 1012, a flint nodule and mortar foundation can be seen to the north. Abutting 1012 to the south is 1015, a series of mortared, reused stonework of varying types.

Both foundations (1012 & 1015) appear to support a continuous course of brick that makes up the west wall of 1013. 1015 is interesting as it contains faced greensand and ragstone blocks. It is unlikely that the builders of the George Inn would have worked this stone then place it in a foundation course, so it is assumed that these blocks are likely recycled from an earlier (medieval) structure. Moreover, placing large stone blocks as foundation material under the various corners of the George Inn is consistent practice (see 11.3). The placement and construction method of foundation 1012 is logical – the compaction and depth (0.2m to 0.3m) of the flint and mortar tolerates the load of 1013's west wall. Indeed, the courses of brick above remain level to this day.

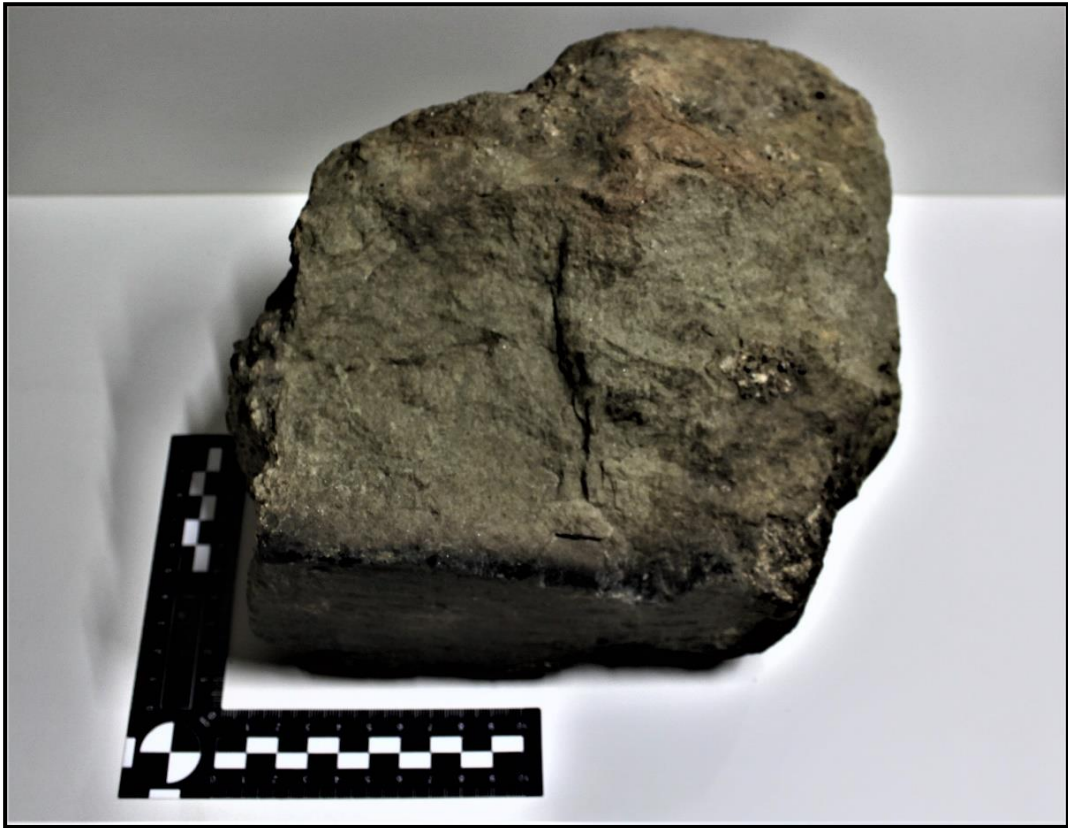
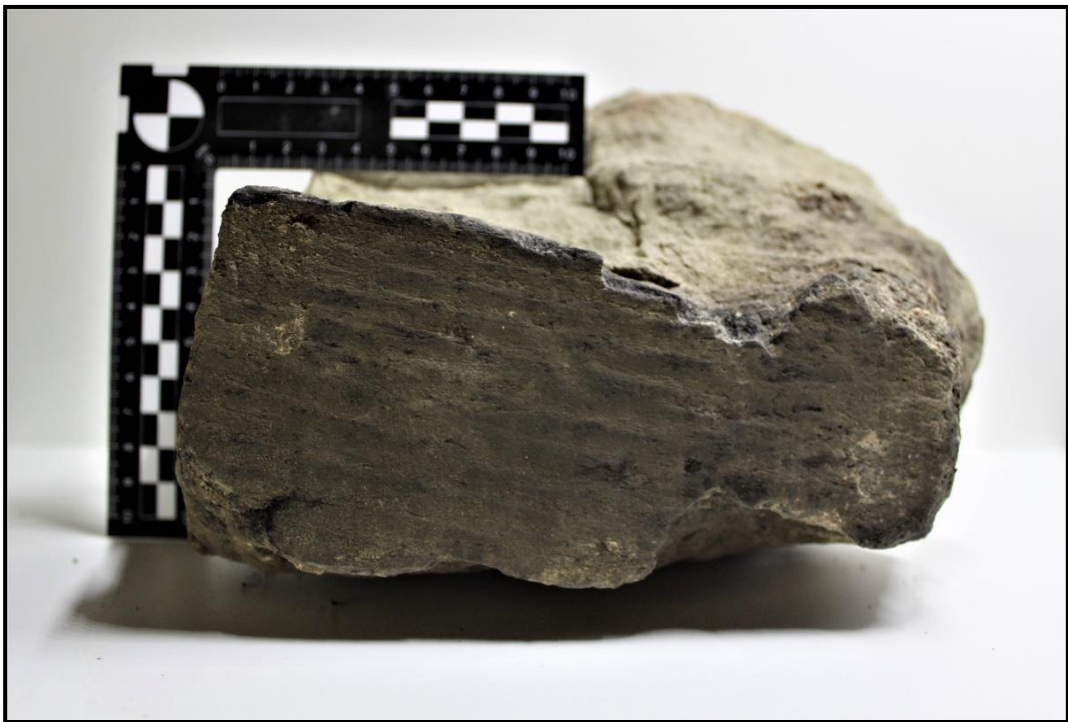
(Fig 24 – transverse view of SF1)

(Fig 25 - Lateral view of SF1 showing tool markings to carbonised face)

Two pieces of discarded building stone were retrieved from the interface between 1038 and 1003, close to foundation 1015. The first piece (SF1) is greensand and has a dressed side exhibiting horizontal/vertical tool markings. This dressed side is carbonised, implying the stone was salvaged/reused from a fireplace or chimney of an earlier Medieval building, likely demolished before the erection of the George Inn c.1550 AD. The second piece (SF2) is ragstone and has two dressed sides with tool markings. Although not as finely worked as SF1, one dressed side is also carbonised and likely salvaged/reused from similar circumstances.

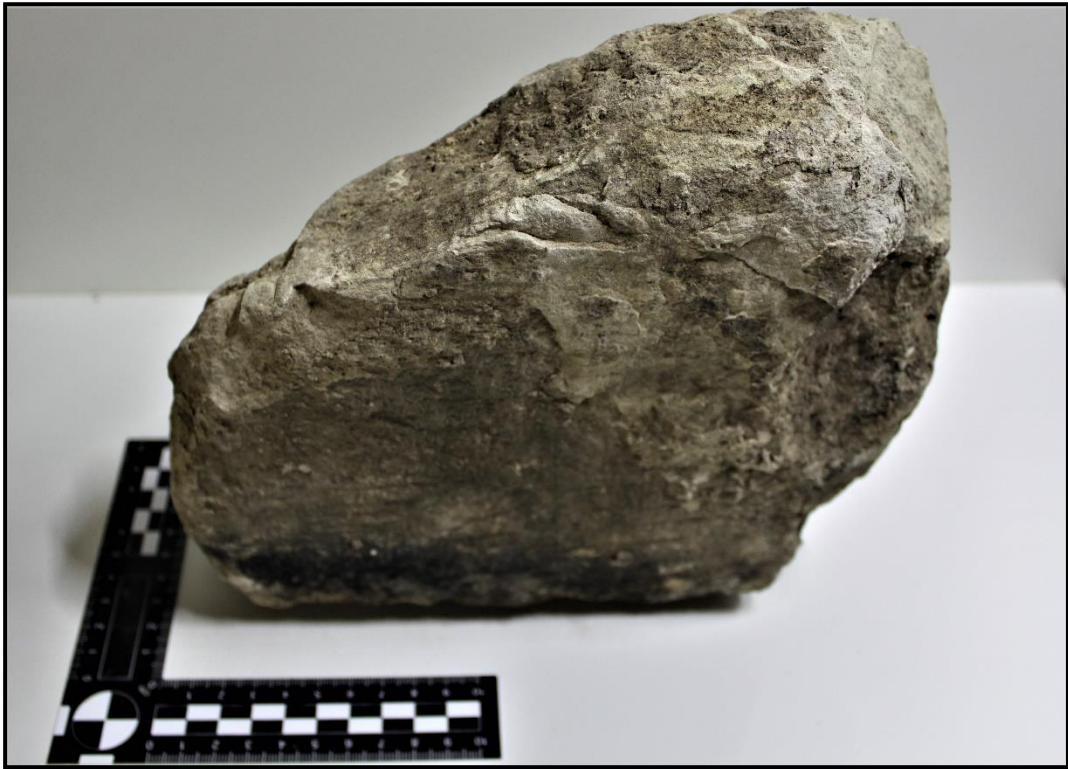
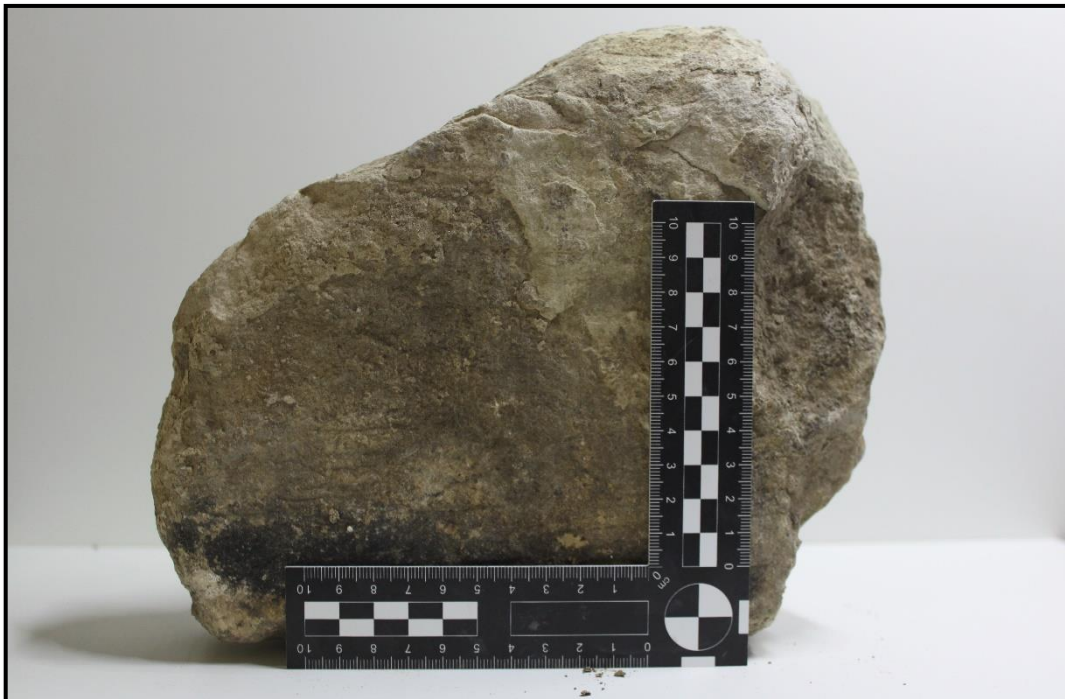
(Fig 26 – transverse view of SF2)

(Fig 27 - Lateral view of SF2 showing tool markings to carbonised face)

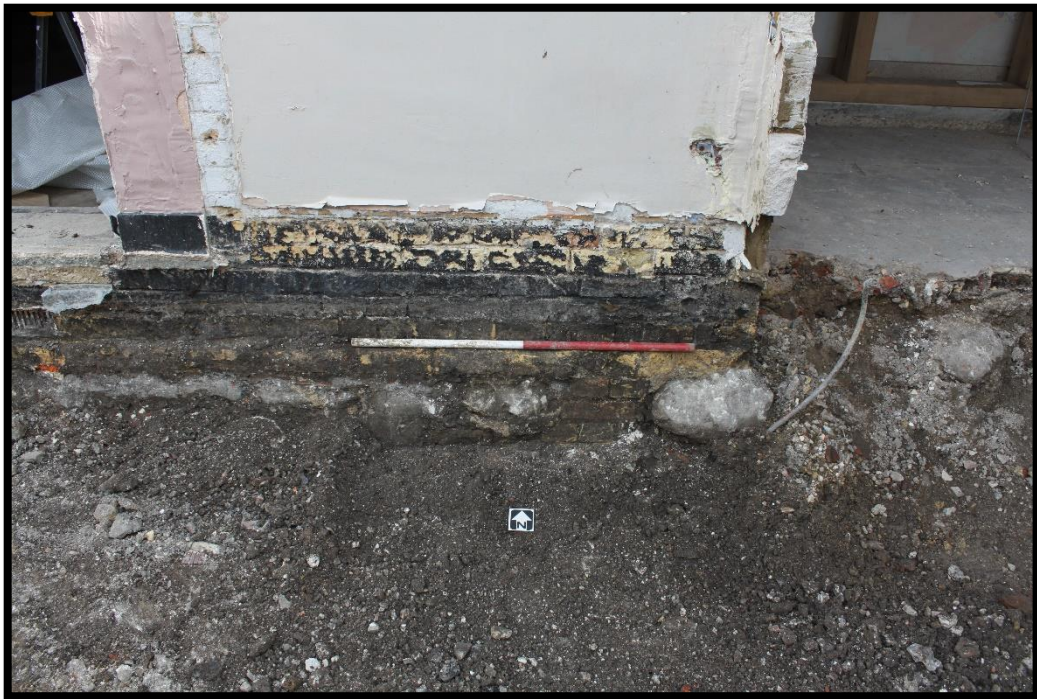
Toward the south of the main building 1033, the underlying material was removed adjacent to the Victorian extension 1041, bringing the area down to the required level.

(Fig 28 – looking north at Victorian extension 1041)

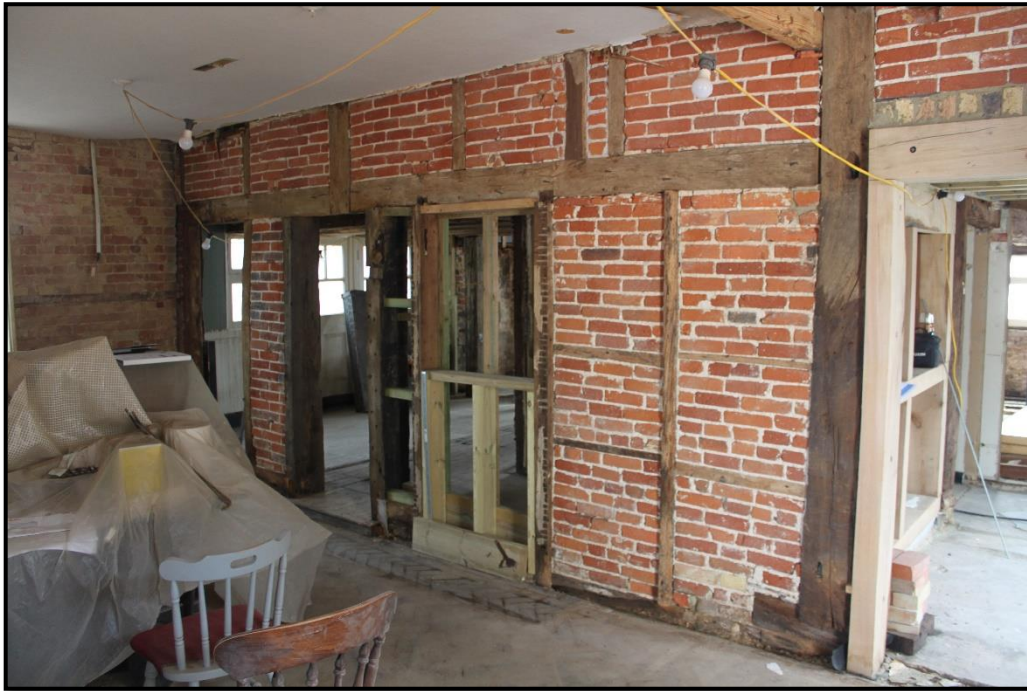
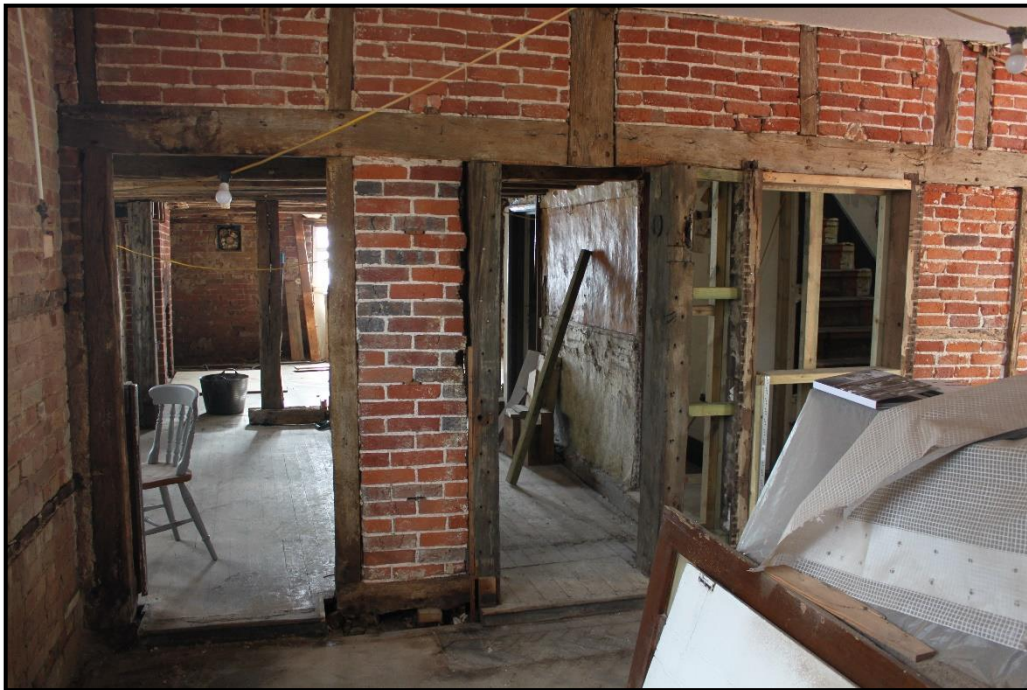
(Fig 29 – looking northeast at timber framework of original west-facing exterior wall c.1550 AD)

(Fig 30 – looking east at timber framework of original west-facing exterior wall c.1550 AD)

The original west-facing exterior of the c.1550 AD build can be seen in the timber framework in Figs 29 & 30.

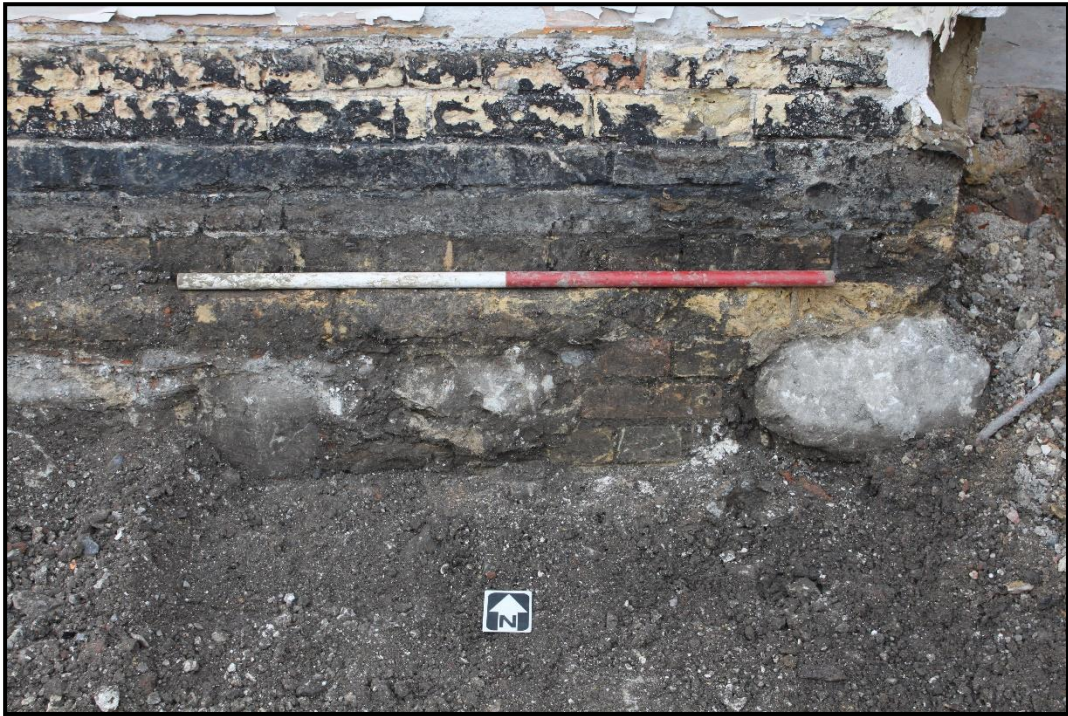
(Fig 32 – Looking north at foundation 1040)

The first material removed from the exterior surface was 1038, then 1003, revealing the foundation 1040 for this part of the main building. Foundation 1040 is comprised of mortared brick and ragstone blocks, cut into 1003. In keeping with their role as foundation material, the ragstone blocks appear crudely shaped and not to be seen above ground. Interestingly, there is no greensand evident in the foundation course, nor is there any evidence that the ragstone is dressed or carbonised in any way. It is less likely that 1040 contains any reused material from a previous medieval structure, given these foundations were built c.300 years after foundation 1012 and 1015. However, the construction methods for both foundation courses are similar.

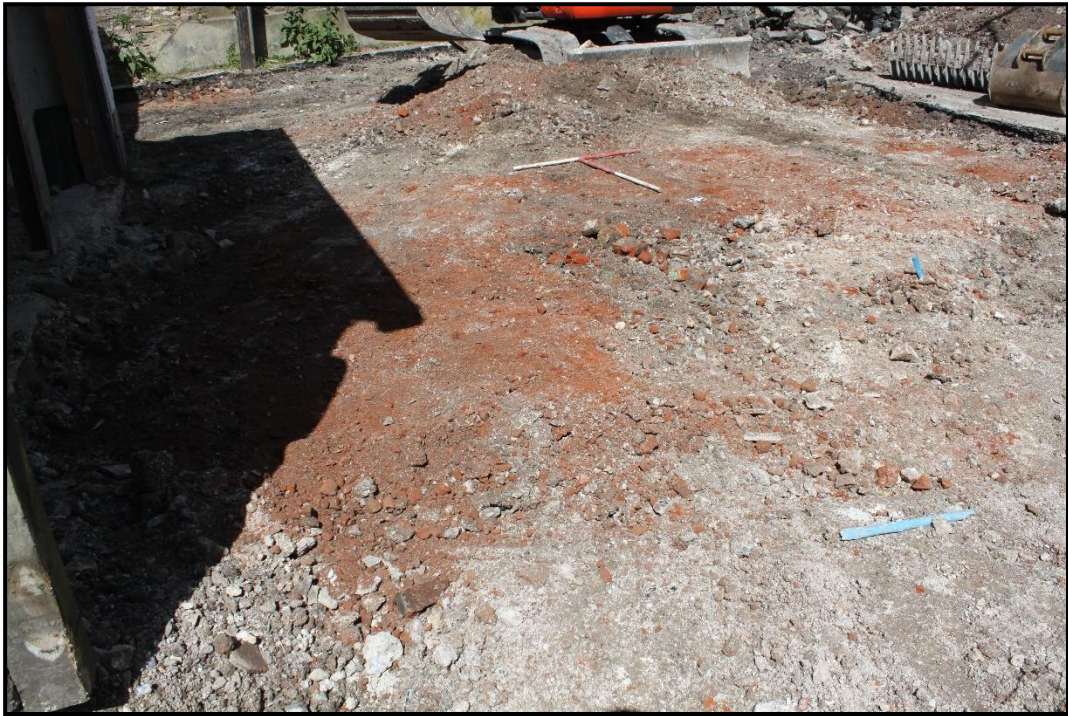
Upon removal of 1001, the courtyard surface 1035, comprising brick pieces & chalk, was revealed across the west extent of the site.

(Fig 35 – looking northwest across courtyard surface 1035)

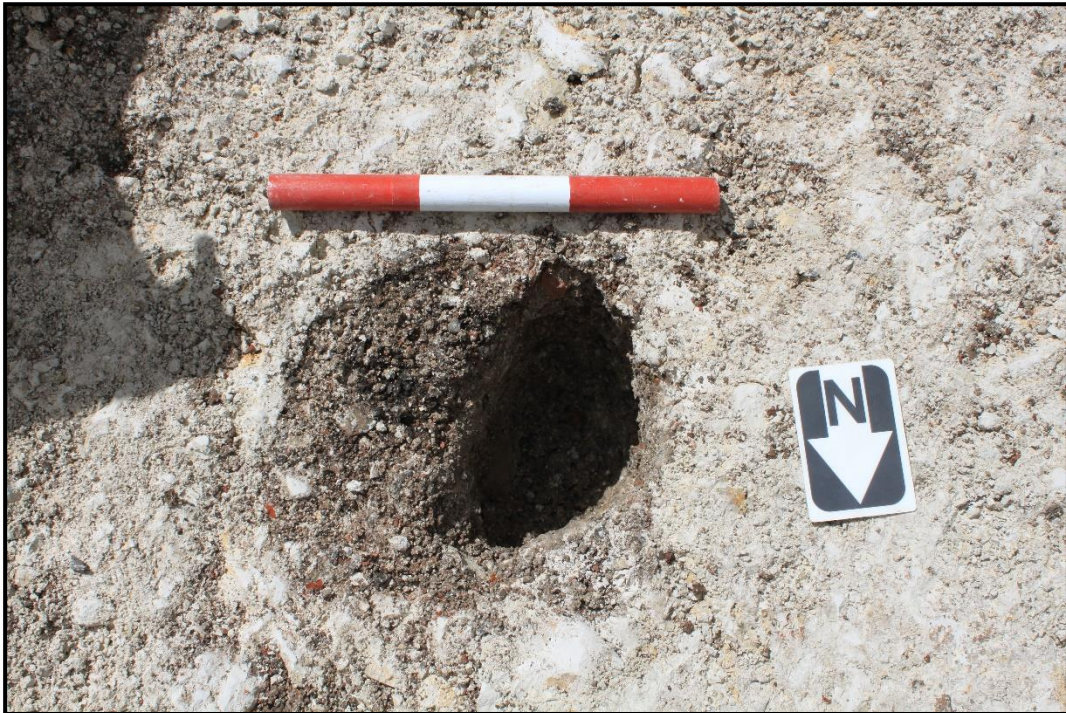
Removal of 1035 revealed an early surface 1019, a redeposited chalk spread, thought to be an early surface or hardstanding, possibly associated with converting the building from private residence to public house. Several features cut into 1019 were observed and recorded. Firstly, a small posthole 1026 c.0.25m in diameter was located near the northeast corner of building 1008. 1026 was filled with 1027, a clay/chalk matrix containing tile and brick pieces.

1027 contained a rim sherd of Kentish red earthenware (C. 1750 – 1800 AD), dating the pit to c.1800 – 1850 AD.

(Fig 36 – Posthole 1026 cut into 1019)

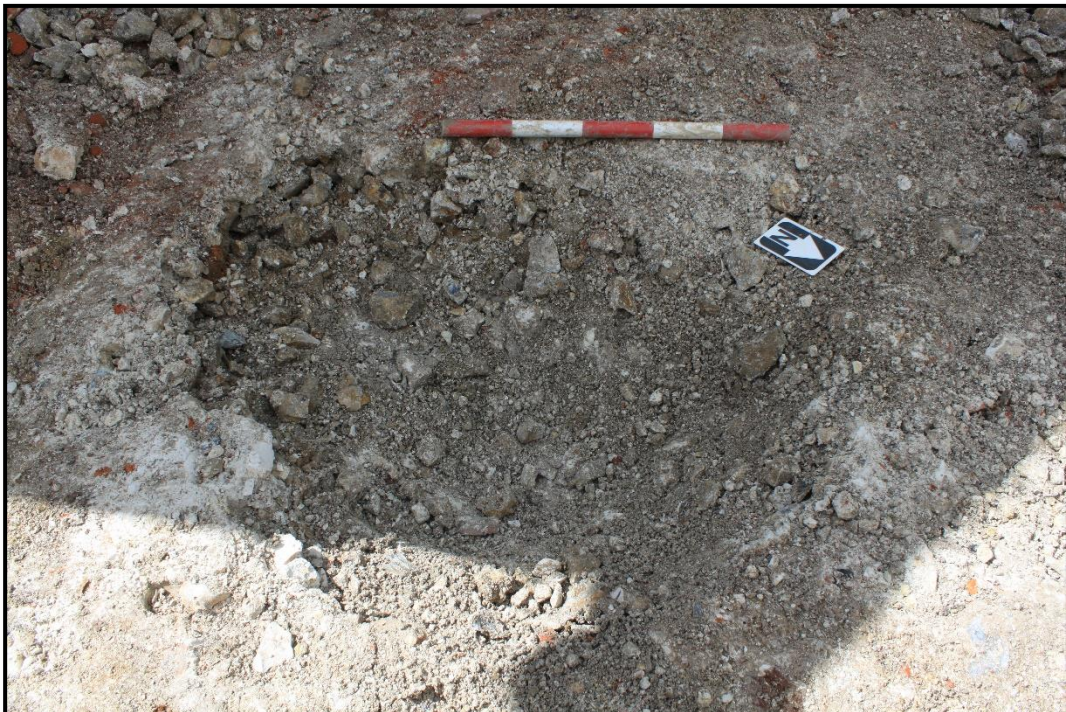
Approximately 1.0m west of 1026 is 1024, a circular pit 1.0m in diameter. 1024 is filled with 1025, a chalk/clay matrix containing flint and roof tile pieces.

(Fig 37 - Pit feature 1024 cut into 1019)

1025 contained sherds of pottery and pieces of animal bone, so likely to have been a small rubbish pit. The pottery sherds included one Staffordshire yellow ware (c.1825 – 1900 AD) and several Kentish red earthenwares (C. 1750 – 1800 AD), dating the pit to c.1825 – 1850 AD.

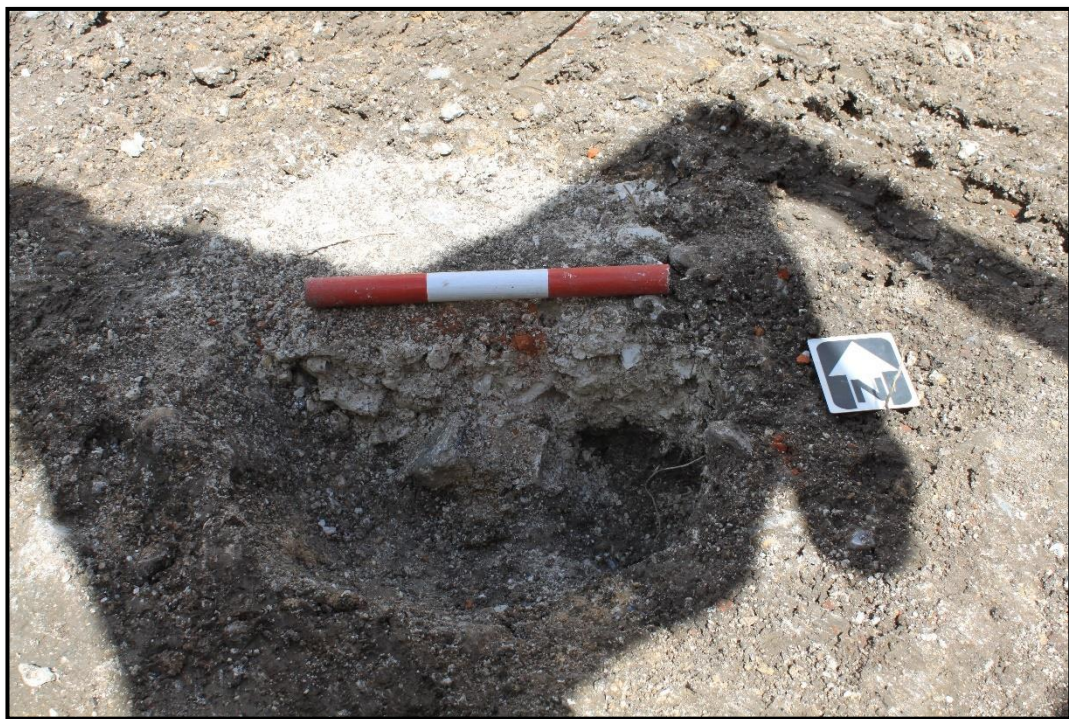
Approximately 3.0m east of 1026 is 1028, a posthole c.0.35m in diameter cut into 1038. 1028 is filled with 1029, a chalk/clay matrix containing tile and brick pieces. 1019 appears as an upper fill or covering. Beyond the brick and tile pieces, only a small quantity of animal bone was recovered from 1029. Unlike 1026 and 1024, which appear to be cut into 1019, 1028 is partially filled by 1019, which predates the chalk spread. Without any diagnostic finds to present an accurate date range, 1028 predates both 1024 and 1026, so a before c.1800 AD date seems appropriate in the broader context of the site and nearby features.

(Fig 38 – Posthole 1028 cut into 1019 and 1038)

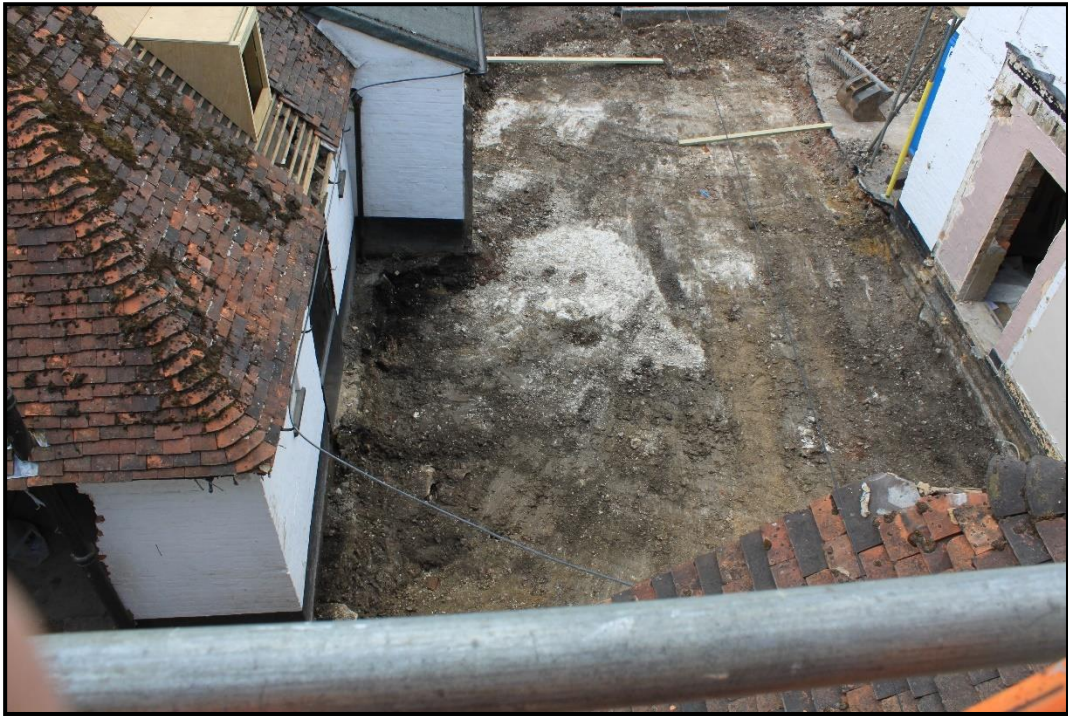
Modern drains 1020, 1031 and soakaway 1022 all cut through 1035, 1016, 1019 1038, 1003 and 1030.

(Fig 39 – excavation area before Stage 3 showing remnants of 1019, 1003 and 1030 appearing at the surface and the darker modern drain cuts of 1020, 1031, and soakaway 1022)

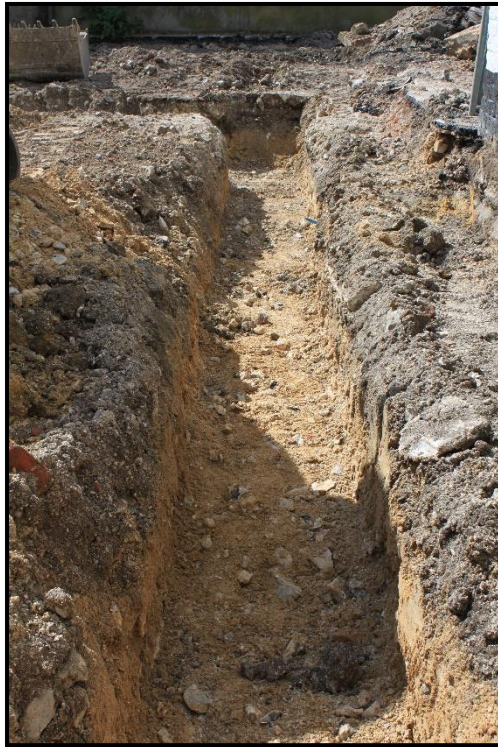
Trench 1 was excavated 0.6m wide and to a depth of 0.6m from the new ground surface. Throughout the 11.0m segment, the remaining 1019 was removed in the west, below which was a 0.1 to 0.2m band of 1003. 1003 sat above natural 1030, which, in turn, continued to the base of the trench. A 0.1m band of 1003 was removed in the east, which also sat above 1030 and continued to the trench base. Throughout the 5.0m segment, the remaining 1019 was removed in the west, below which was a 0.1 to 0.2m band of 1003. 1003 sat above natural 1030, which, in turn, continued to the base of the trench.

(Fig 41 - looking west along Trench 1)

No archaeological features or finds were recovered during the excavation of Trench 1. However, Trench 1 did confirm natural geology, above which is 1003, the dark brown sandy clay – chalk flecks – and, due to its stratigraphic position, further implies it is probably an early occupation layer across the site.

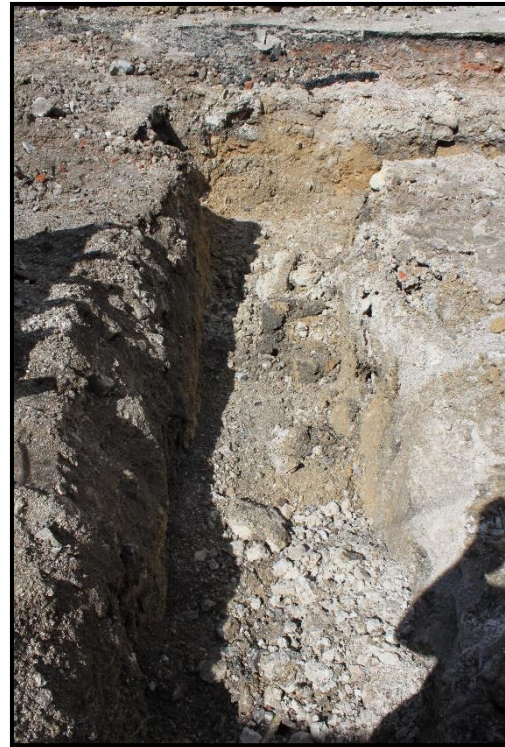
(Fig 42 - looking north along Trench 1)

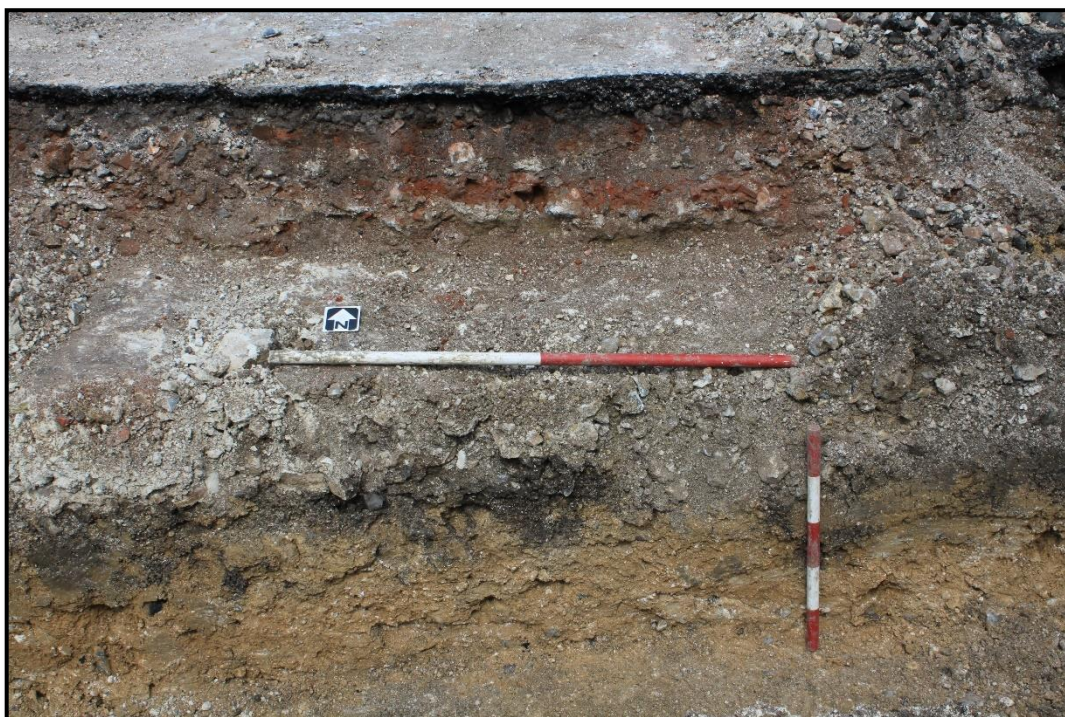
(Fig 43 – looking north at Section 4 at a stratigraphic sequence from 1001 to natural geology)

A complete stratigraphic sequence from 1001 to the natural geology 1030 is visible at the northeast of Trench 1. Modern tarmac 1001 sits above 0.1m of 1035, a later courtyard surface of brick pieces in a thin clay and chalk matrix. 1035 sits above 1034, 0.05m of a chalk spread. Below 1034 is 0.1 to 0.15m of 1016, an earlier courtyard surface of brick pieces and chalk. 1016 sits above 0.05m of 1036, a layer of brown sand believed to be bedding for 1016. Below 1036 is 0.1m to 0.2m of 1019, a surface of compacted chalk, and likely the earliest courtyard or hard standing associated with the George Inn. Below 1019 is 1003, a dark brown sandy clay with chalk flecks and a probable early occupation layer. Foundation courses 1012 and 1015 are cut into 1003, suggesting a date of before c.1550 AD. 1003 sits above an undetermined depth of 1030, a buff sandy silt containing pulverised chalk and probable upper Head deposits (natural).
