REPORT FOR AN ARCHAEOLOGICAL WATCHING BRIEF AT THE GEORGE INN, CHURCH STREET, SHOREHAM, KENT

George Inn, Church Street, Kent
Archaeological Watching Brief
Report reference: # DAS 0016-21
© Darnley Archaeological Services
01 June 2021

Planning Reference: 20/03465 & 20/03466

DAS Site Code: TGS21-WB

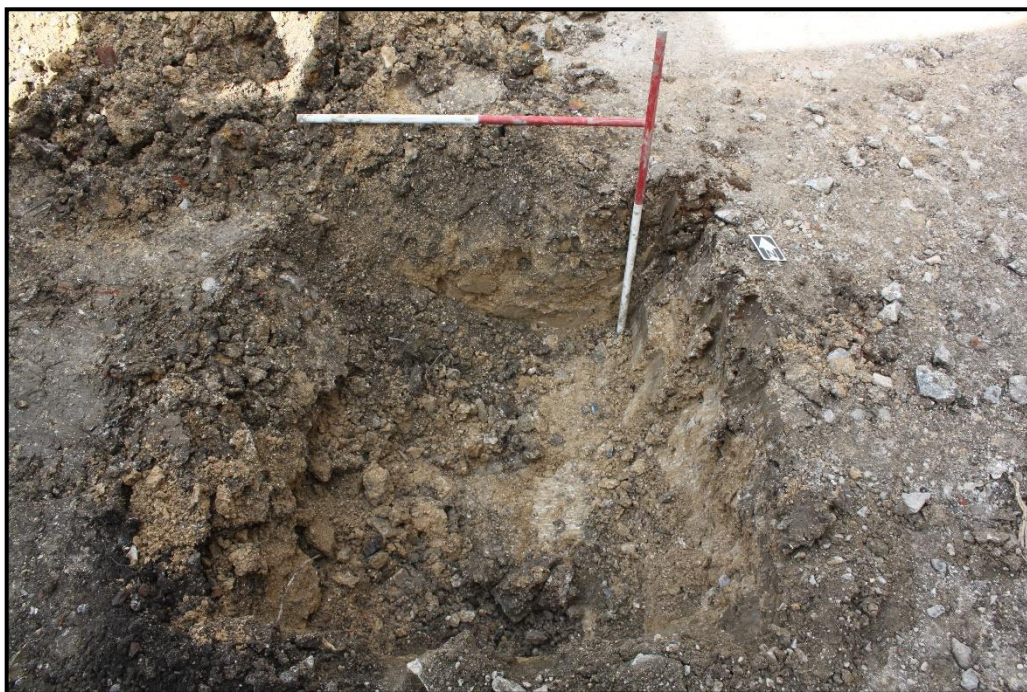
Trenches 2 and 3, both 1.0m² post pads, were excavated to a depth of 0.6m. In Trench 2, 0.2m of 1003 sat above 0.4m of 1030. Three sherds (same vessel) were recovered from 1003; they reaffirmed that 1003 is a medieval layer. All three sherds are Northwest Kent fine-moderate greyware (Dartford 'rilled' ware) c.1225-1400 AD (Fig 46 and **12.3**).

(Fig 45 - looking north at Trench 2)

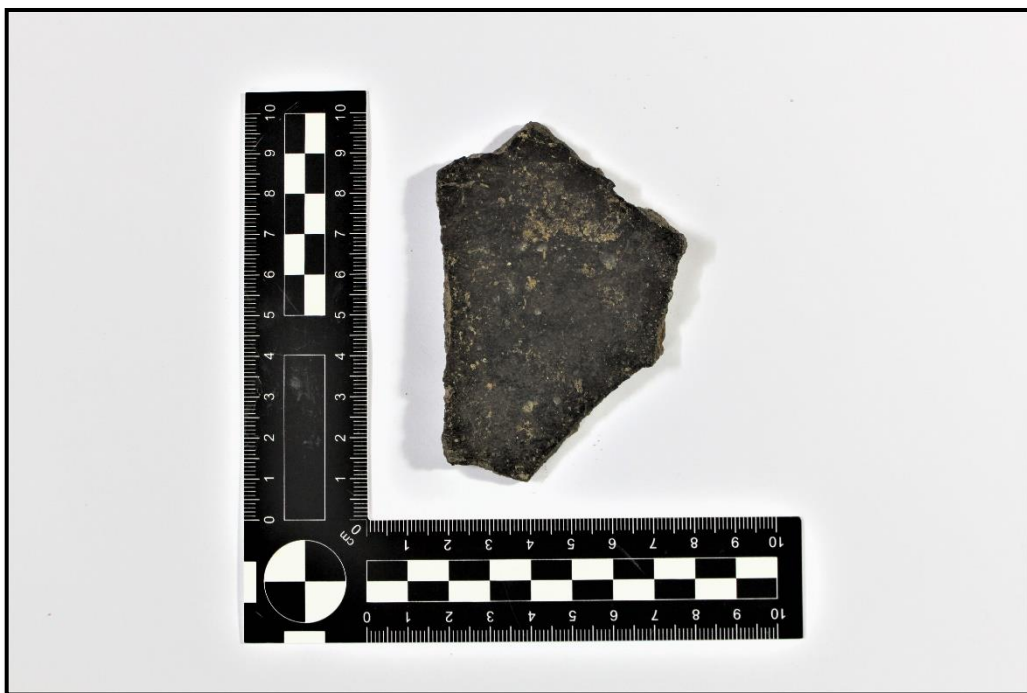
(Fig 46 - Northwest Kent fine-moderate greyware (Dartford 'rilled' ware) c.1225-1400 AD from 1003)

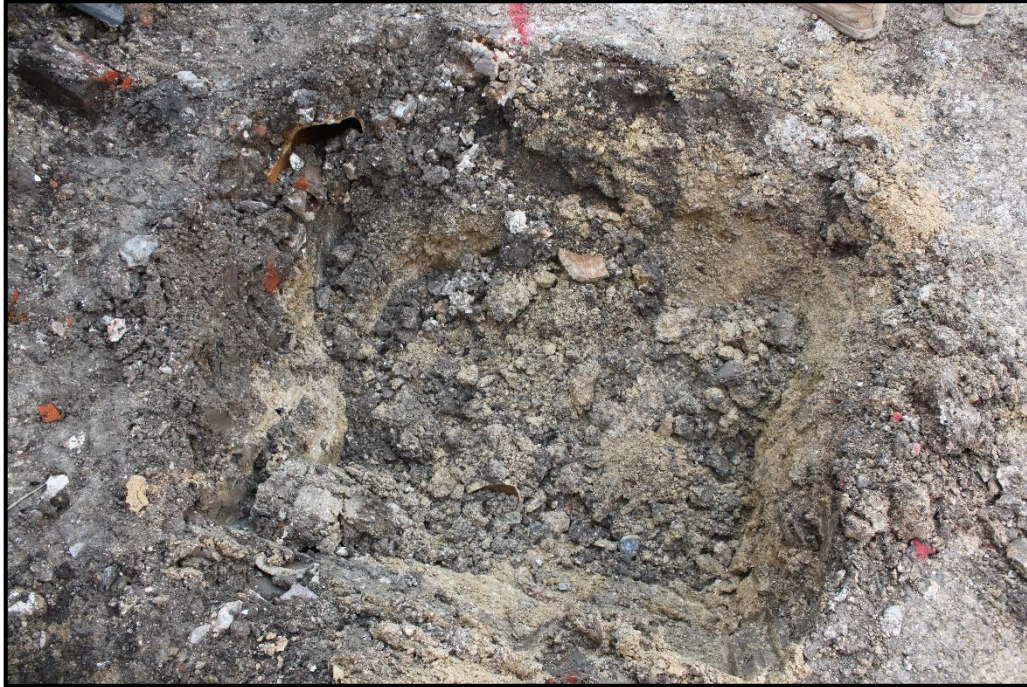
In Trench 3, 0.2m of 1003 sat above 0.4m of 1030. No archaeology or finds were recovered from Trench 3.

(Fig 47 - looking north at Trench 3)

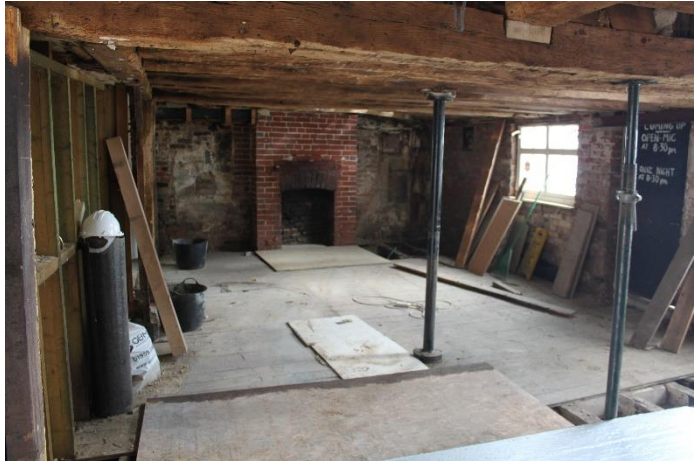
1033 is the oldest part of the building, thought to have been erected c.1550 AD when the building served as a private residence. Inside 1033 shows the remains of an open hall with much heavy exposed timber throughout (See 11.1 and 11.2).

<p>11.1</p> <p>Interior of 1033 looking north through bar area; Church Street is behind the Chimney stack to the north. Inside 1033 shows the remains of an open hall with much heavy exposed timber throughout.</p>

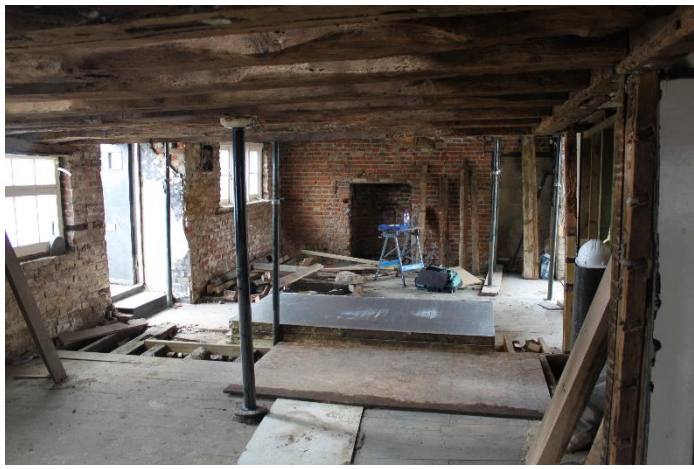
<p>11.2</p> <p>Interior of 1033 looking south through bar area; 1013 is behind the Chimney stack to the south. Inside 1033 shows the remains of an open hall with much heavy exposed timber throughout.</p>

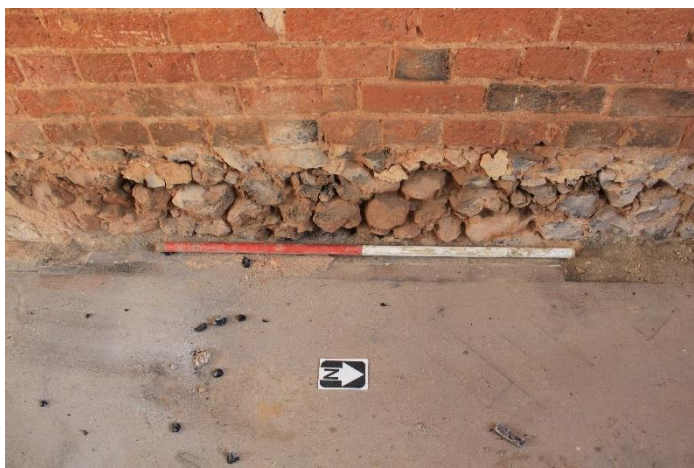
<p>11.3</p> <p>Interior aspect of the west wall for 1041 – note how foundation course is made up of flint nodules bonded with mortar, not dissimilar to 1012</p>

Interestingly, a foundation course for the west wall of 1041 comprises flint nodules bonded with mortar, not dissimilar to 1012 (See 11.3).

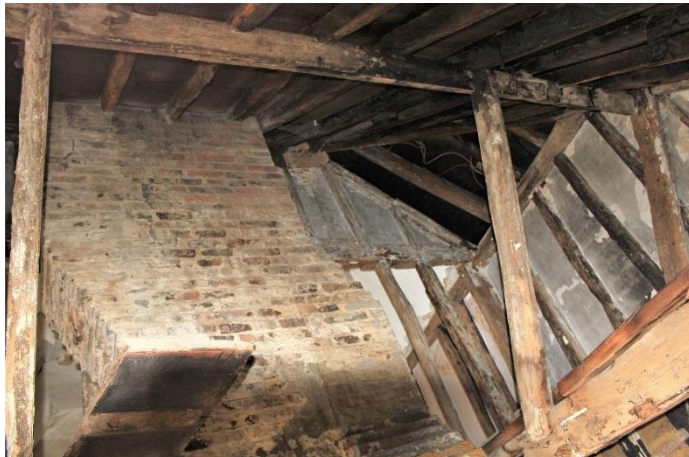
<p>11.14</p> <p>Looking north at probable original gable end to building 1033. The timbers to the south appear an addition to the gable.</p>
 	<p>11.5</p> <p>Looking north at chimney stack. Much of this is contemporary with 1033 (c.1550 AD) and would have been an external feature exposed to the elements before the construction of 1013.</p>

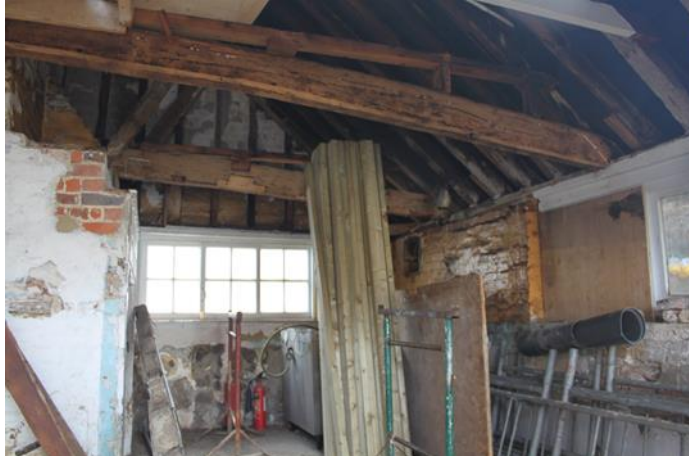
<p>11.6</p> <p>Looking east at timber framework for 1013. Notice how the chimney stack has been adapted later to make an additional open fireplace for 1013 when the extension was constructed.</p>

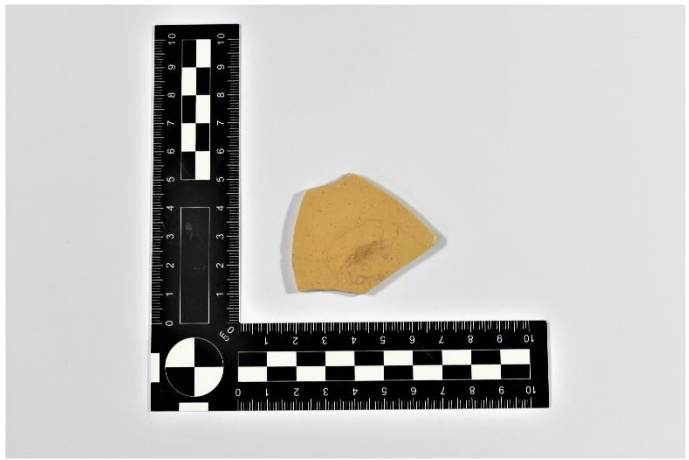
<p>12.4</p> <p>Staffordshire Yellow Ware c.1825 – 1900 AD.</p>

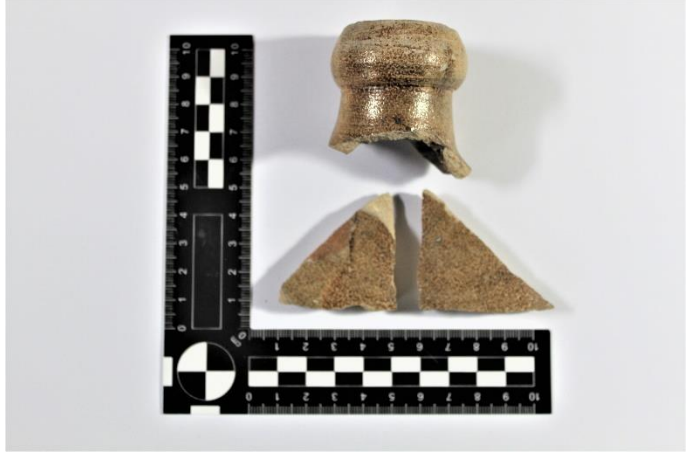
<p>12.6</p> <p>Stoneware Jug (1 x neck; 2 x body sherds) c.1850 – 1900 AD</p>

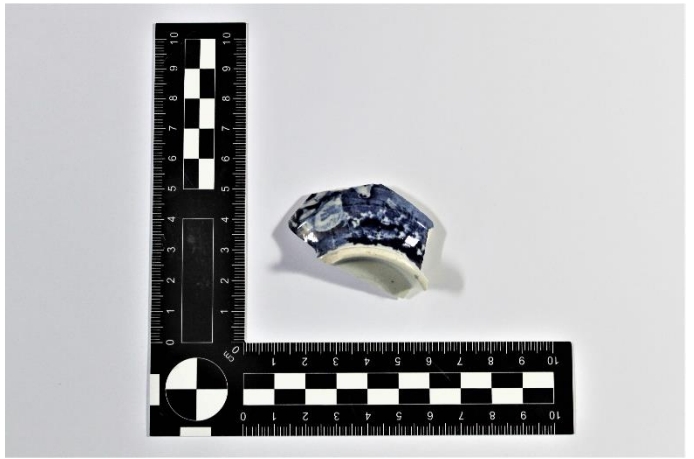
<p>12.7</p> <p>Blue & White Teacup Base c.1850 – 1900 AD</p>

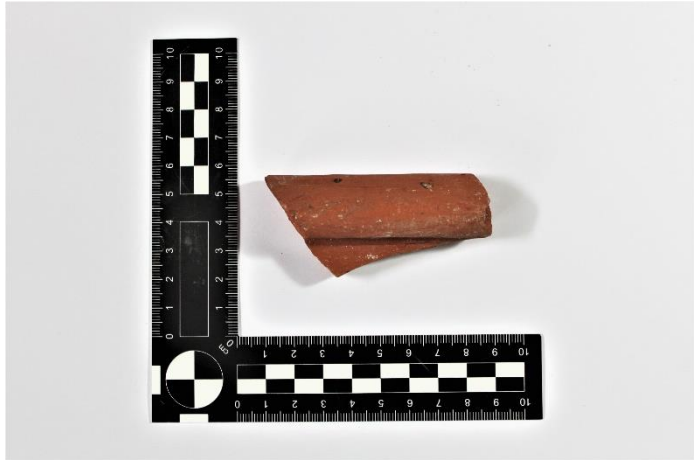
<p>12.8</p> <p>Kentish Red Earthenware – Rim c.1750 – 1800 AD</p>

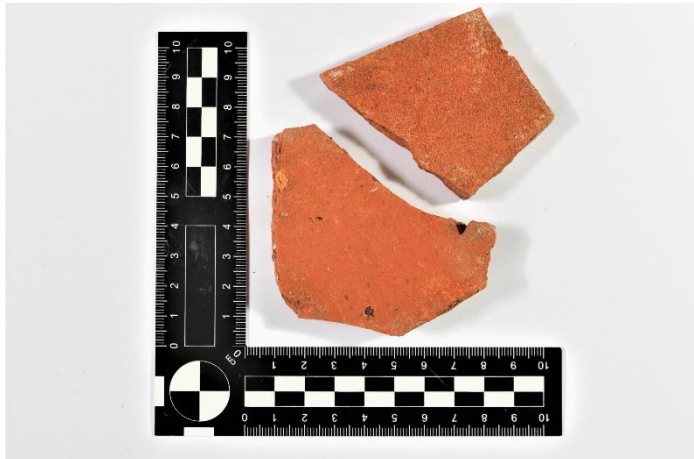
- 6.4. A small assemblage of Kentish peg tile **(12.9)** comprising three fragments was obtained from contexts 1016 and 1027 and probably associated with construction or repair episodes of the George Inn over time.
- 6.5. A small assemblage of animal bone **(12.10 & 12.11)** and oyster shell **(12.12)** comprising butchered animal bone (cow & sheep) from contexts 1025, 1029, and an oyster shell from context 1025.

<p>12.9</p> <p>A small assemblage of Kentish peg tile c.1800 - 1900 AD</p>
