# No. 20 Kings Street, Canterbury, Kent CT2 8AX

## Evaluation report

Project Code: 20KSC-EV-16  
Planning Ref: CA/15/01844/FUL  
NGR: 614950 158130 (centred)  
Report No: 2016/33  
Archive No: 3698

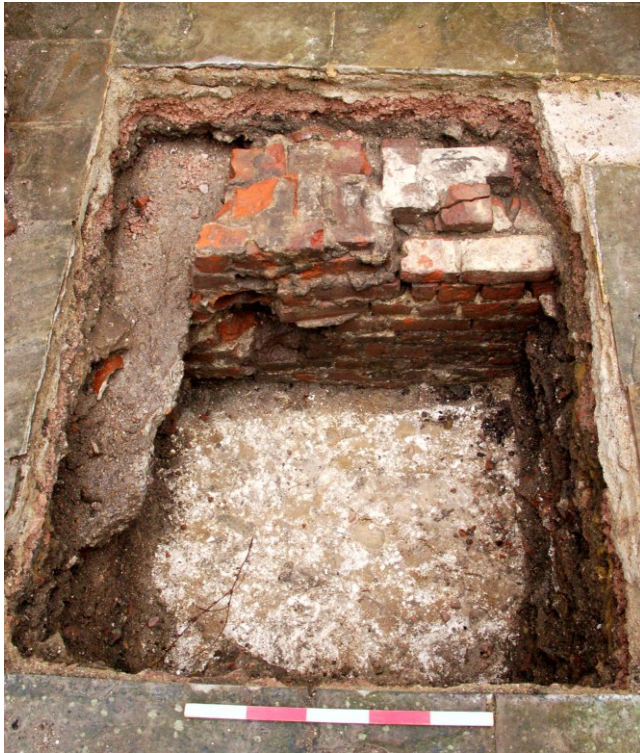
Plate 1: Trench looking south-east, showing walls (4 and 6), and chalk floor (11). Scale 0.5m

- 2.4 The earlier levels were sealed by a horizontal deposit (15), c 0.04m thick that covered most of the trench area. This was composed of small and medium compacted chalk fragments. It was immediately superseded by layer (11), about 0.06m thick, which was of very similar composition, small and medium compacted chalk fragments with pale brown compacted clay. The very flat and regular upper surface of this layer (suggesting that it and layer (15) were floors or floor beddings) was at a depth of 0.8m (7.92m OD).

- 2.5 On the south-east, layer (11) was cut by the narrow construction trench [5] for a brick wall (4). The fill of the construction trench (which was 0.16m deep) was a grey, fairly loose silty clay, with abundant small to medium chalk and common medium red brick fragments. The wall was aligned north-east/south-west (similar to the earlier walls), 0.36m wide and survived to a height of 0.8m. It was constructed of red un-frogged bricks, bonded with a pale greyish yellow sandy mortar, with 10 surviving courses on a single course offset foundation of broken red bricks, which rested directly on the top of wall (20). At a later date, a sewer pipe had been inserted through this wall and the hole re-filled with a brick-built plug (wall (6)). This plug was built from red bricks (one frogged) bonded with pale grey hard mortar. Within the trench area, the pipe had been dug out (cut not shown on plan). Another sewer pipe was probably represented by a thick spread of concrete in the northern corner of the trench. Again the pipe had been removed; some nineteenth-century pottery was recovered from the backfill (8) of the construction cut [10].

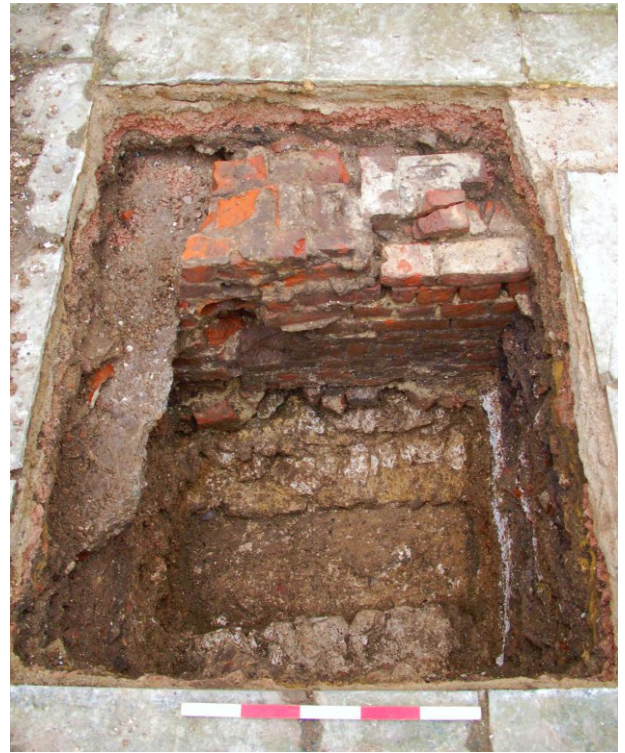
Plate 2: Trench looking south-east, showing medieval walls (13, 14 and 20). Scale 0.5m

2.1 Trench 1 (Fig. 2) was excavated to a maximum depth of *c* 1.2m (7.52m OD). The earliest deposit exposed at the base of the trench (21; not excavated) was a horizontal layer of pale brown compact silty clay, with common small chalk inclusions. This deposit abutted a masonry wall (14) on the south-east. The wall was 0.25m wide, aligned north-east/south-west and of chalk and flint build in an off-white lime mortar containing abundant small chalk. Only one course was visible. This was parallel to and abutted another wall of similar construction (20). This was only partially exposed and again only one course was visible.

2.2 Layer (21) was sealed by a deposit (19) of dark grey moderate very silty clay with common small and medium gravel *c* 0.11m thick at maximum, exposed 1.08m below modern ground level (7.64m OD). The layer abutted wall (14) and yielded one pottery sherd of fourteenth- or fifteenth-century date. On the north-east side of the trench it was probably cut by the construction trench [23] for another wall (13). This wall was similarly aligned to wall (14), but only partially revealed within the trench. The wall was constructed of chalk lumps and degraded blocks (80x80mm to 160x180mm in size), bonded with an off-white soft, gritty mortar containing abundant small chalk. Only one course survived, laid on a bed of unmortared flints within construction cut [23]. The upper courses had been cut away by robber trench [17] (below).

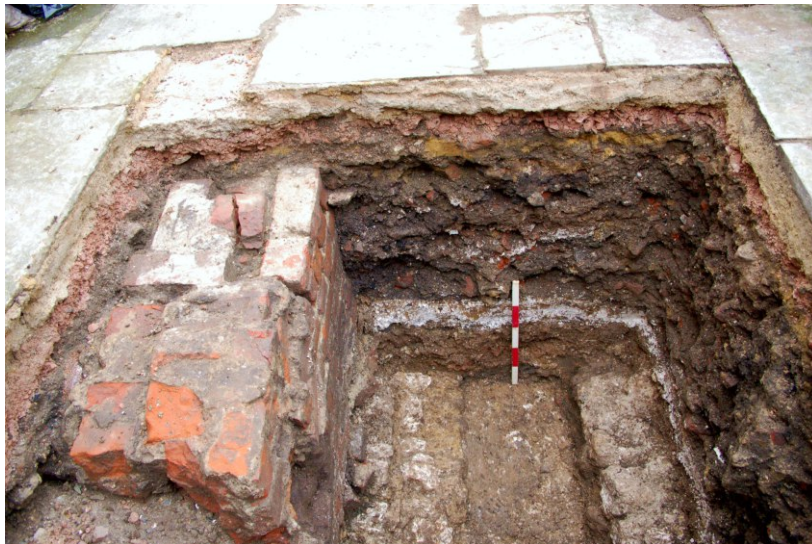
Plate 3: Trench looking south-west, showing medieval walls (13, 14 and 20) and soil sequence. Scale 0.5m

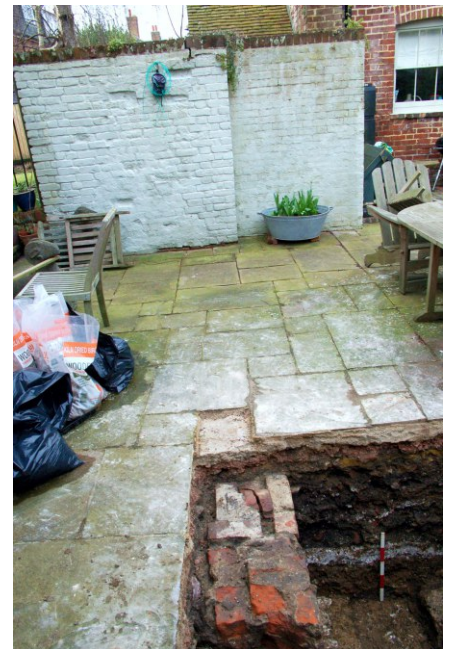
Plate 4: Wall 4 looking south-west, showing alignment with scar of rebuild in adjacent garden wall. Scale 0.5m

- 4.4 Yet another phase of reconstruction is represented by brick wall (4). The construction trench for this (25) cut through the possible chalk floors/beddings (11/15), indicating that the wall was later than this phase. The wall (4) corresponds closely with the wall line of a building or outshot shown on the First Edition Ordnance Survey (1874; see Fig 3). This indicates that it probably represents the north-west, external side of a structure to the rear of the main property, and a contiguous wall to the south-west enclosing a back yard. Scars from the demolition of this wall are still visible in the surviving walls to north and south. The only problem with this interpretation is the low level of the contemporary ground surface to the rear, which appears to be equivalent to the surface of chalk floor (11), 0.8m below present ground surface. This seems rather low for the probable late eighteenth-/early nineteenth-century construction date of the wall (which is suggested by the brickwork and nature of the foundation). It is possible that yet another external half-cellaried building was present here however, perhaps with a sunken floor level utilizing the earlier chalk floors, and which may have been demolished
