Canterbury Christ Church University, North Holmes Road Wall

Watching brief report

Project Code: CCCU NHRW WB16
NGR: 615672 157929
Report No: 2016/71
Archive No: 3732

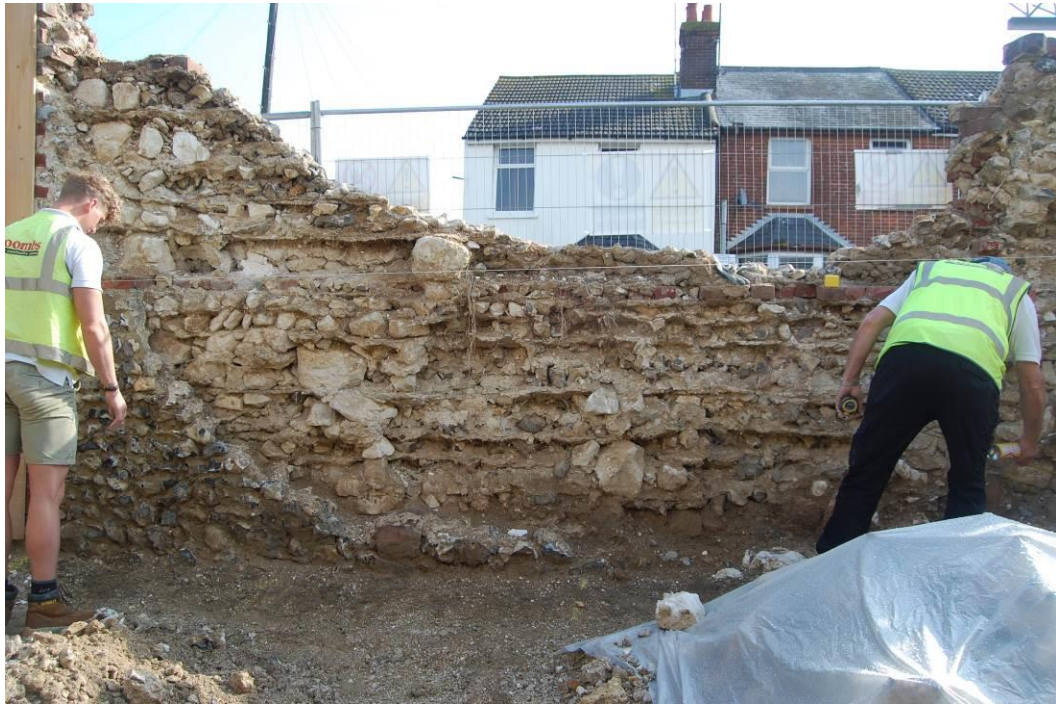
- 2.3 The boundary wall in this area of the campus is constructed with a core of flint and ashlar rubble, bonded with pale brown mortar, faced with flintwork and brick. Flints form the main facing material, whilst bricks form vertical and horizontal banding, and cap the structure (Plates 1, 2).

Plate 1. The standing boundary wall along North Holmes Road, looking north-east. The south facing of the wall collapsed during recent stormy weather.

- 4.2 The watching brief was conducted during repair work to a length of the standing boundary wall running along North Holmes Road, work which was necessitated by the collapse of a section of the wall during a period of severe weather.

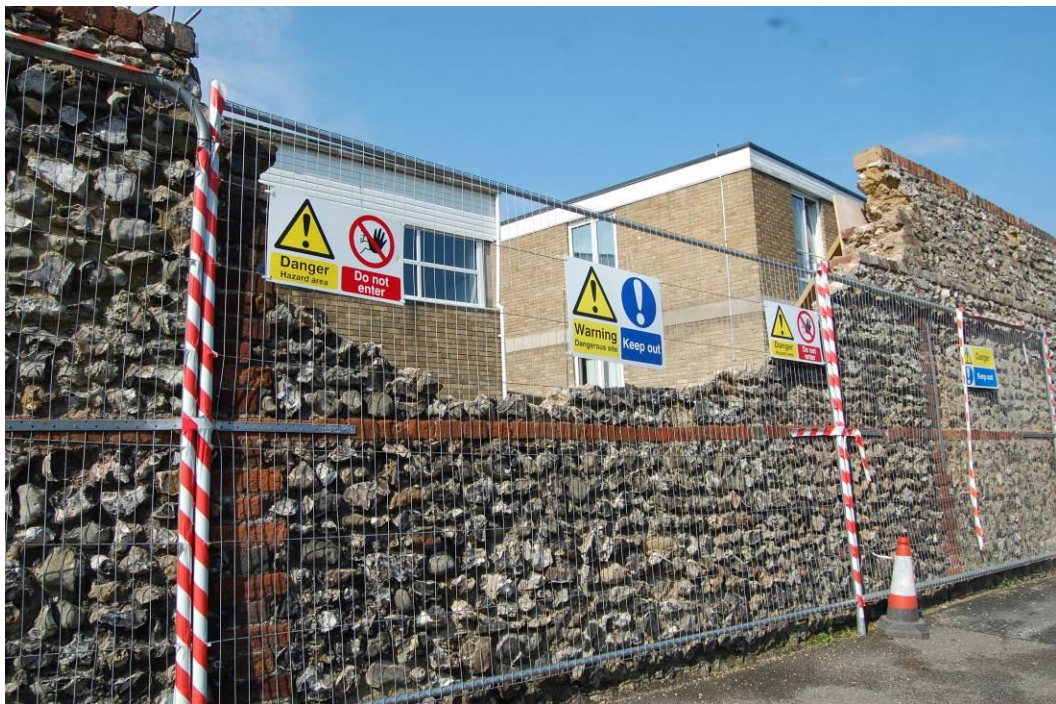
Plate 2. The standing boundary wall along North Holmes Road, looking south-west.

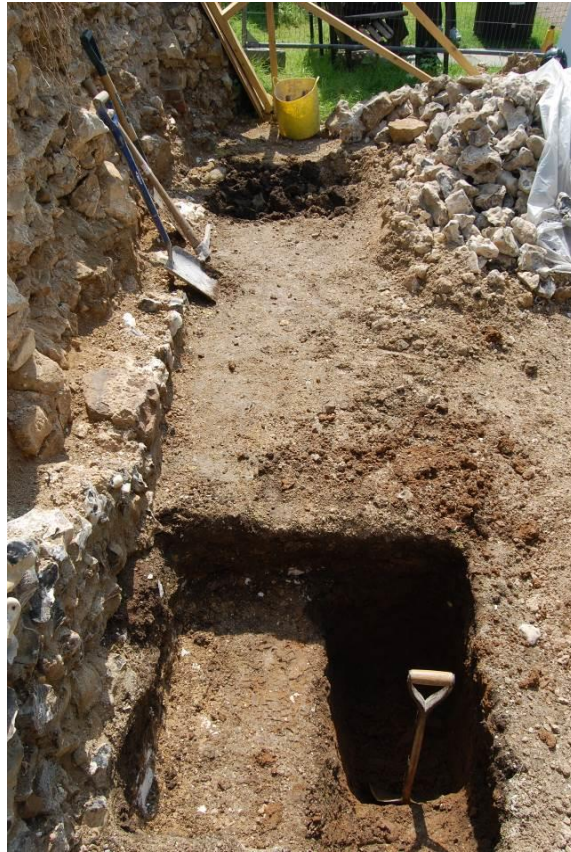
Plate 3. Pit 1 during excavation, looking south-east.

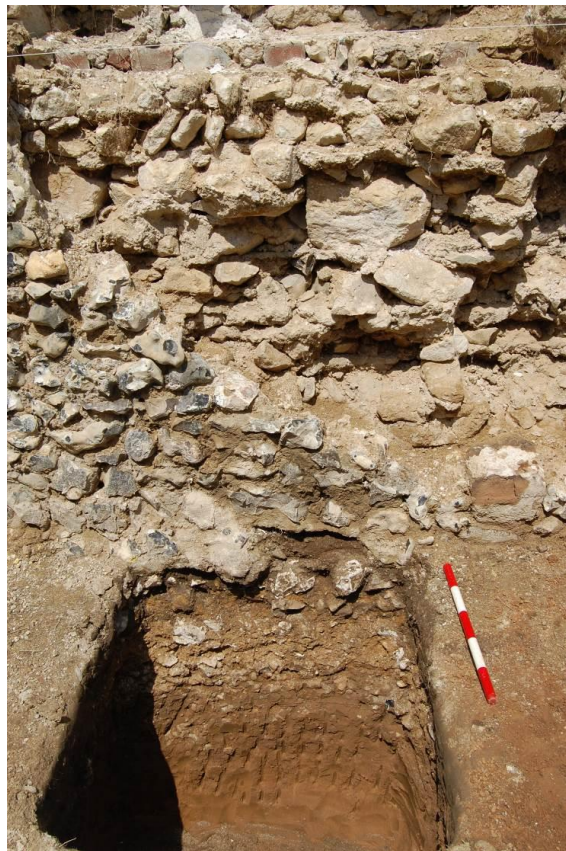
Plate 4. Pit 1 after excavation, looking north-east.
Scale 0.5m

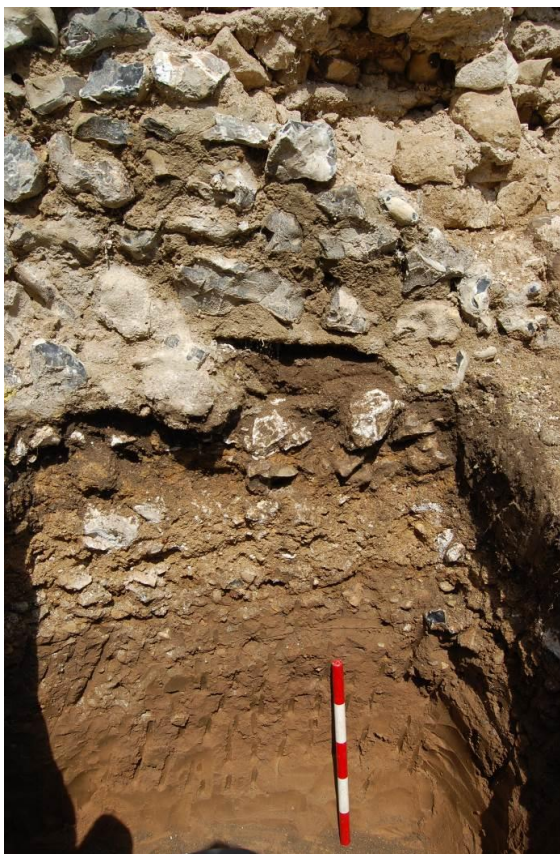
- 6.1 Natural ground, comprising a head deposit of clay and silt (brickearth) (4) was seen at the lower levels of Pit 1, lying at a depth of 0.34m below the ground surface. Overlying the brickearth was a deposit of mid grey-brown silty clay subsoil (3) containing occasional small flint pebble inclusions. The subsoil was up to 0.24m thick. Overlying the subsoil was a deposit of very loose, buff coloured coarse mortar containing chalk and flint fragments (2), up to 0.20m thick, which petered out as the deposit extended southwards. The mortar deposit had probably been laid as levelling material, preparing the ground for the construction of a wall. Overlying mortar (2) were wall remnants comprising chalk and flint rubble bonded with fine orange-brown mortar (5) standing to a height of 0.33m, apparently forming the footings of an earlier boundary wall.

Plate 5. Pit 1 looking north-east, showing detail of wall remains lying upon mortar, chalk and flint deposit (2). Scale 0.5m.

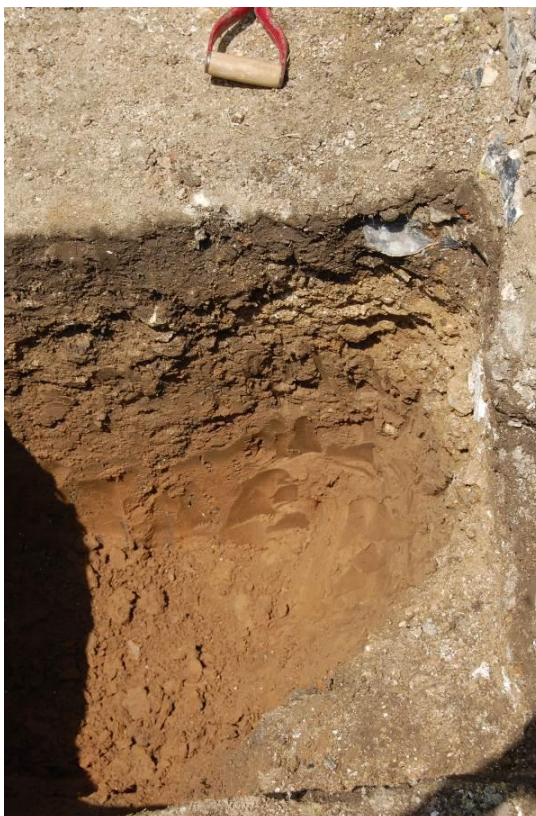
- 6.2 Built upon the wall remains (5) was the boundary wall which stands today (not numbered), formed with a core of flint and ashlar rubble, bonded with pale brown mortar, faced with flintwork and brick. Flints form the main facing material, whilst bricks form vertical and horizontal banding, and cap the structure. Abutting the southern face of the wall was a deposit of topsoil and turf (1), up to 0.16m thick, forming the current ground surface.

Plate 6. Deposits revealed in Pit 1, looking north-west.

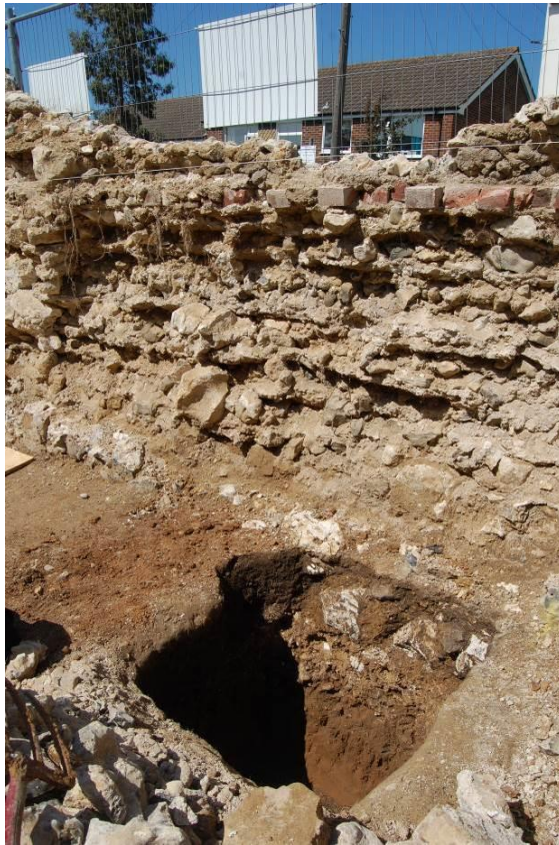
- 6.3 An identical sequence of deposits to that in Pit 1 was observed in Pit 2. Natural brickearth (4) was seen at the base of the pit, overlain by a subsoil deposit of mid grey-brown silty clay subsoil (3) containing occasional small flint pebble inclusions, up to 0.19m thick. A deposit of very loose, buff coloured coarse mortar containing chalk and flint fragments (2), up to 0.16m thick, lay above, dipping down and petering out to the south. Overlying the mortar deposit were wall remnants of chalk and flint rubble bonded with fine orange-brown mortar (5), only partly revealed because a later deposit (topsoil (1)) was left partially intact.

Plate 7. Pit 2 looking north-west.

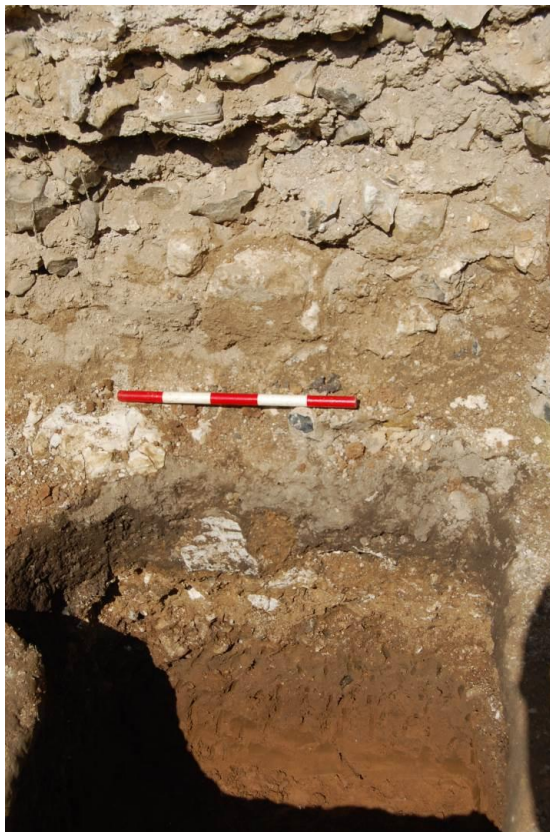
- 6.4 Built directly upon the earlier wall remains (5) was the boundary wall which stands today (not numbered), as described above. Abutting the southern face of the standing wall was modern topsoil and turf (1), some of which had been left *in situ* against the wall face, so obscuring some of the earlier remains.

Plate 8. Pit 2 looking north-east showing detail of early wall remains, partly obscured by remnants of deposit (1), overlying mortar, chalk and flint deposit (2). Scale 0.5m.

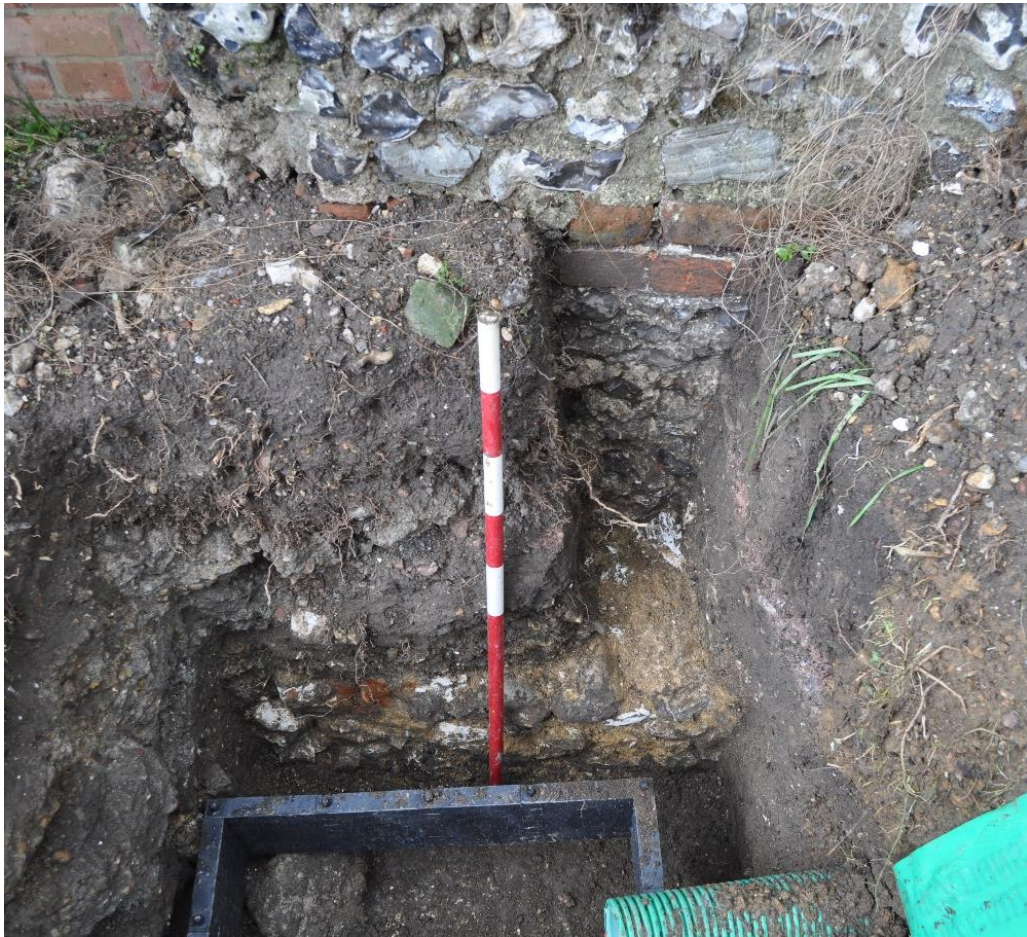
- 5.6 An abbey boundary wall was erected in 1320, over which a monk, Peter of Dene, effected his escape from the abbey in 1330. The standing wall within the study area is thought to run along the line of the fourteenth-century boundary wall. Sections of the original wall have been revealed during the insertion of a dark fibre route around the campus (Hicks 2012).

Plate 9. Early boundary wall next to CCCU Gate 1, lying below the current standing wall, revealed by work associated with the dark fibre scheme in 2012, looking north-east. Scale 1m.
