## **ARCHAEOLOGICAL WATCHING BRIEF**

### **SUMMARY REPORT**

**Canterbury Cricket Club  
St Lawrence Ground  
Old Dover Road  
Canterbury  
Kent**

**June 2016**

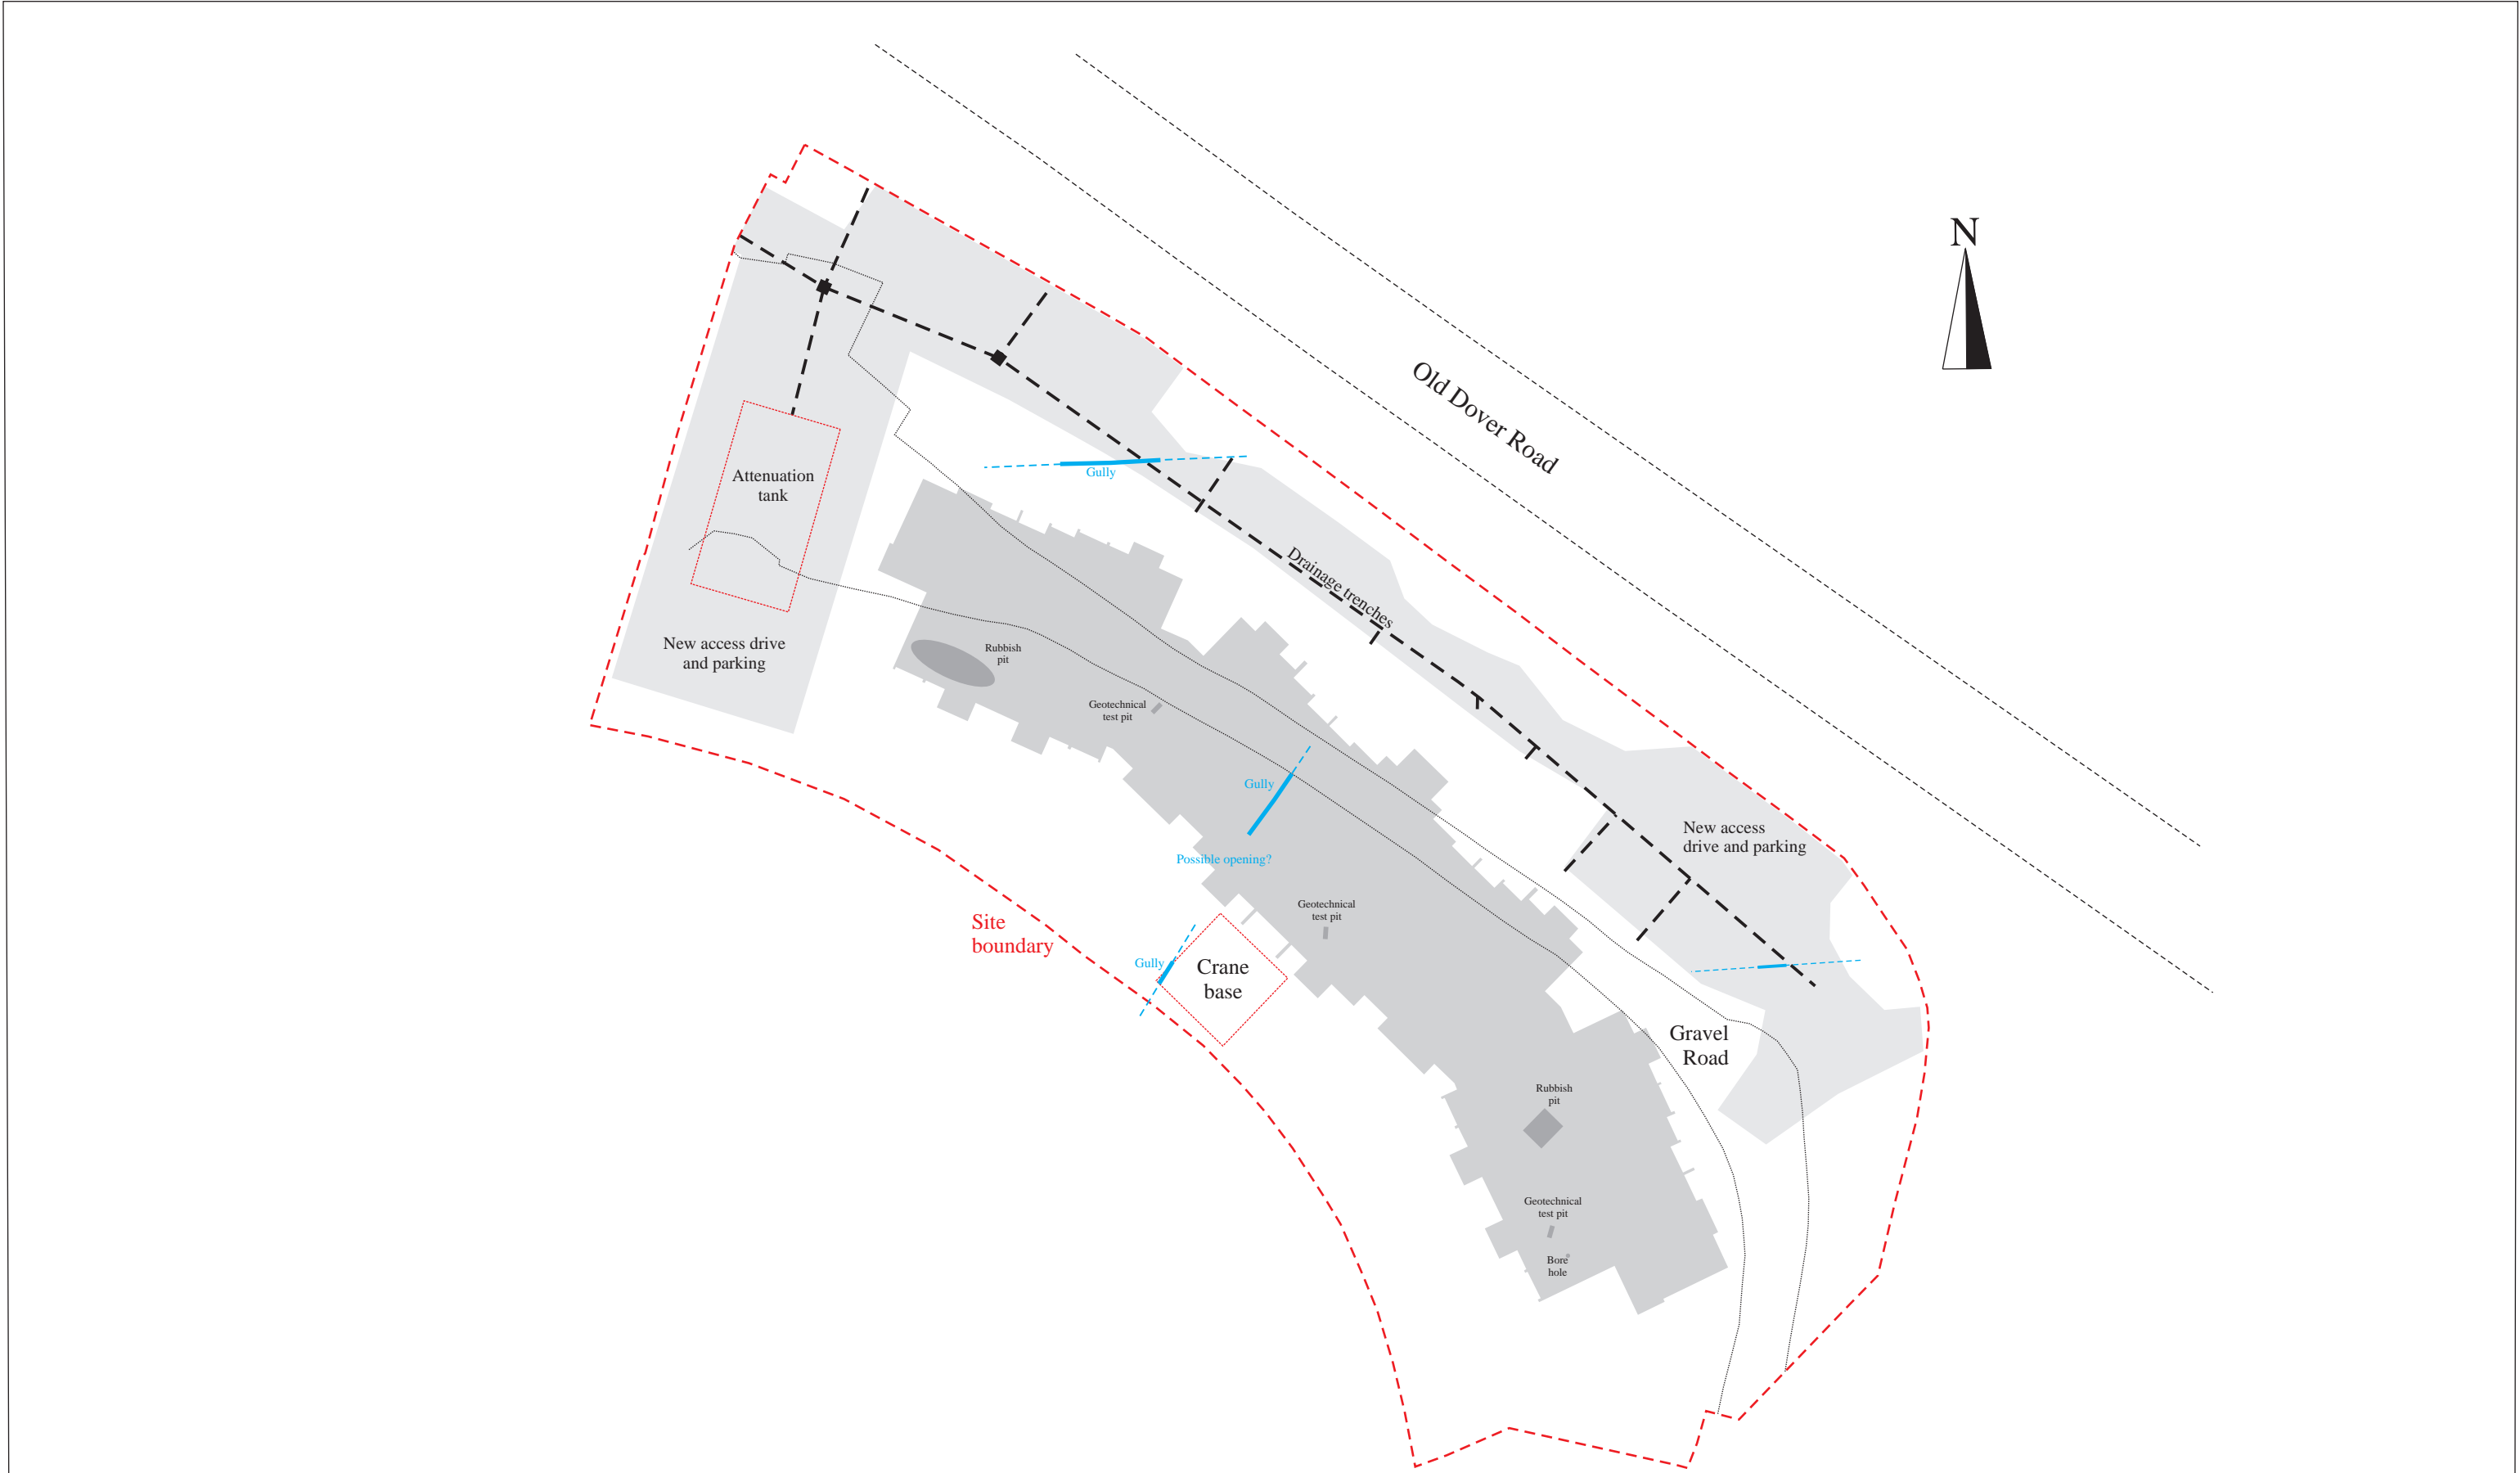
Figure 3. Plan of the proposed development areas of monitored ground works and encountered archaeological features.

- 3.1.1 Initial groundworks concentrated on the excavation of new service drainage associated with a new access road extending northwest by southeast along the northern limit of the Proposed Development Area (PDA) (Fig. 2). This commenced with the excavation of a 48m long trench running on a northwest to southeast alignment parallel with Old Dover Road, approximately 10m from a line of mature trees. A service access chamber was excavated at either end of this trench alignment with shorter, shallower trenches running perpendicular to this trench taking ground water from proposed surface drains (Fig. 3).

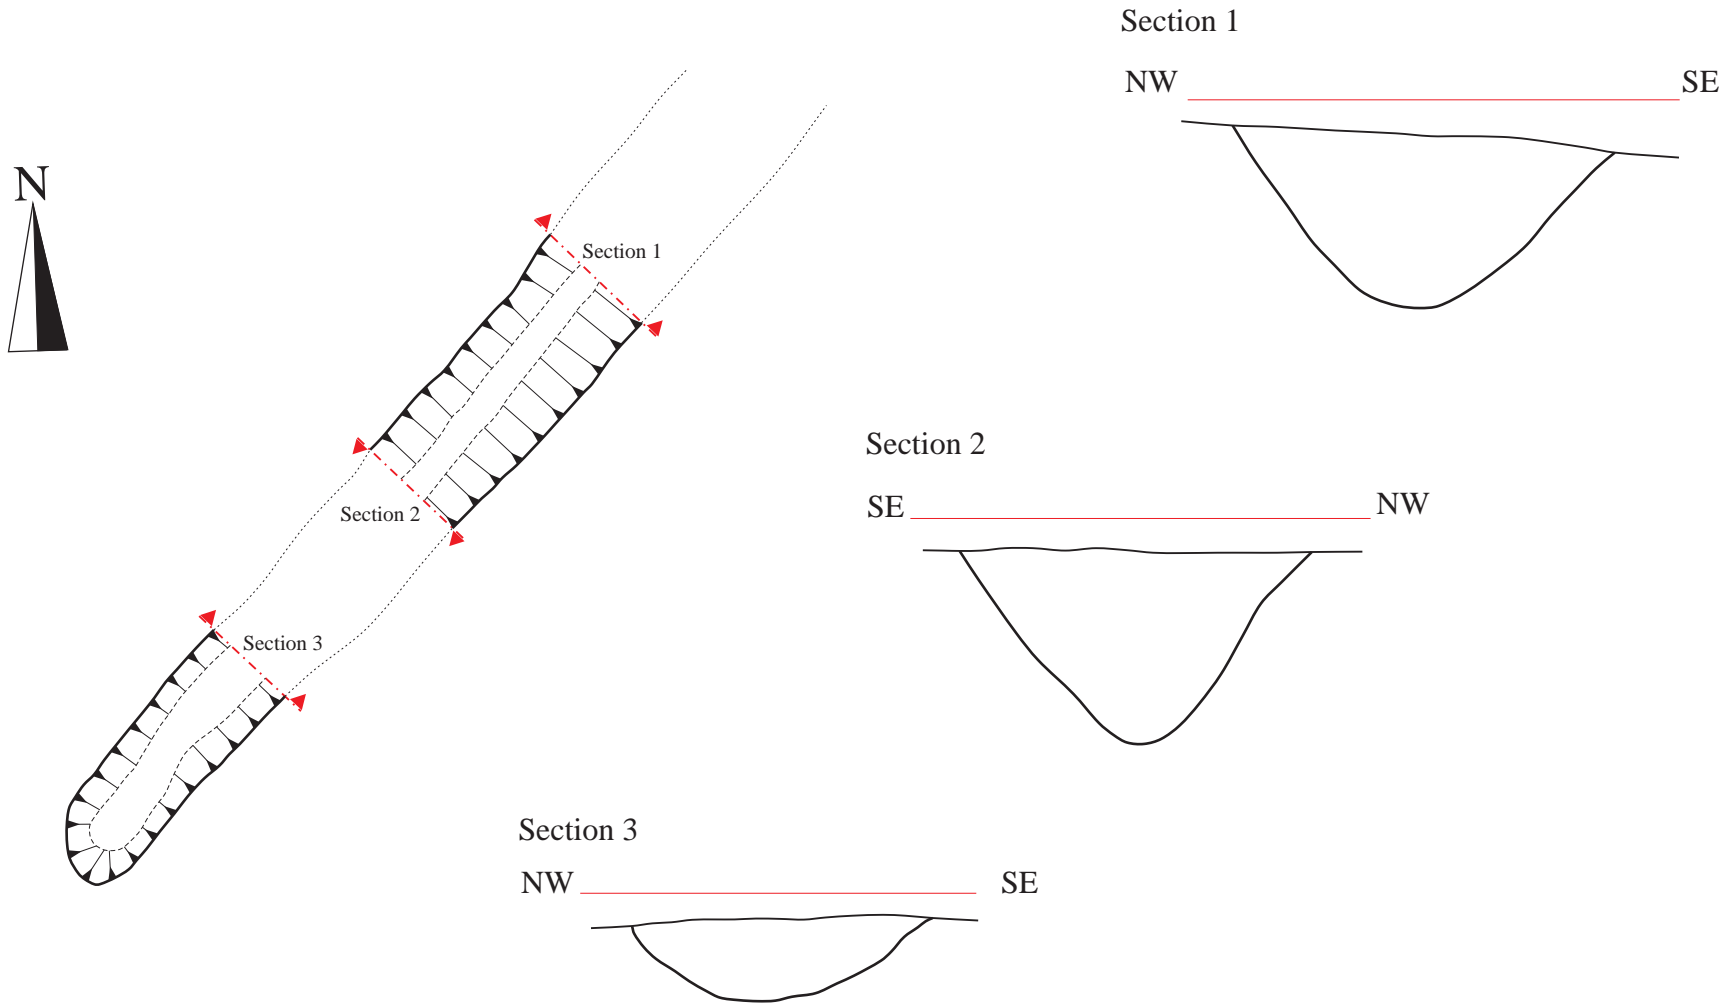
Figure 5. Plan of pre-Roman gully terminal with profile sections revealed within the proposed new building footprint.

- 3.3.3 The alignment of this feature ties in well with the continuation of the long narrow linear exposed in the main building footprint located to the north-east. It is possible this represents a continuation of this feature towards the southwest suggestively extending beyond a break in its alignment?

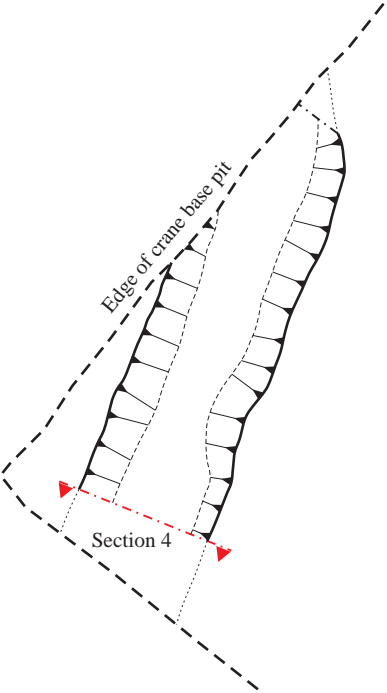
Section 4

Figure 6. Plan and profile section of pre-Roman gully continuation within the footprint of the crane base pit.

- 3.3.2 Across the crane pit's western corner, an approximate 2m length of a linear feature was exposed cutting into the upper surface of the underlying Brickearth geology. Continuing beyond two edges of the crane pit, the exposed portion of this feature was excavated and found to be roughly 420mm wide and only 120mm deep. Filled with a single deposit of firm – soft mid – dark greyish-brown silty clay it possessed occasional small pieces of burnt clay daub and charcoal flecking. Several small – medium flint waste flakes and occasional small crumbled flint tempered pot were also present, representing a typical deposit within a feature of probable Pre-Roman date?

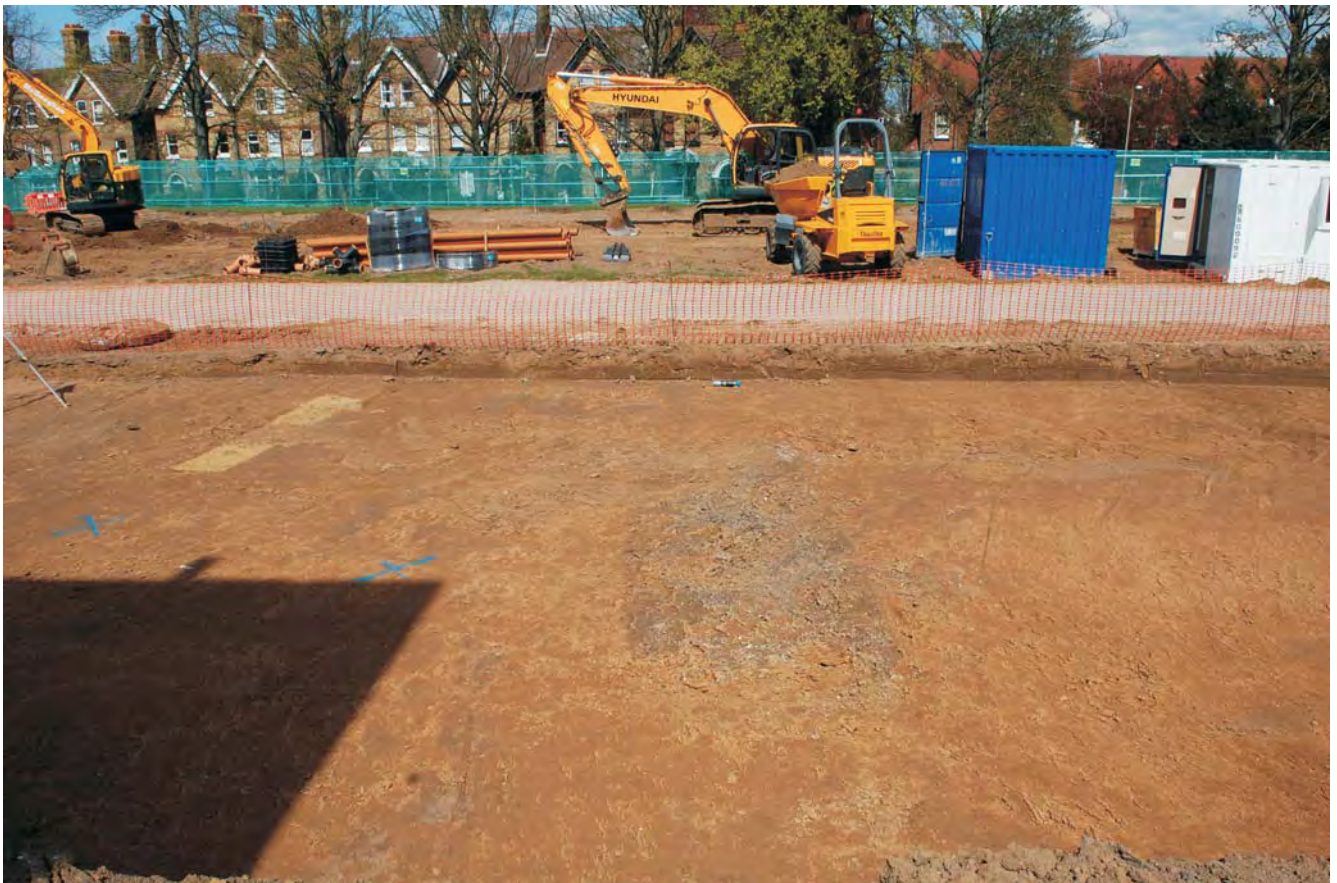
Plate 4. Geo-technical test pit (left) and base of evaluation trench 23 (centre). Looking NE.

- 3.5.5 Nearby to the east, the northeast by southwest aligned scar to the base of a previous evaluation trench was identified and possibly related to Trench 23 from the previous scheme of evaluation prospecting? South-east of this evaluation trench base (poss. Trench 23), a narrow linear feature was exposed extending south-west, under the existing gravel road, for approximately 8.5m before terminating. Two separate interventions were excavated in this feature; both measuring approximately 1m long with the first situated close to excavation limit and the other across its terminus. Across both excavated portions the linear feature was roughly 500mm at its widest and gradually diminished to only 350mm wide close to its terminus. Surviving to a maximum depth of 230mm, the form and character of the feature suggests a correlation to those gully type features encountered in the previous evaluation of the site? As with those a small collection of waste flint flakes and several small flint tempered pottery crumbs, suggestive of a pre-Roman date were noted within its fill. Examination of its alignment in relation to that encountered in the crane base pit, located to the southwest, suggests this may represent a north-eastward continuation of the same feature alignment. However, it is possible the portion of its continuation between the two encountered portions may represent a break within the alignment or due to its ephemeral survival may have been ploughed away at a later stage of cultivation?

- 3.5.6 Further to the southeast, another possible geotechnical test pit was encountered cut into the underlying upper surface of the natural Brickearth geology. As previously observed, this was of similar dimensions and had also been machine cut, though it was infilled with soft – firm dark-brown silty-loam. However, the inclusion of numerous modern red brick fragments clearly indicate its late date.

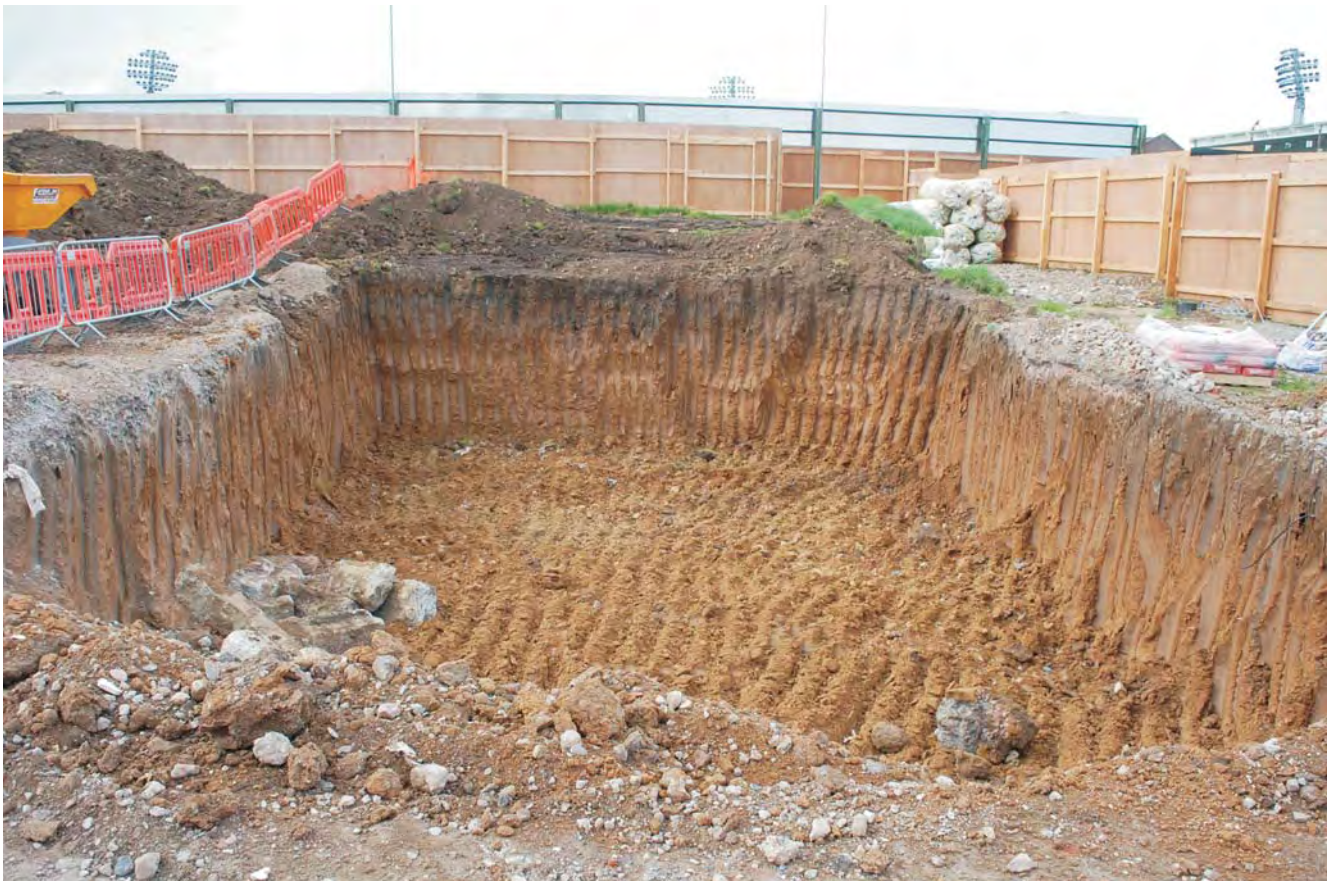
Plate 10. Completed excavation of pit for attenuation tank. Looking SSW.

- 3.2.1 In the area destined to become a large parking court, a large rectangular pit was excavated north-west of the building footprint. Measuring approximately 30m in length and 10m wide, this pit was aligned approximately northeast by southwest excavated to a depth in excess of 3m below the present ground level. At its north-eastern end of this pit, a secondary chamber pit was further excavated 1m through the base of the initial pit to a depth in excess of 4m below the present ground surface.
- 3.2.2 The initial excavation of the attenuation tank pit was monitored whilst the overburden was removed to expose the upper surface of the underlying natural Brickearth across its footprint. Throughout this process, no finds, features or deposits of archaeological significance were encountered.

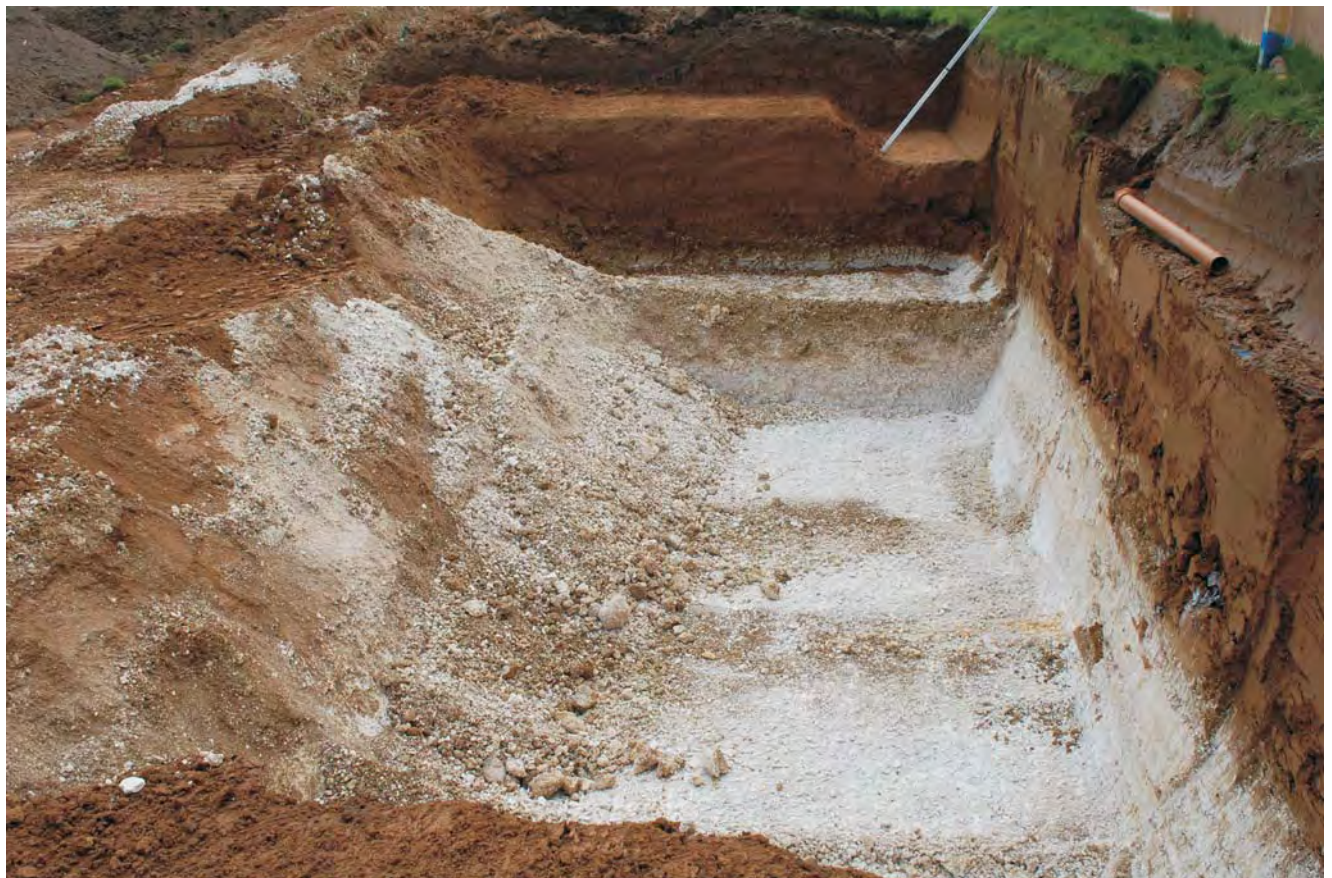
Plate 14. Completed excavation of large pit for crane base. Looking SE.

- 3.3.1 To the south-west of the main building footprint, approximately halfway along the buildings length, a large pit measuring approximately 8m square and in excess of 2m deep was excavated. Extending into the upper surface of the natural Chalk bedrock, the pit was to form a concrete base for a tower crane to be used in construction of the adjoining apartment building. Following its construction, which included steelwork and 200 tons of concrete, this base will remain insitu and landscaped over.

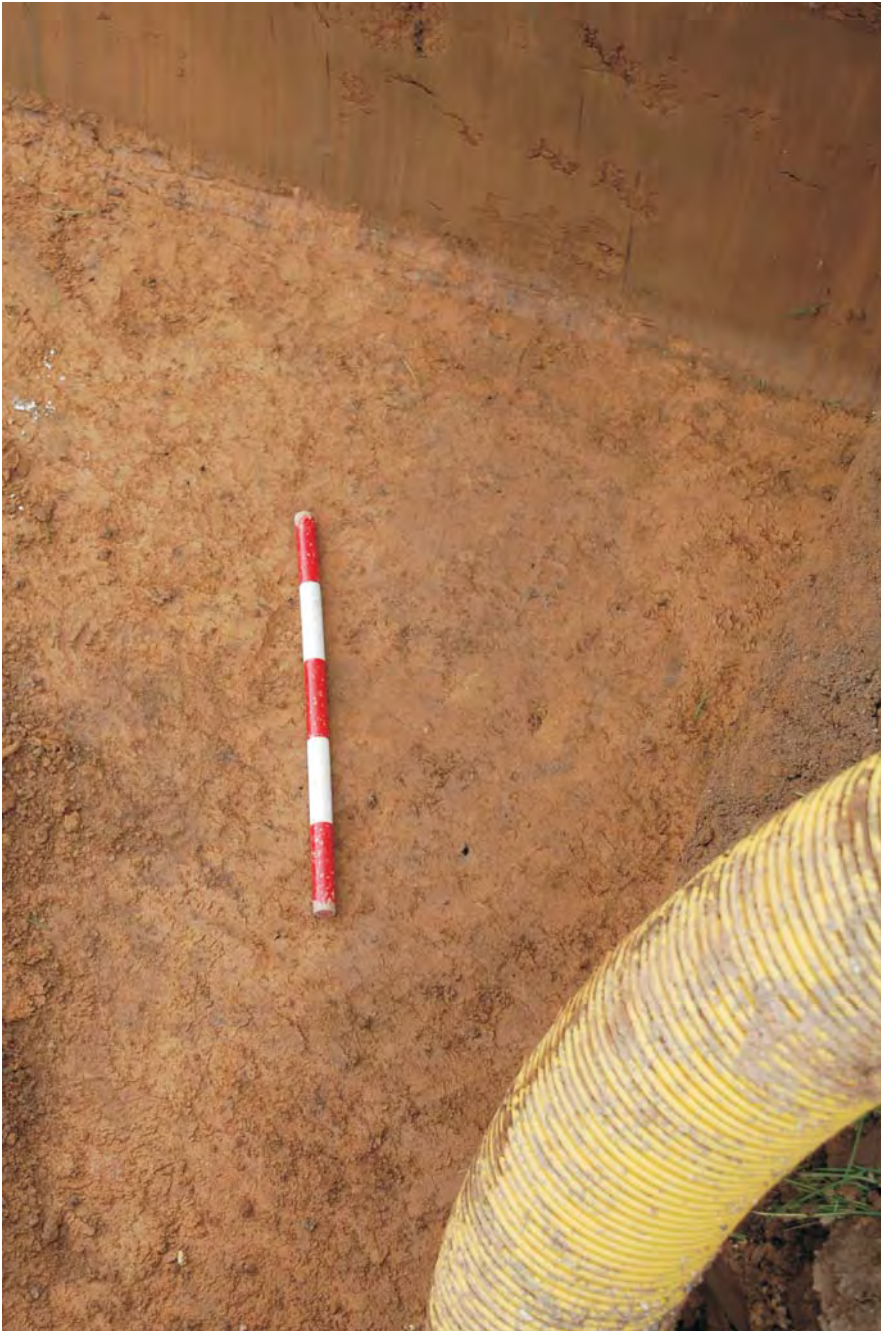
Plate 15. Pre-Roman gully in crane base pit exposed. Looking SW.

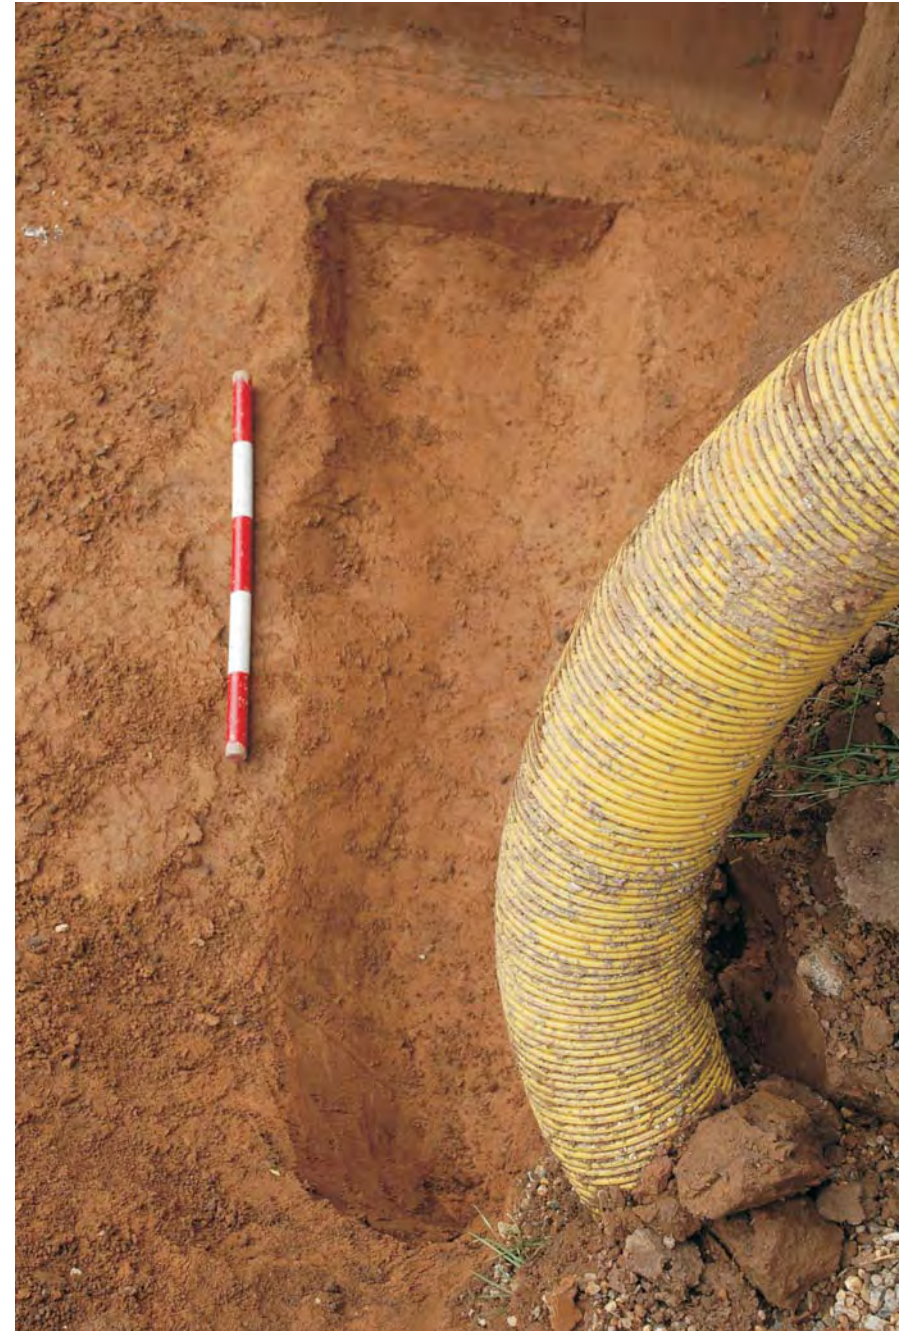
Plate 16. Pre-Roman gully in crane base pit excavated. Looking SW.

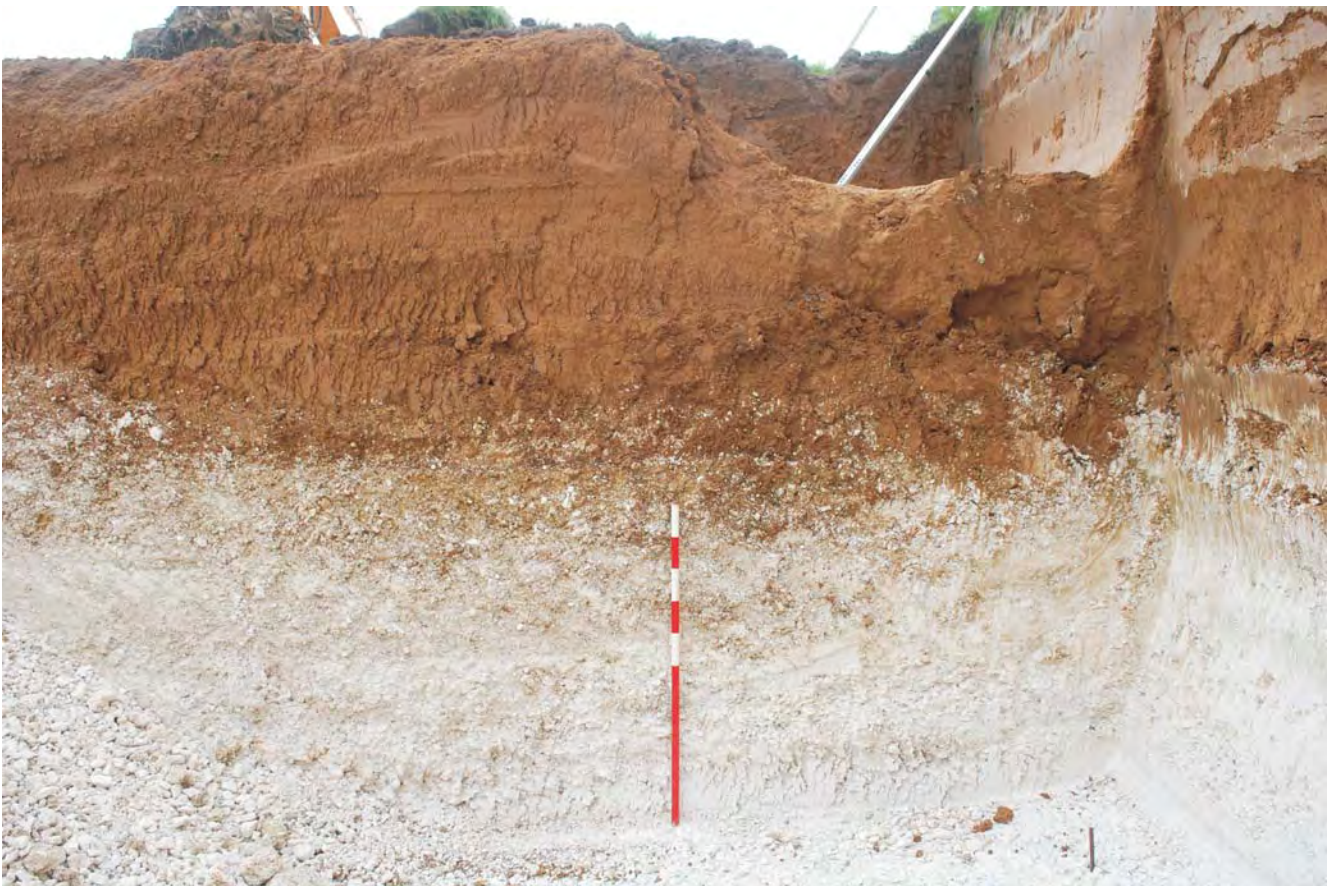
Plate 17. Section view into side of crane base pit, showing natural deposits. Looking SE.
