Canterbury Cathedral International Study Centre Wall

Archaeological evaluation report

Project Code: CC-ISC-EV16
NGR: 615078 157868
Report No: 2016/102
Archive No: 3770

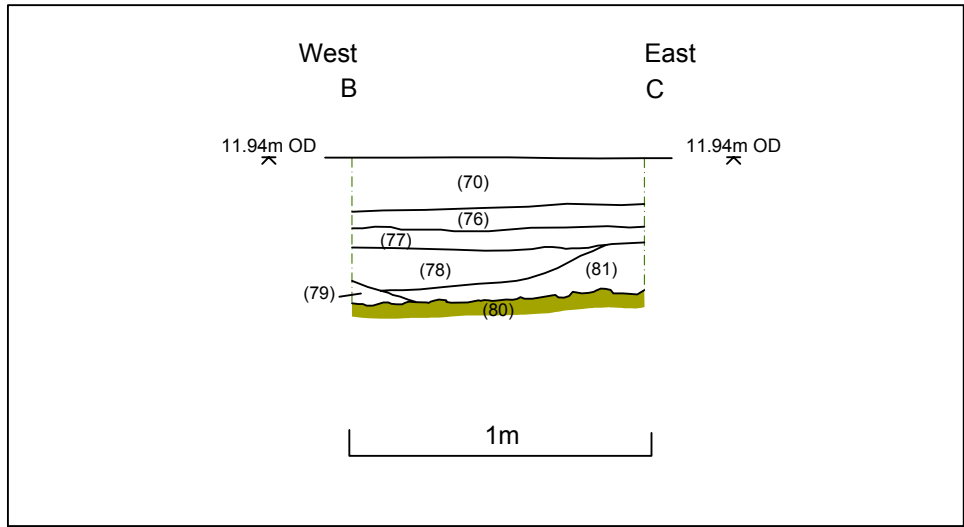
Figure 9. Sections of remains in Pit 3.

- 7.19 The earliest deposit in Pit 3 comprised a yard surface (80) formed of flint, Caen stone and peg tile fragments, mortar lumps, oyster shell and rare animal bone lying within a sparse dark brown silty clay matrix. The deposit was observed in plan at the northern end of the pit and in the side of a later service trench, where it was seen to have a thickness of up to 0.16m.

- 7.21 Deposit (81) was overlain by a layer of dark brown sandy clay and sand (78), up to 0.14m thick, containing two fragments of fifteenth-century pottery and pieces of post-medieval bottle glass, sealed by a deposit of yellow-brown sand, flint and brick fragments (77), up to 0.06m thick, which was in turn sealed by a deposit of orange-brown silty clay and gravel (76) up to 0.12m thick. All were observed in section lying towards the northern end of the evaluation pit. A lens of dark brown silty clay (83), up to 0.22m thick, containing Caen stone, brick and tile fragments and small flints, was observed in section in the north-eastern side of the pit. These deposits are thought to have been levelling horizons, preparing the ground for subsequent occupation.

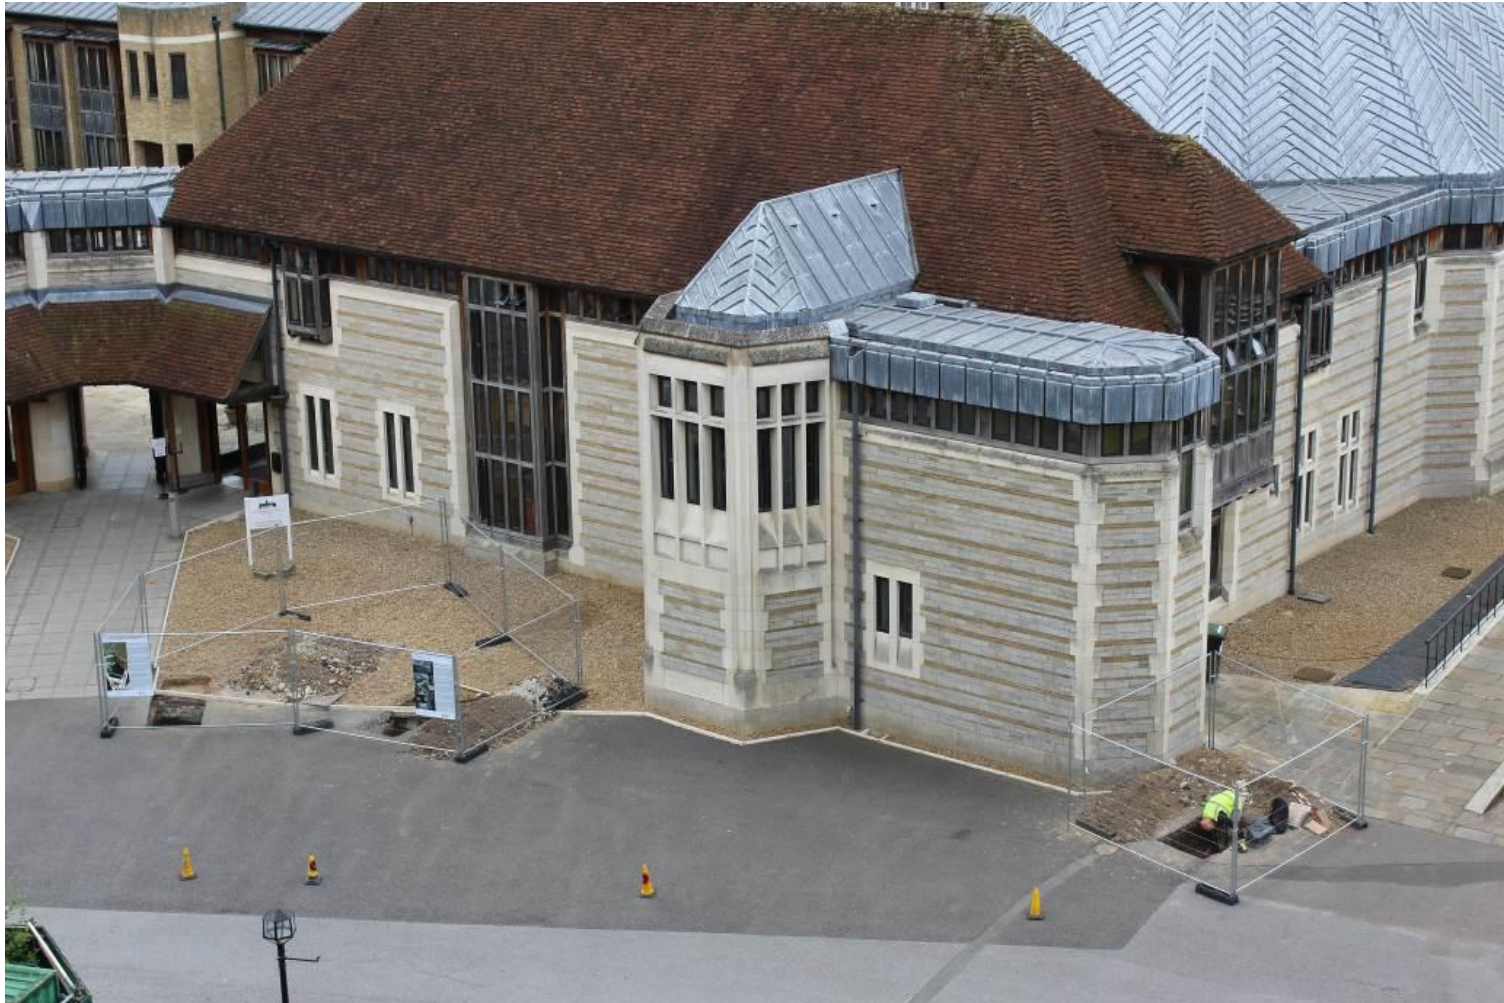
Plate 1. The three evaluation pits cut beside the International Study Centre, looking south. Pit 1 to the west (right), Pit 2 in the centre and Pit 3 to the east (left).

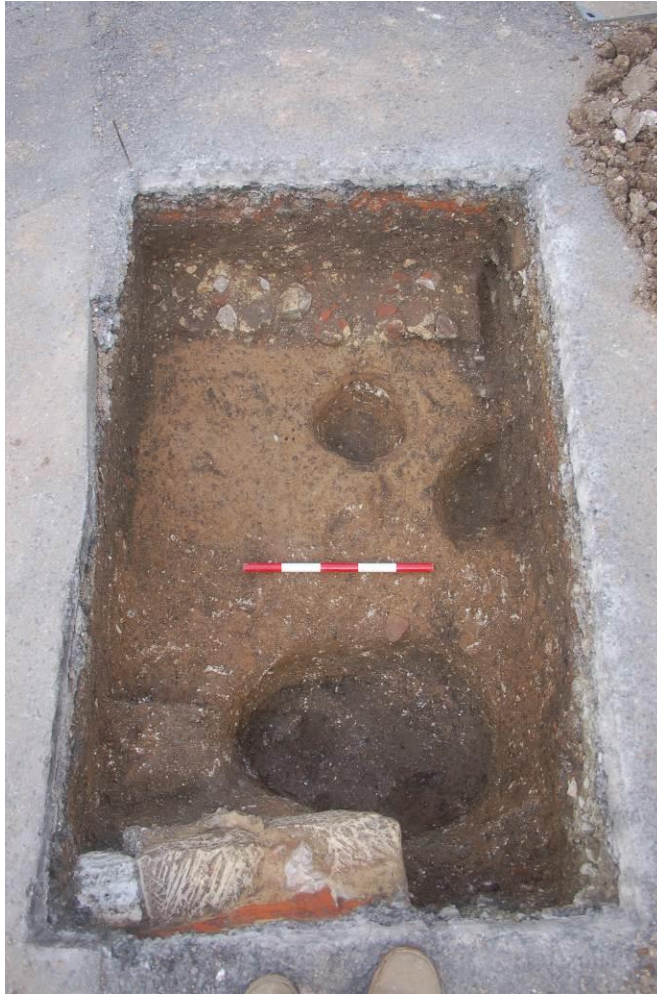
Plate 2. Pit 1 looking north. Wall (104) is in the foreground, wall (98) to the top abutted on its southern side by clay floor (96). Scale 0.5m.

- 7.3 At the northern end of Pit 1, potentially overlying deposit (105) though not proved by excavation, was a wall (98), aligned north-west to south-east and constructed of re-used brick, Ragstone and occasional Caen stone fragments, many with earlier mortar still adhering to their sides. The wall was largely only seen in plan, so its depth is unknown.

- 7.4 Abutting the southern side of wall (98) was a floor (96) formed of compact light orange-brown clay with a smooth, level upper surface. The floor was largely observed in plan, confined to a strip along the northern side of the evaluation pit, but in the sides of later intercutting features it was seen to have a thickness of up to 0.07m.

- 7.10 Cutting deposit (94) was the construction cut [103] for a boundary wall (104) which stood prior to the construction of the ISC, formed by a single depth of Caen stone blocks bonded with pale yellow-brown mortar, capped by a single depth of red bricks lying inset from the wall face. The wall had a total height of 0.25m. Backfilling the gap between the construction cut and the wall face was a deposit of dark grey-brown silty clay (102).

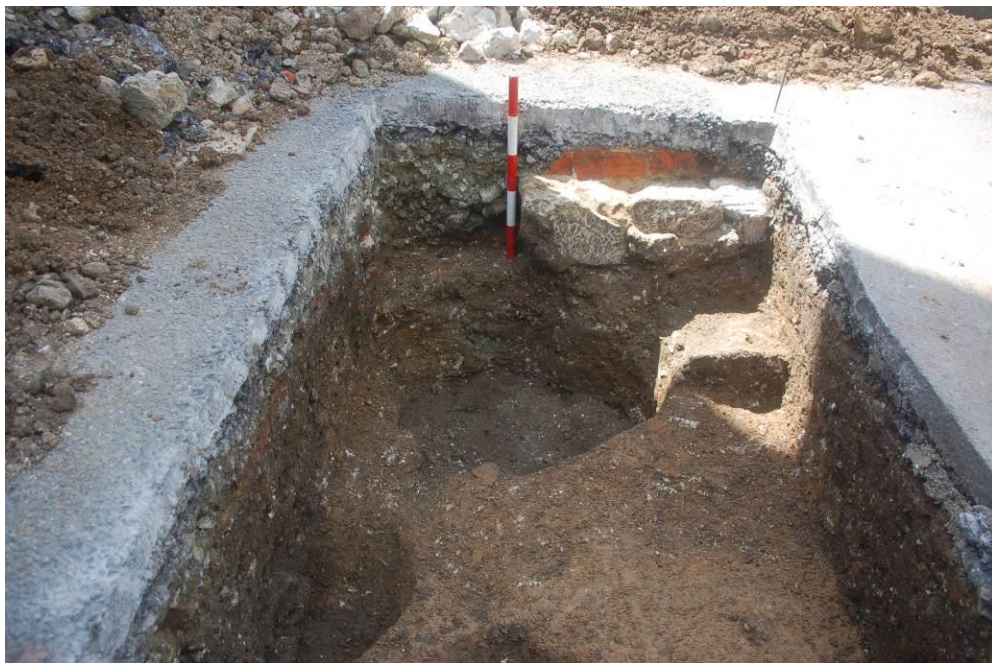
Plate 3. Pit 1 looking south, showing detail of wall (104). Scale 0.5m.

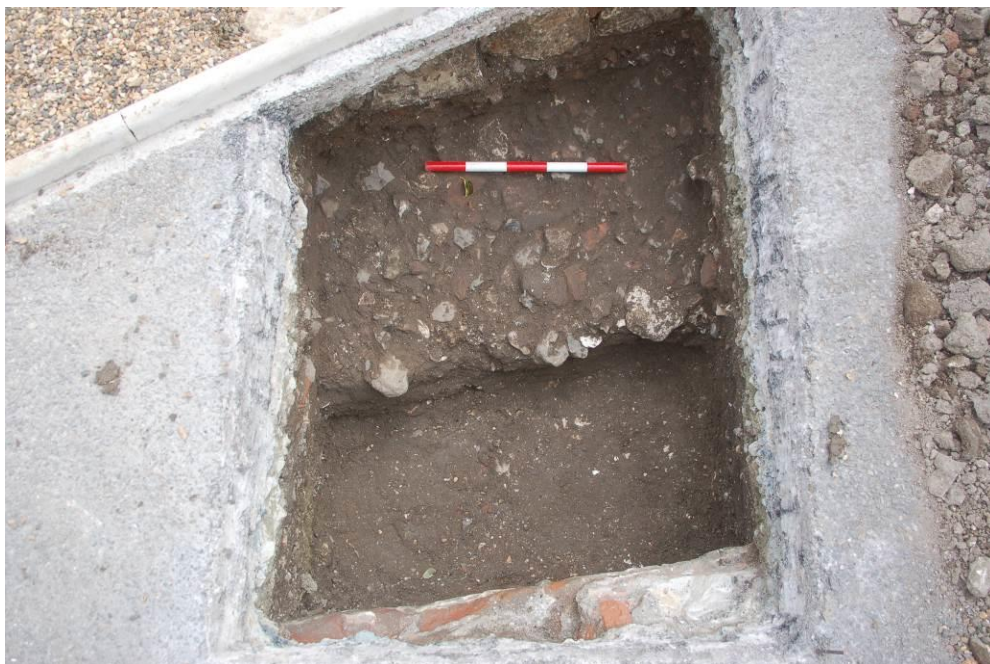
Plate 4. Yard surface (59), cut by later service trench [61] in the foreground, looking south. Scale 0.5m.

- 7.14 Overlying deposit (64) was a yard surface (59) formed of Caen stone, flint, brick and peg tile fragments, rare oyster shell and animal bone lying within a sparse dark brown silty clay matrix. The deposit was observed in plan towards the northern end of the evaluation pit, and was quite compact, up to 0.14m thick, with a fairly level surface. Lying above the yard surface, covering the same extent in plan, was a probable occupation deposit of dark brown silty clay (58), up to 0.10m thick, flecked with oyster shell and charcoal, and containing four fragments of thirteenth-/fourteenth-century pottery, pieces of medieval/post-medieval brick and tile, and animal bone.

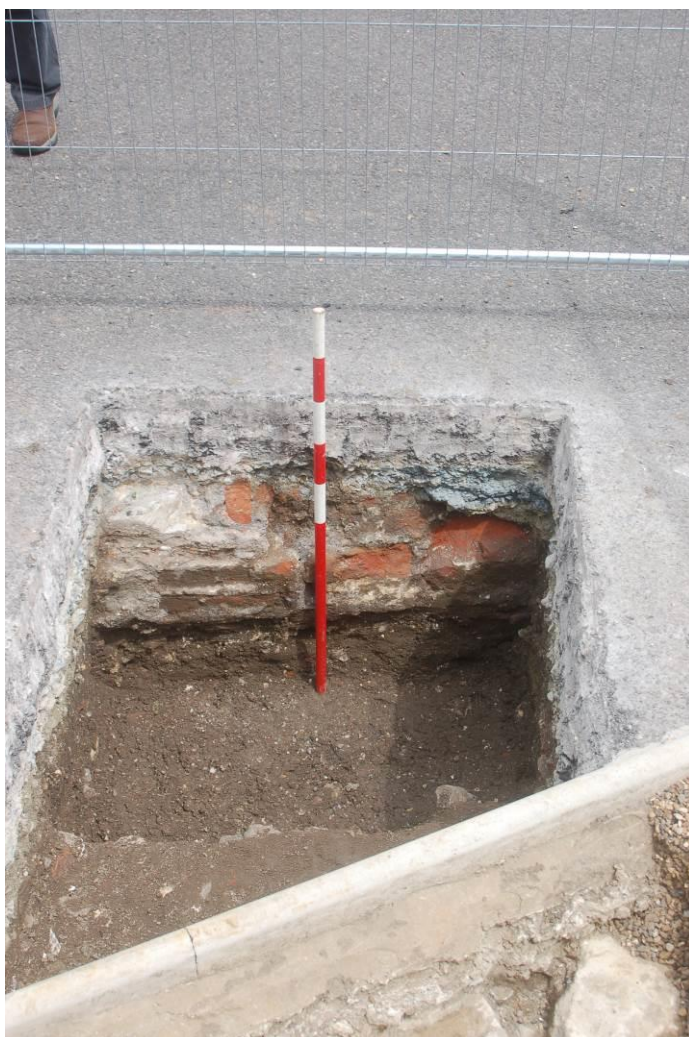
Plate 5. Wall (56) at the northern end of Pit 2, looking north. Scale 1m.

- 7.16 Perhaps originally cutting into deposit (57) was a length of wall (56) visible at the far northern end of the evaluation pit, aligned north-west to south-east and extending below the northern section edge. It was constructed of coursed soft red brick, and occasional blocks of Caen stone and ragstone, bonded with grey mortar flecked throughout with charcoal and chalk. The nature of the mortar suggests that the wall is of nineteenth-century date. It stood to a height of four courses (0.34m).

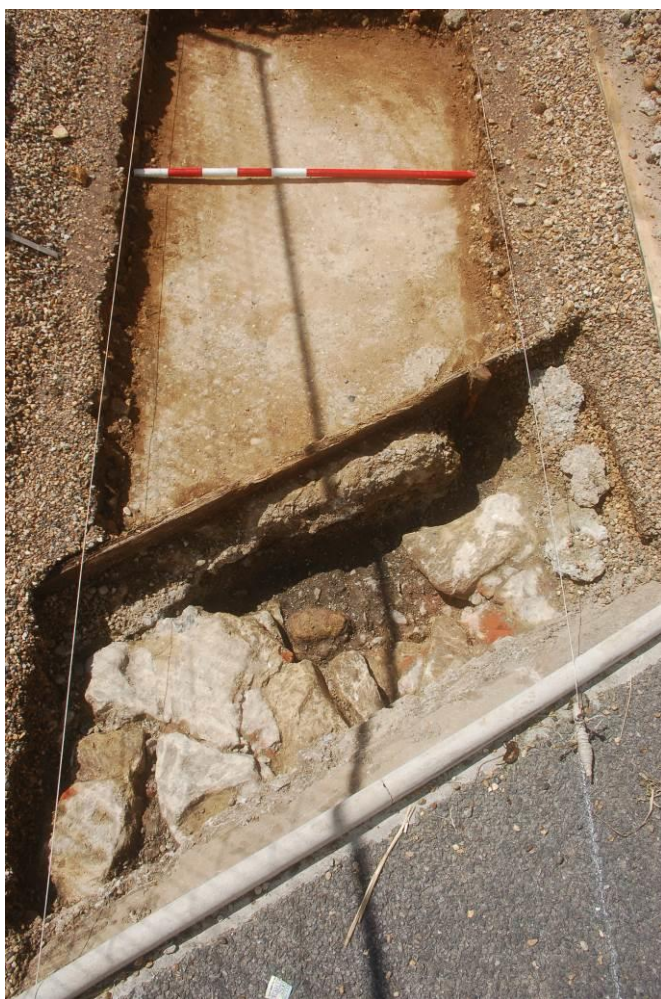
Plate 6. Boundary wall (55), looking south. Scale 1m.

- 7.17 Set into deposit (57) further south was another wall (55), aligned east–west, crossing the centre of the evaluation pit. It formed the remains of the boundary wall which stood before construction of the ISC, and was constructed of re-used Caen stone blocks and occasional brick fragments bonded with pale yellow-brown mortar. The wall had a total height of up to 0.20m. Part of the wall was obscured by a later kerb line which was left *in situ*.

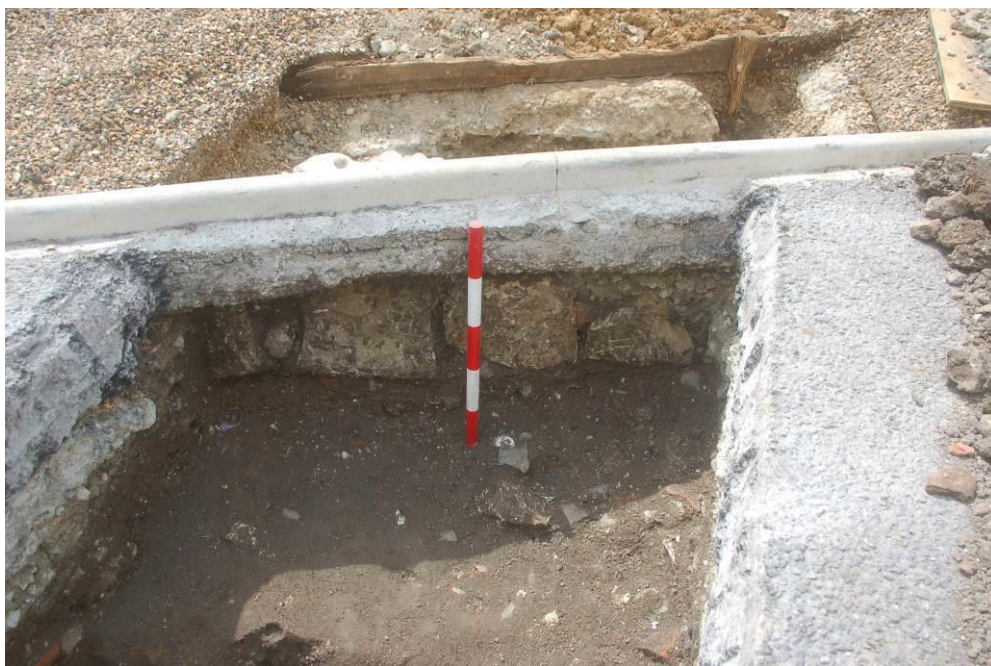
Plate 7. Boundary wall (55) lying below concrete kerb (50), looking south. Scale 0.5m.

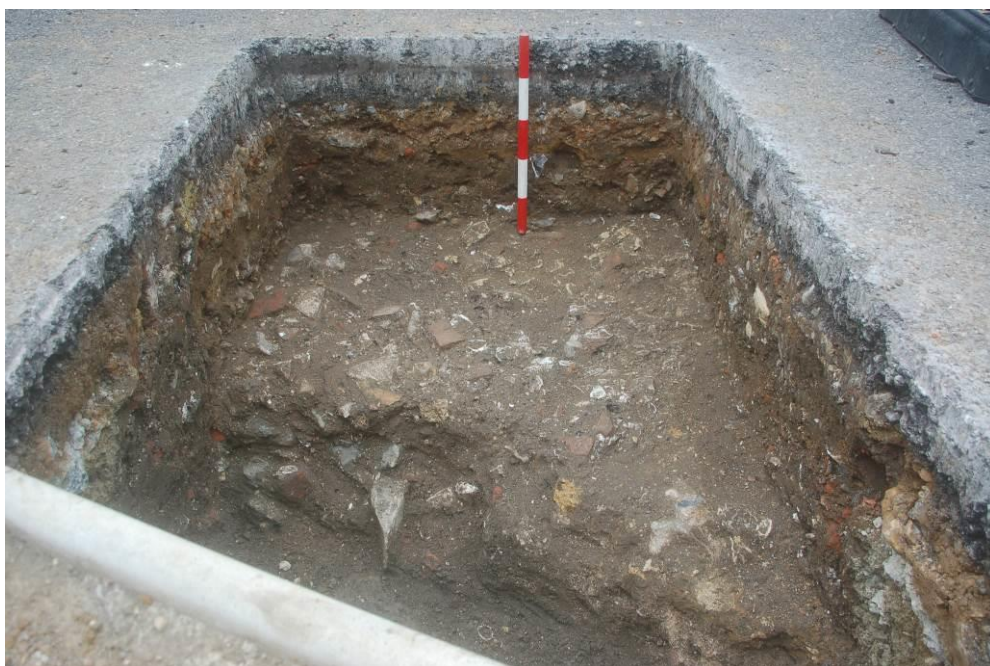
Plate 8. Detail of yard surface (80), looking north. Scale 0.5m.

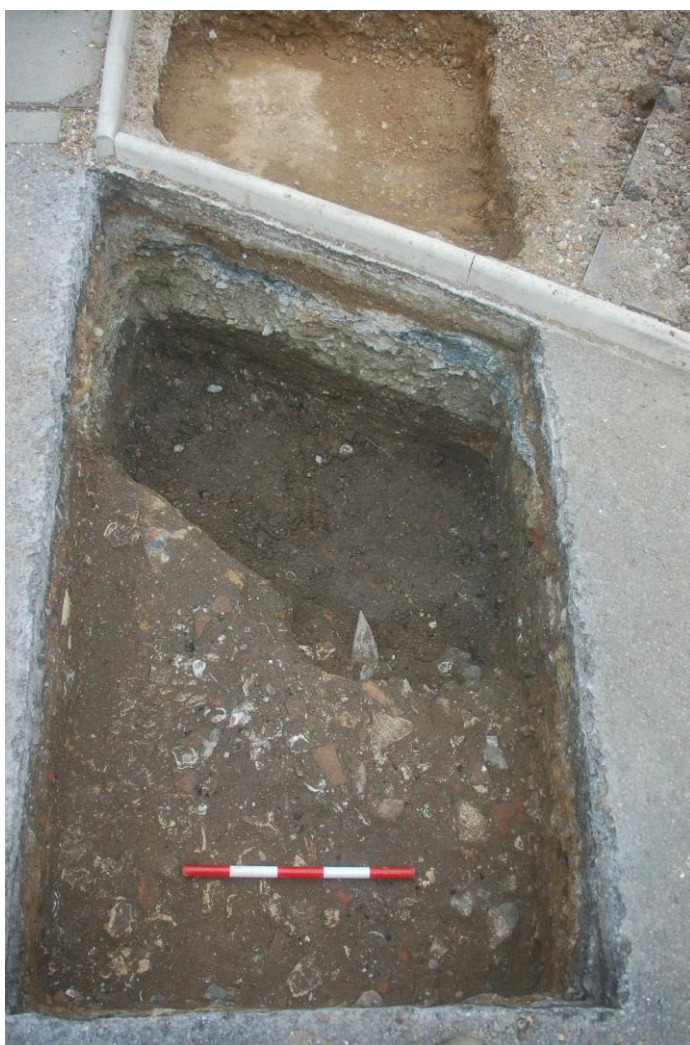
Plate 9. Pit 3 looking south, with yard surface (80) in the foreground. Scale 0.5m.
