Archbishop's Palace, Canterbury, Kent Wall rebuilding works

Archaeological evaluation

Project Code: ABPW-EV-16

Report No: 2016/113

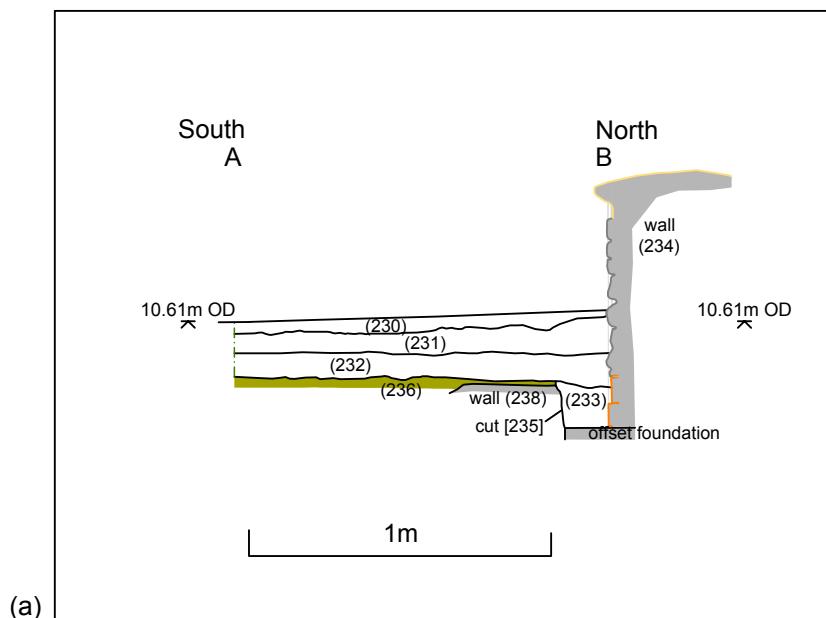
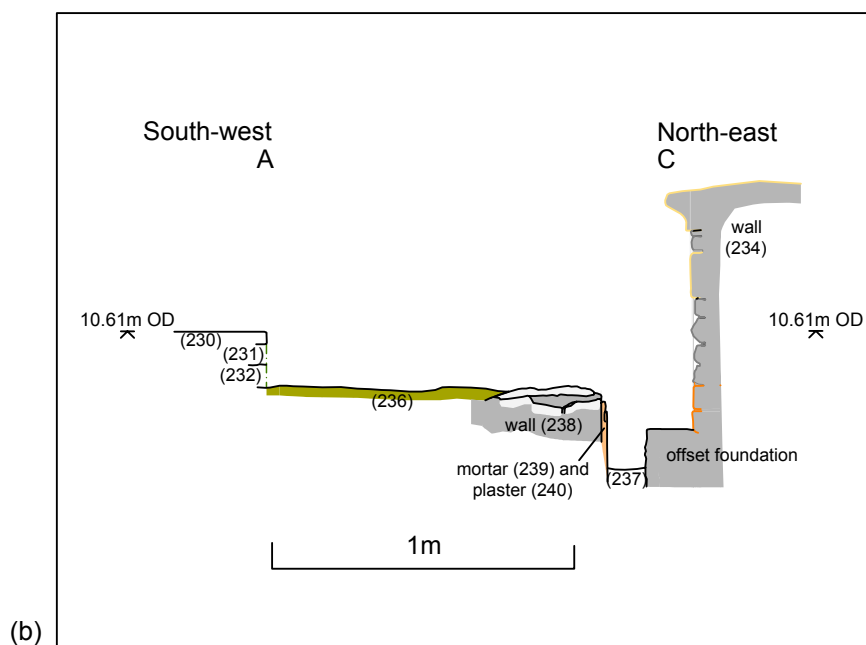
Figure 4. Sections of remains in pit 1.

aligned masonry wall (238) were encountered at a depth of 0.2m (10.41m OD) below the present ground surface. The fabric of the wall comprised chalk, Caen stone fragments and flint nodules, bonded with a pale brown sandy mortar containing small flint inclusions. The wall was not fully exposed and therefore no complete dimensions could be determined, although it could be seen to survive to a height of at least 0.25m and its width was at least 0.5m. A small area of the north face of the wall was revealed in a narrow excavated slot; it was rendered with a base layer (arriccio) of coarse pale grey mortar (239) measuring up to 0.02m thick, which was overlain with a layer of fine white plaster (240) up to 0.01m thick.

- 4.1.2 To the north and abutting the face of wall (238) was a deposit of loose pale brown mortar containing flint nodule and rare red brick fragments (237), possibly a demolition horizon. It was observed in plan within the narrow slot excavated at the base of the evaluation pit. Sealing both this deposit and the upper surface of the wall was a compacted layer of small angular flint with rare small fragments of Reigate stone, peg-tile (some glazed) and brick, set within a light brown sandy silty clay (236), probably an external surface.

- 4.1.3 These earlier features and deposits were cut to the north by the construction cut [235] for the present boundary wall (234). The wall comprised a cemented brick rubble offset foundation with two courses of red brick (brick size – 22.5cm x 11cm x 7cm), above which was constructed the flint- and stone-faced element of the wall. The construction cut for the wall was filled with a deposit of grey-brown sandy silt and mortar rubble (233) which produced two sherds of mid to late nineteenth-century pottery.

- 4.1.4 Wall (234) was abutted by a compact bedding deposit of gravel set within an orange-brown silty clay (232) measuring 0.1m in thickness. This was sealed by a coarse tarmac deposit (231; 0.08m thick) which was in turn sealed by the present tarmac surface (230; 0.05m thick).

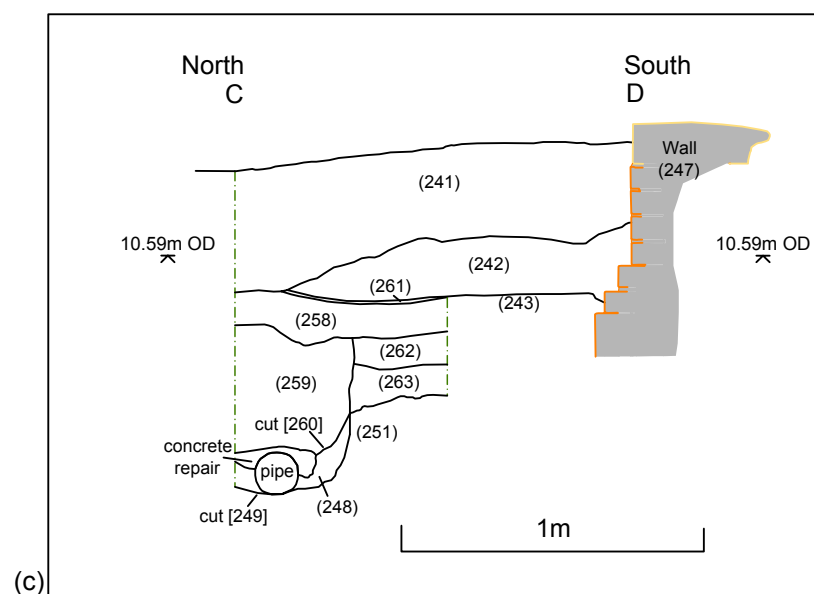
Figure 6. Sections of remains in pit 3.

- 4.2.2 At the base of the excavation, and seen in the southern section (not illustrated) abutting wall (252), was a deposit of loose pale brown mortar containing common red brick fragments (251) which could have represented demolition material. It was observed to a thickness of up to 0.26m but extended beyond the base of the trench. The deposit included some complete bricks which corresponded in form to those in wall (252).

- 4.2.5 A construction cut for the present boundary wall was not visible in this investigation pit. However extensive root damage near the face of the wall foundations may have disturbed any evidence for this. The present boundary wall (247) appeared to have been built directly upon wall (252), a layer of concrete (not separately numbered) forming the foundations of the new wall. The method of construction is as described above (section 4.1.3). However the north face of the wall comprised four offset brick courses and brick walling above, with no flint and stone facing.

- 4.2.6 Sealing the service trench and abutting the wall was a thick (up to 0.33m) deposit of pale brown silty clay containing common small fragments of mortar, flint, brick and peg-tile (244). This was sealed by a thin layer of compacted brown clay, crushed mortar and flint (243) measuring up to 0.02m thick, which is thought to have formed a surface. In the north-east corner of the investigation pit, deposit (243) was cut by a pit [260] (not illustrated in plan) (filled by 258 and 259), up to 0.60m deep, made to effect a repair on the foul water pipe. Towards the south of the evaluation pit, deposit (243) was cut by the concrete foundation for a wooden post supporting fencing (not numbered).

- 4.2.7 Capping pit [260] was a layer of clay (261) which appears to have reinstated the former surface (243). Overlying deposit (261) were two thick (up to 0.40m) dumps of garden soil (241 overlying 242) abutting the present boundary wall which now forms the garden border.

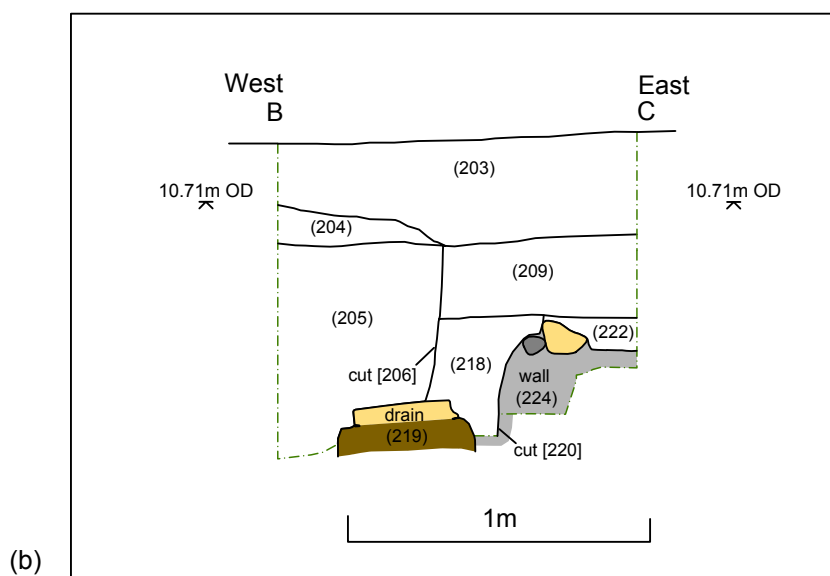
Figure 8. Sections of remains in pit 4.

- 4.3.4 Cutting deposits (211) and (216) was the construction cut [215] for the present boundary wall (213 and 214; filled by 212). The method of construction of the wall was as described above (section 4.2.5), the new wall resting upon a layer of concrete (214).

- 4.3.5 Sealing the earlier features and abutting the present boundary wall was a thick (up to 0.34m) deposit of mid brown-grey clay silt containing mortar flecks and rare chalk, flint and ceramic building material (209 and 210). Cutting these deposits was a large feature [206] (not illustrated in plan) in the north-western corner of the pit, at least 0.87m deep, possibly the result of the removal of a tree or shrub, which was filled with a deposit of very loose mid brown-grey clay silt containing common ceramic building material, crushed mortar and rare stone, flint and chalk fragments (205), in turn sealed by loose brown-grey clay silt containing common chalk and mortar flecks (204). Capping the evaluation pit was the present garden soil (203), up to 0.35m thick, and a post-hole [202], 0.53m deep, holding a concrete base (201) for the existing fence and capped by further topsoil (200).

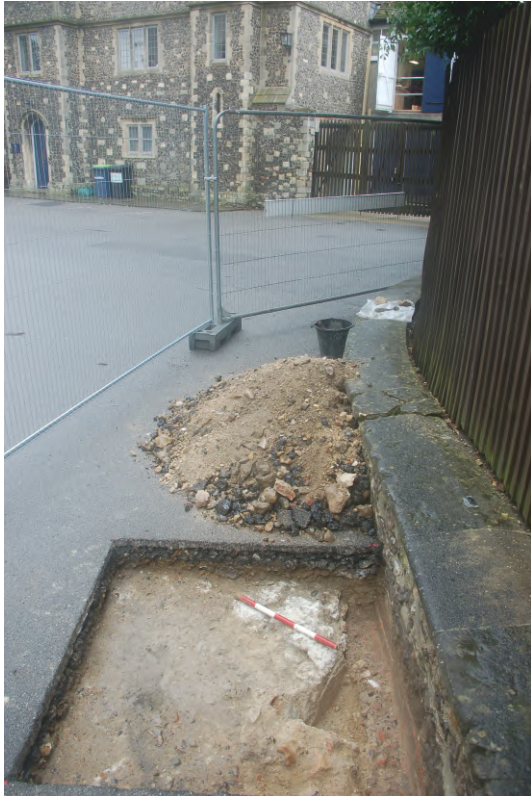
Plate 1.
Wall investigation pit 1 with No. 10 The Precincts
in the background. The present palace boundary
wall can be seen to the right.
Looking south-west. Scale 0.5m.

4.1 Wall investigation pit 1 (Figures 3 and 4; Plates 1 and 2)

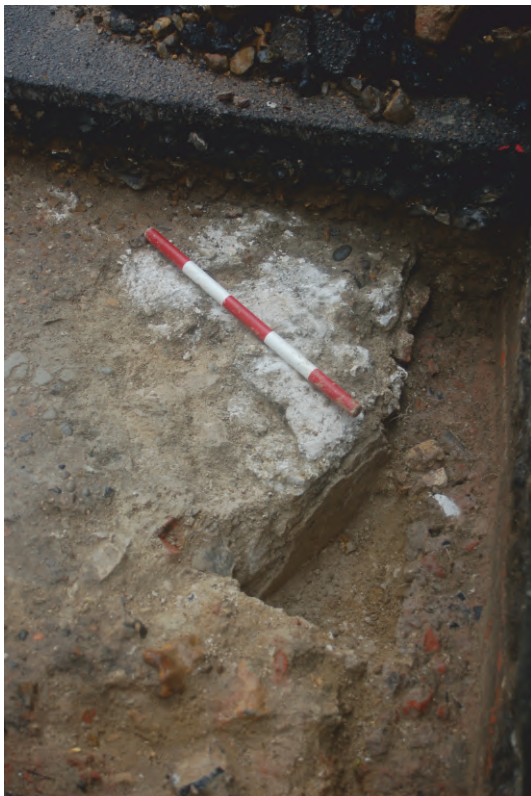
Plate 2.
Wall investigation pit 1, showing detail of
wall [238] with plaster rendering visible below
and right of the scale.
Looking south-west. Scale 0.5m.

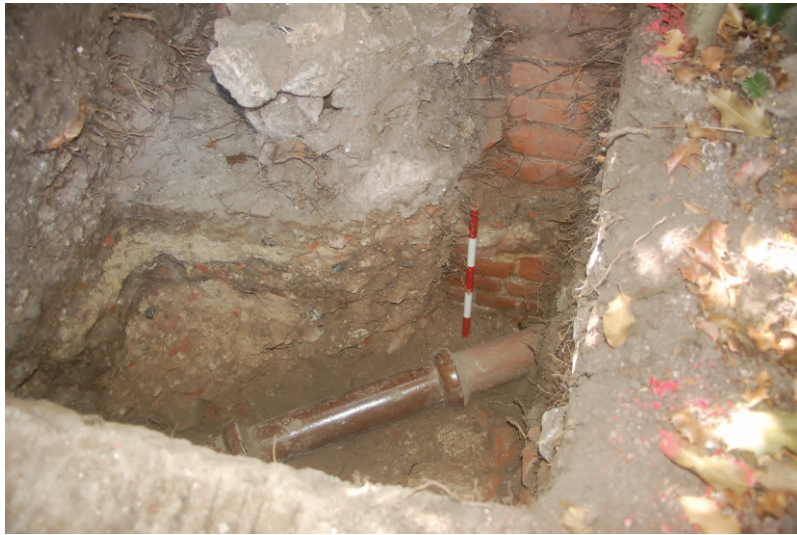
Plate 3. Wall investigation pit 3, showing earlier brick wall [252] at base of the sequence with the footings for the present palace boundary wall above. Looking south-east. Scale 0.5m.

- 4.2.1 Wall investigation pit 3 was situated immediately north of the present boundary wall to the Archbishop's Palace, within the palace garden. The earliest feature observed within this investigation pit was a section of wall situated within the south-west corner, at a depth of 0.8m (10.17m OD) below the present ground surface. The wall (252) was aligned east to west and constructed of red brick bonded with a hard cream-coloured mortar and, in places, pale brown mortar with common inclusions. The bricks measured 25cm x 12.5cm x 6cm and were slightly irregular in form suggesting that they were hand-made. The visible section of wall comprised five courses (0.35m height) in an English bond and extended beyond the base of excavation.

- 6.6 A further section of masonry was observed in investigation pit 3. It is not clear how this red brick wall (252) relates to the Archbishop's Palace, and no associated datable material was recovered. However, based on the wall fabric, in particular the type and size of brick it is possible that the wall dates to the late medieval or early post-medieval period. A deposit of rubble associated with the demolition of this wall was also recorded (251).

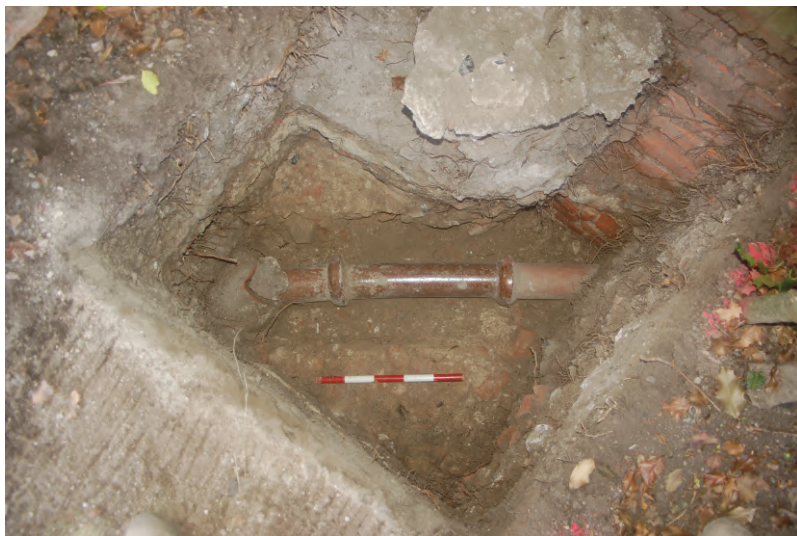
Plate 4. Wall investigation pit 3, showing the foul water pipe [249] cutting wall demolition deposits (251). Looking south-east. Scale 2m.

- 4.2.4 A service trench [249] (filled by 248), for the provision of a foul water pipe, cut all of the earlier features and deposits. The service, aligned north-east to south-west, comprised a ceramic pipe and probably dates to the nineteenth century. It was not possible to determine whether the service pre-dates the present boundary wall or whether it tunnelled underneath it.

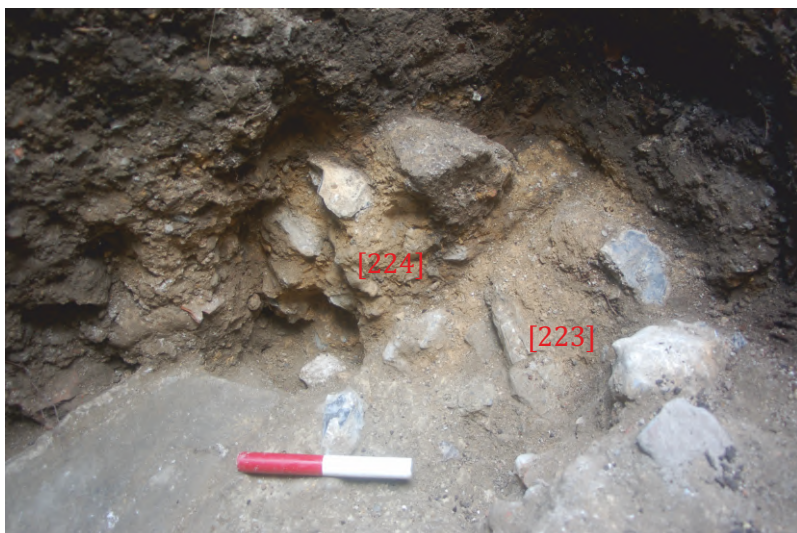
Plate 5. Wall investigation pit 4, showing walls [223] and [224]. Looking north-east. Scale 0.2m.

- 4.3.1 Wall investigation pit 4 was situated immediately north of the present boundary wall to the Archbishop's Palace, within the present palace garden and to the east of investigation pit 3. Two small fragments of masonry (223) and (224), standing to a maximum height of 0.30m, represent the earliest features exposed in this investigation pit; both were situated in the north-east corner of the pit at 0.72m (10.24m OD) below the present ground surface. Wall (223) was constructed of flint nodule bonded with a yellow-brown sandy mortar. Immediately adjacent to this wall, to the north, wall (224) comprised flint nodule and stone fragments bonded with mid yellow hard sandy mortar. Both walls continued beyond the base of excavation and no complete dimensions, nor a true orientation, could be determined, although from the evidence seen it appears that they were aligned east-west. It was not possible to establish which wall was the earlier. Both walls were sealed by a deposit of loose yellow and brown crushed mortar containing flint and stone fragments (222), up to 0.1m thick, probably a demolition horizon.

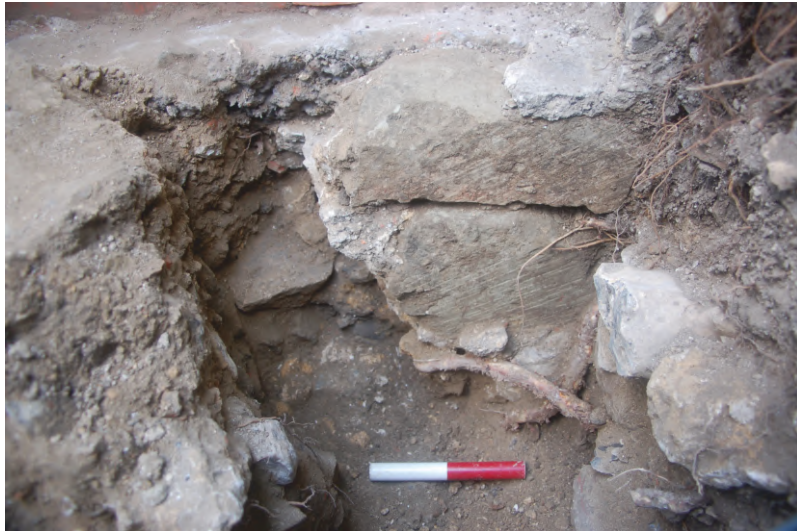
Plate 6. Wall investigation pit 4, showing wall [221].
Looking south. Scale 0.2m.

- 4.3.2 In the south-west corner of the investigation pit, a further section of masonry survived at a depth of 0.55m (10.43m OD) below the present ground surface. This wall (221), standing to a visible height of 0.55m, comprised large blocks of dressed stone (possibly Reigate stone) bonded with a hard brown-yellow mortar with chalk inclusions. Aligned roughly east to west, evidence for four courses survived. The wall was sealed by a deposit of very loose grey mortar and rubble (211) perhaps infilling a void resulting from the removal of a further course of masonry.

- 7.4 In investigation pit 4, the highest surviving element of probable medieval masonry, wall (221) was recorded at a depth of 0.55m (10.43m OD) below the present ground surface.
- 7.5 The results therefore demonstrate that archaeological remains lie at a shallow depth within the PDA. The remains observed date to the medieval and post-medieval periods. Any groundworks associated with the proposed rebuilding of the boundary have the potential to impact on the archaeological resource if any work falls outside the line of the current wall foundations.

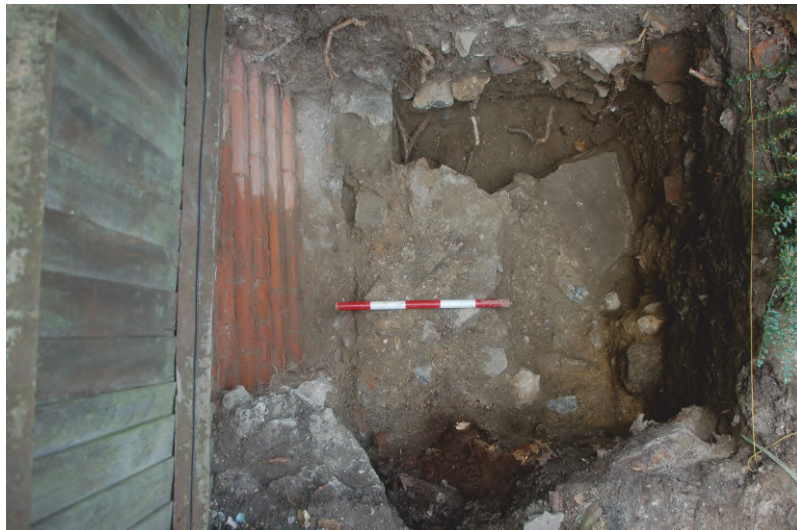
Plate 7. Wall investigation pit 4, showing the footings of the
present palace boundary wall to the left and the stone capped
drain [219] crossing the pit on a north-west to south-east alignment .
Looking west. Scale 0.5m.

- 4.3.3 Cutting the masonry in this investigation pit was a north-west to south-east aligned drain set within a construction trench [220] up to 0.39m deep. The drain (219) was constructed of brick and tile bonded with a hard white lime mortar with a stone slab capping. Mortar was poured over the capping stones prior to backfilling with a compact rubble deposit of crushed yellow and cream mortar containing flint nodule, chalk, tile and stone (218). The drain was sealed by two further deposits; a compact dark brown-grey clay silt containing common brick and flint rubble (217) measuring 0.06m thick, sealed by a thin layer of compact flint and ceramic building material (216; 0.02m thick) which could have formed a surface.
