# Canterbury Cathedral

## Water management works: Investigations within the South Precincts

Archaeological evaluation report

Project Code: CC-WMW-EV16  
NGR: 615066 157878  
Report No: 2016/114  
Archive No: 3778

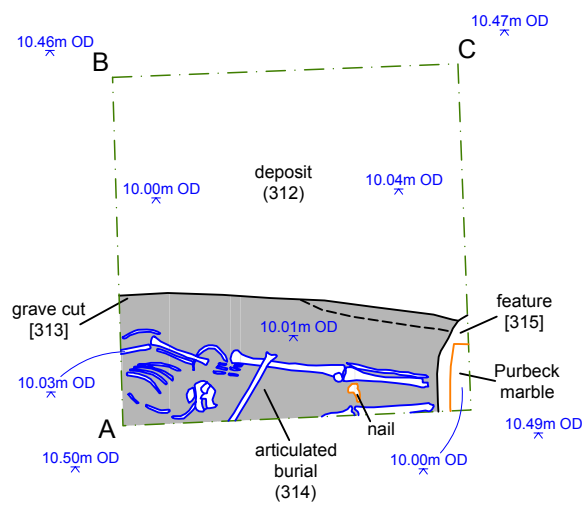
Fig. 10. Canterbury Cathedral Water Management Works.  
Plan of remains in Pit 4.

- 7.29 Cutting the eastern end of grave [313] was a feature just extending into the south-east corner of the evaluation pit, possibly another grave. The feature cut [315] was partly exposed in plan, having a curved end extending below the eastern and southern sides of the pit. The side of the cut was steeply angled, and the feature was up to 0.45m deep though not bottomed. At the base of the cut, as observed, was a single block of Purbeck marble (not separately numbered) possibly forming part of the surround to a grave. Overlying, and backfilling, the cut was a deposit of mid grey-brown silty clay (316) containing flint, chalk, mortar and rare small tile fragments.

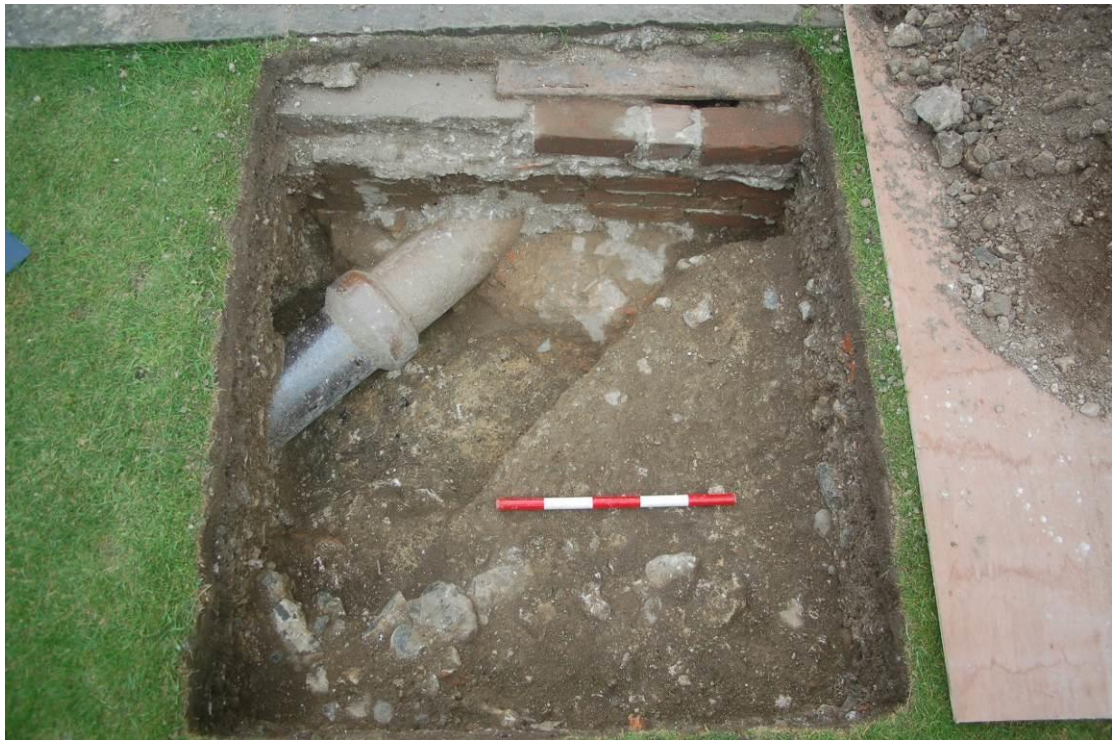
Plate 5. South Precincts Pit 1, south end, looking north. Deposit (32) lies to the south-east (bottom right). Scale 0.5m.

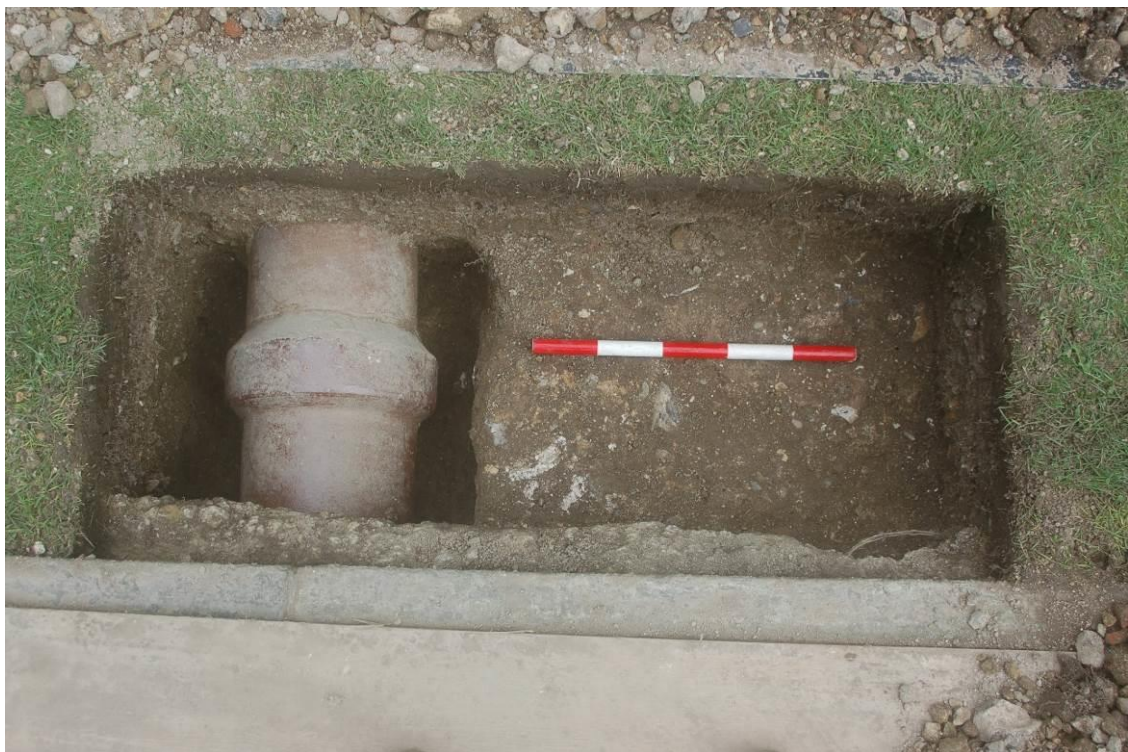
Plate 6. South Precincts Pit 1, north end. Looking north. Deposit (32) lies to the east (right). Scale 0.5m.

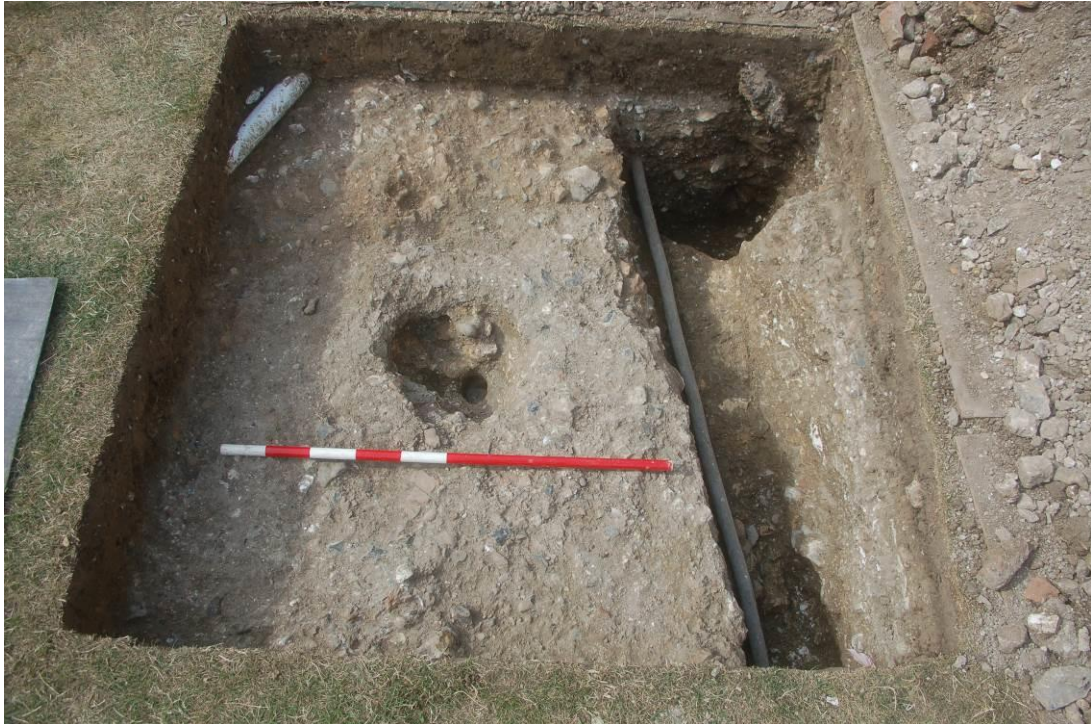
Plate 7. South Precincts Pit 2, looking north-west. The 1m scale rests upon surface (358), overlying surface (367) beyond.

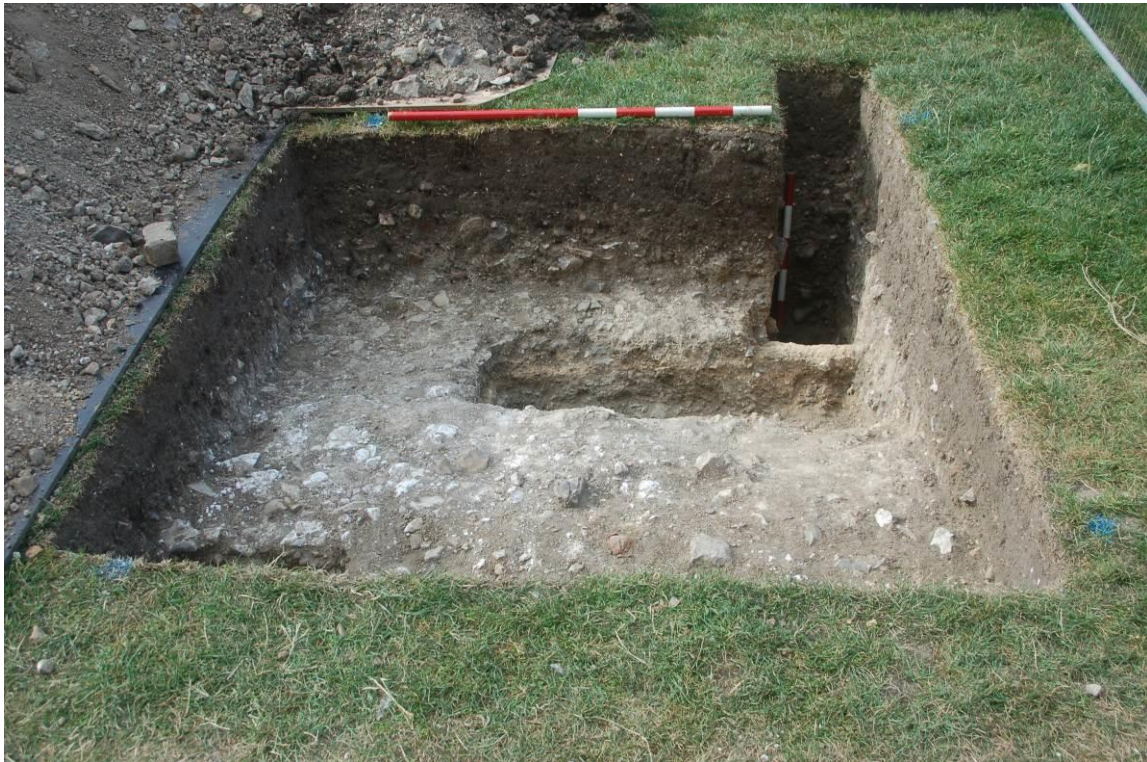
Plate 9. South Precincts Pit 3 with surface (293) exposed and showing underlying feature [295], looking south. Scale 1m.

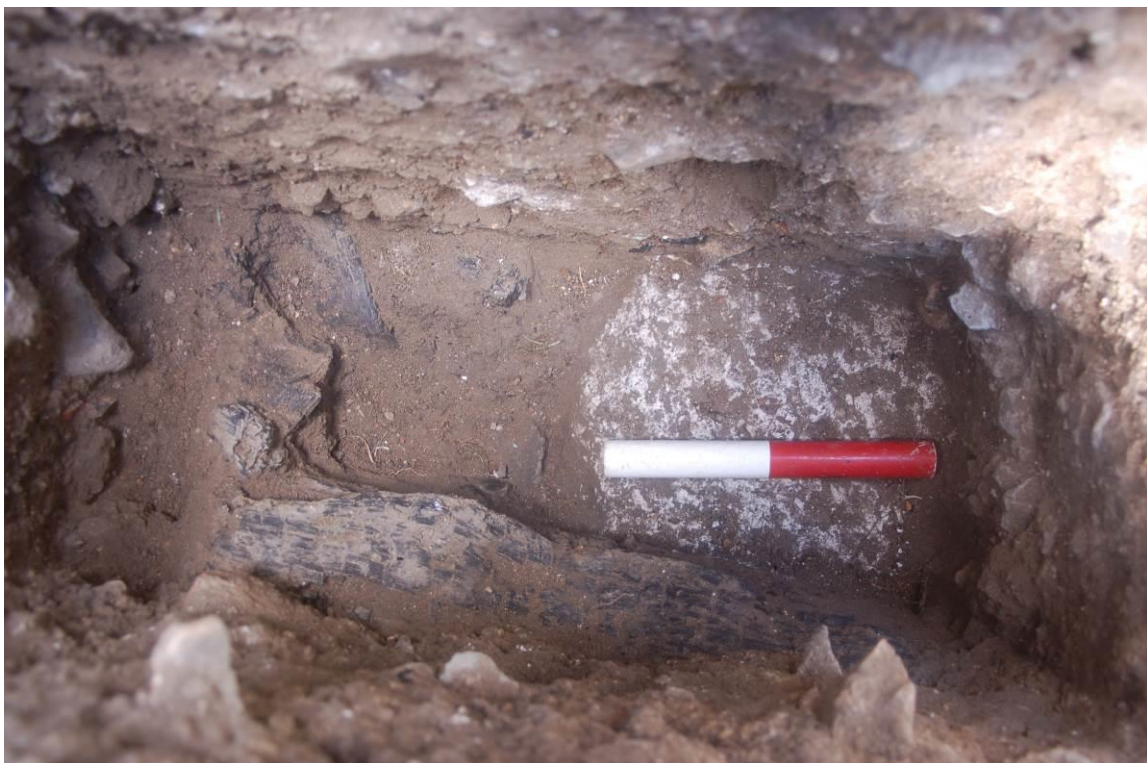
Plate 10. Detail of chalk surface (301) and charred wood (297) within the backfill of feature [298], observed within the sondage cut beside the south-west corner of South Precincts Pit 2. Looking west. Scale 0.2m.

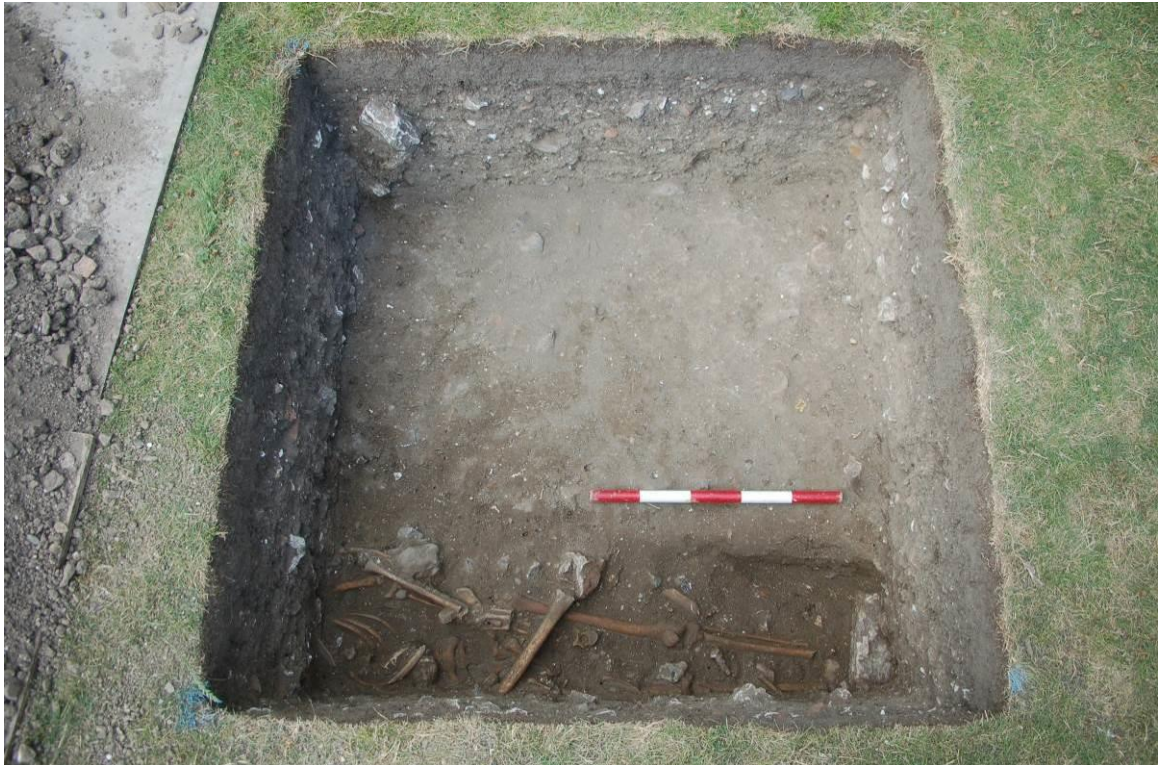
Plate 11. South Precincts Pit 4, looking north, with grave [313] in the foreground and feature [315], containing a block of Purbeck marble, to the south-east (bottom right). Scale 0.5m.

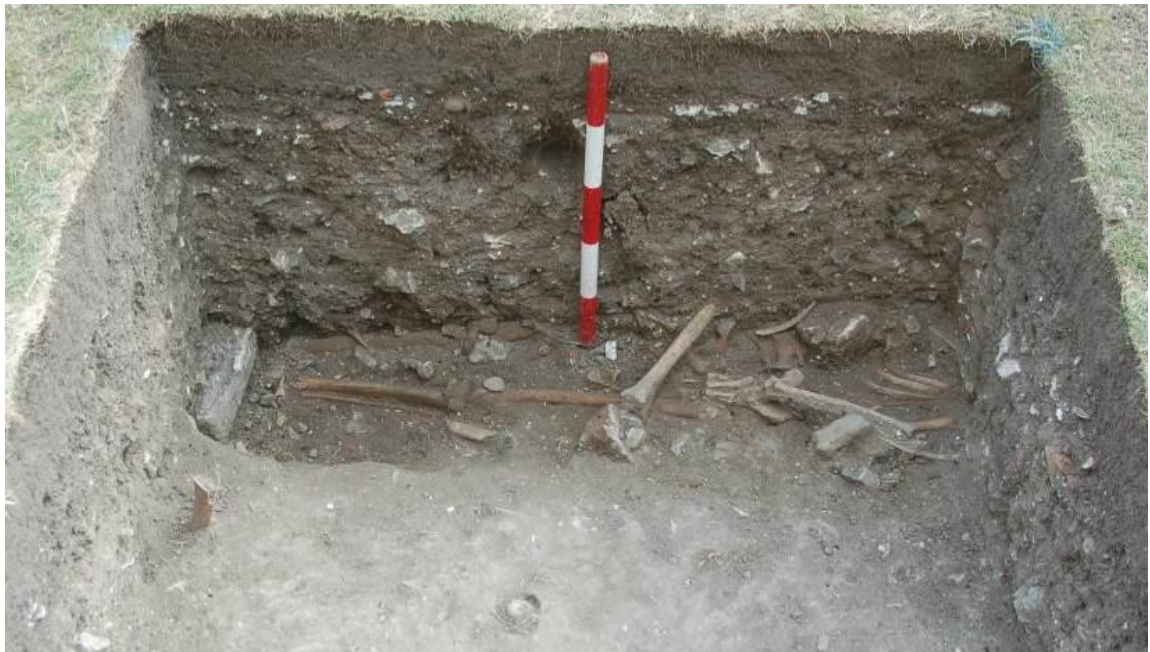
Plate 12. South Precincts Pit 4, looking south, showing grave [313] and feature [315] containing a block of Purbeck marble. Scale 0.5m.

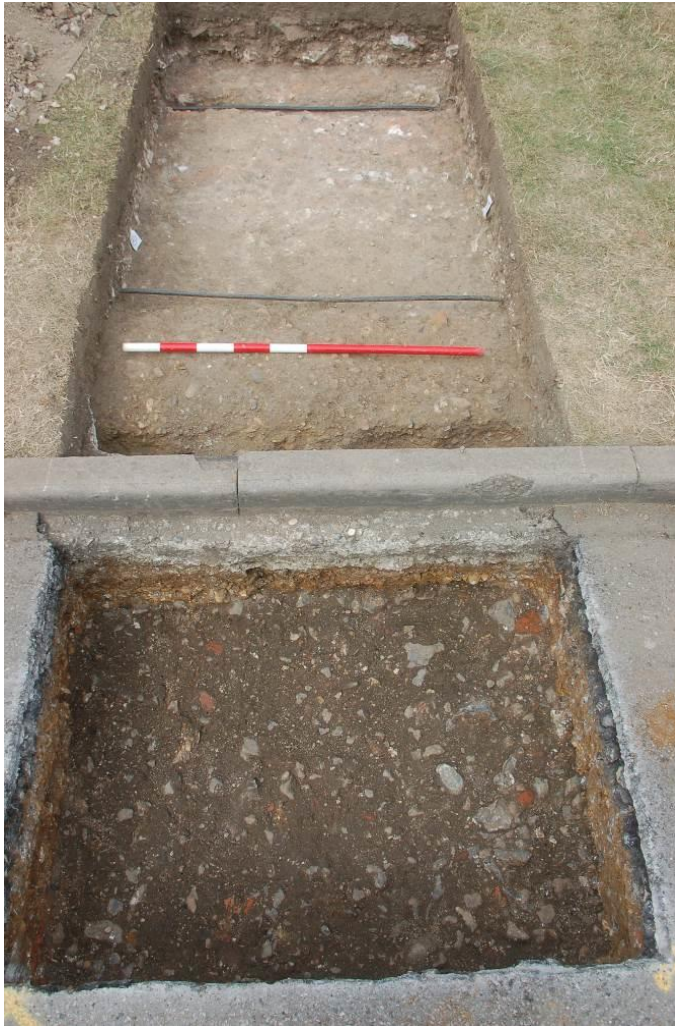
Plate 13. Southern end of South Precincts Pit 6 looking north, with metalling (280) in the foreground. Scale 1m.

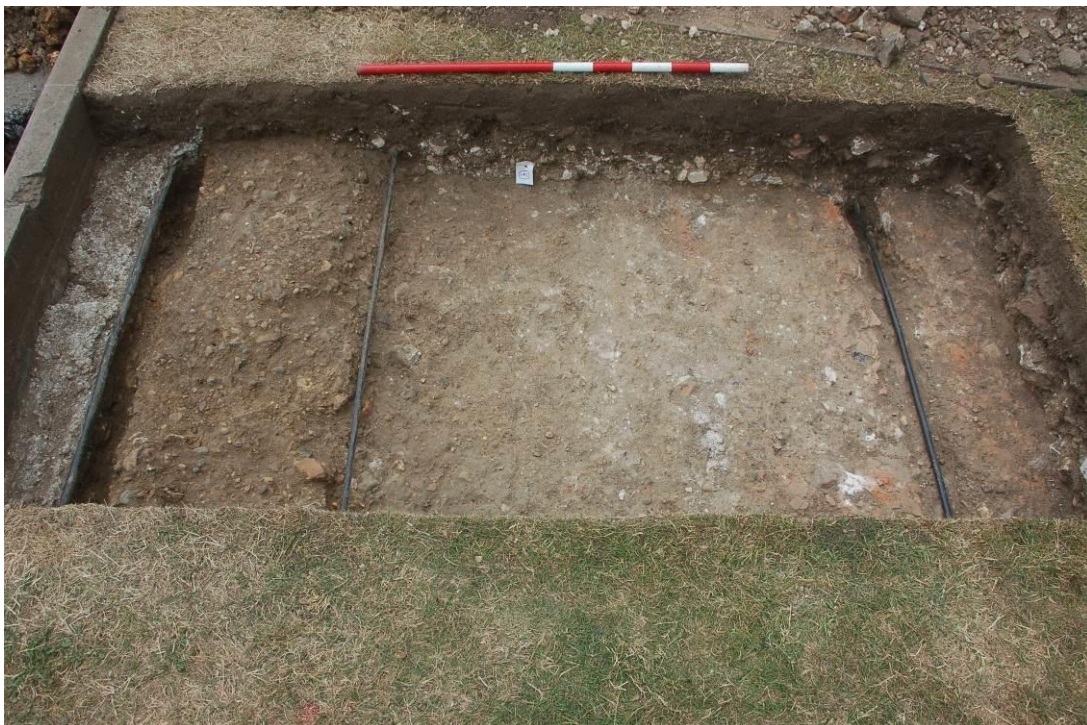
Plate 14. Northern end of South Precincts Pit 6 looking west, showing surface (281) to the south (left) and (282) to the north (right). Scale 1m.

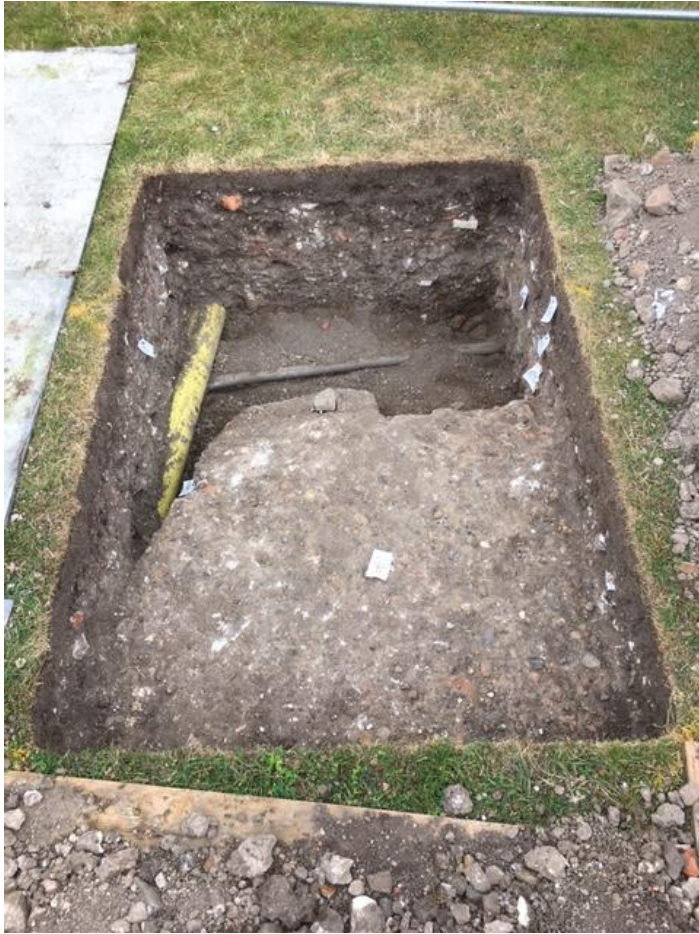
Plate 15. South Precincts Pit 7 looking north, showing surface (175) in the foreground.

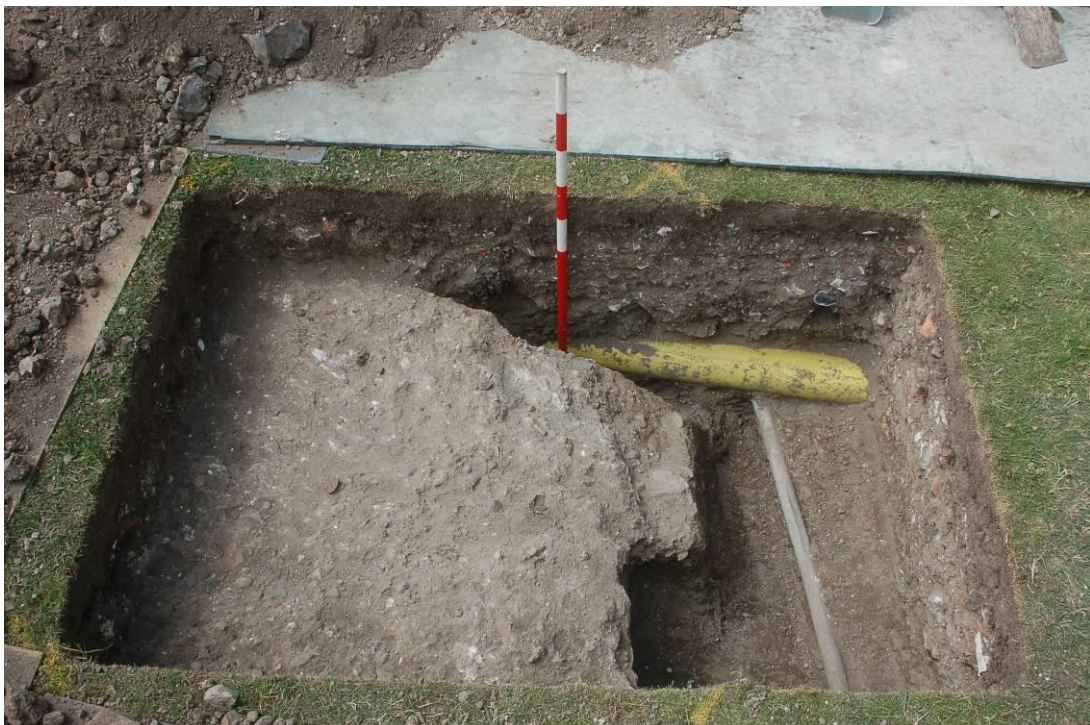
Plate 16. South Precincts Pit 7 looking west, with surface (175) exposed to the south (left). Scale 1m.

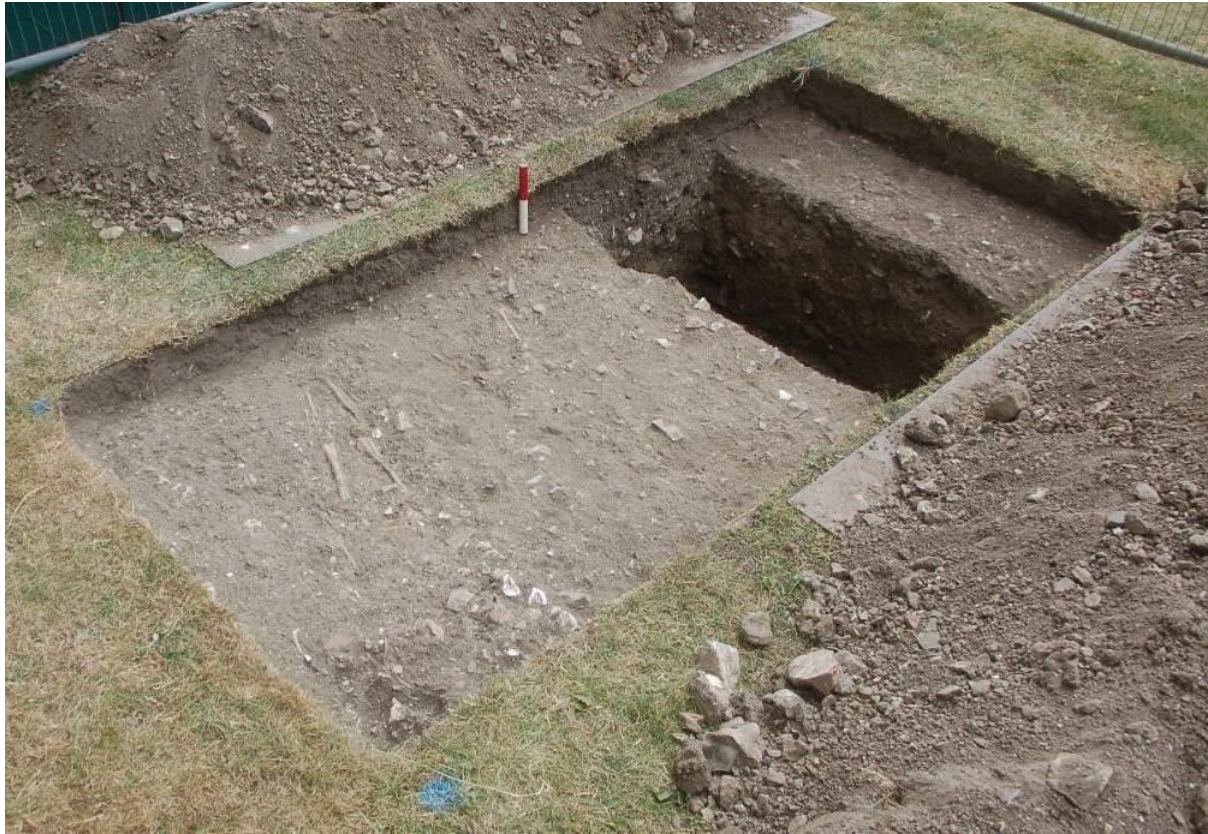
Plate 17. South Precincts Pit 8, looking south-east. Burial (405) lies in the foreground. Scale 0.2m.

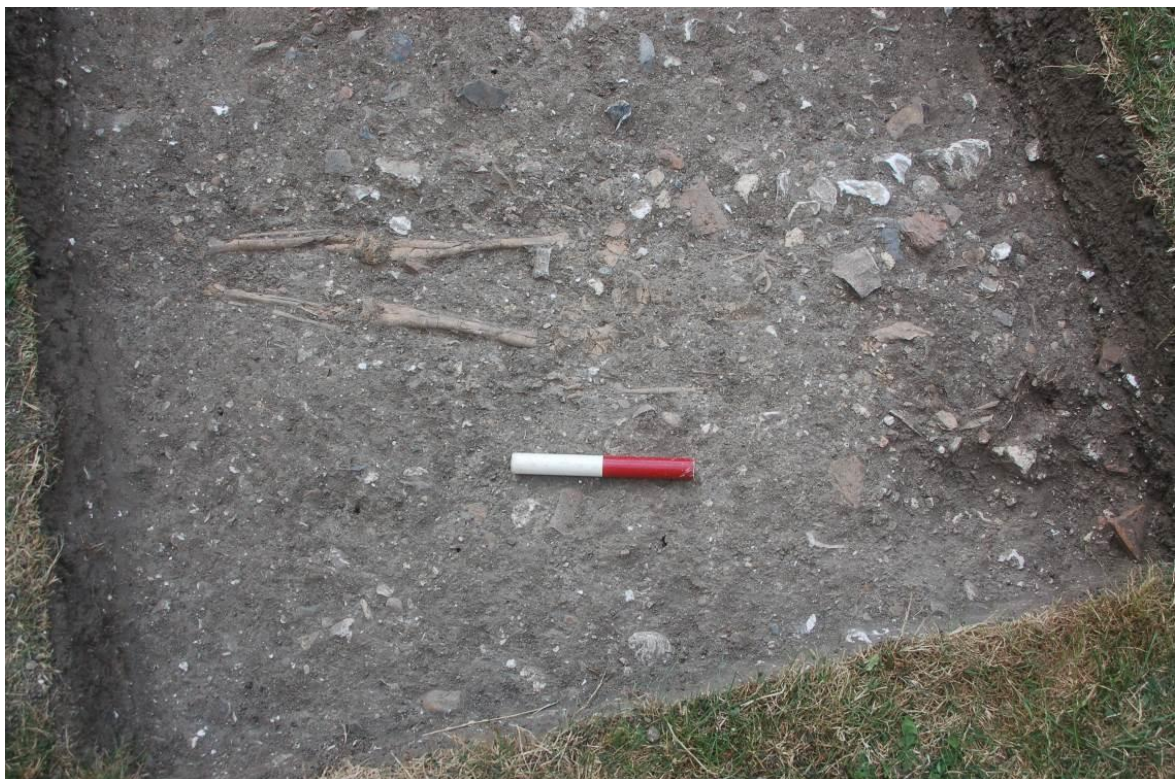
Plate 18. Detail of articulated burial (405) at the northern end of South Precincts Pit 8, looking south. Scale 0.2m.

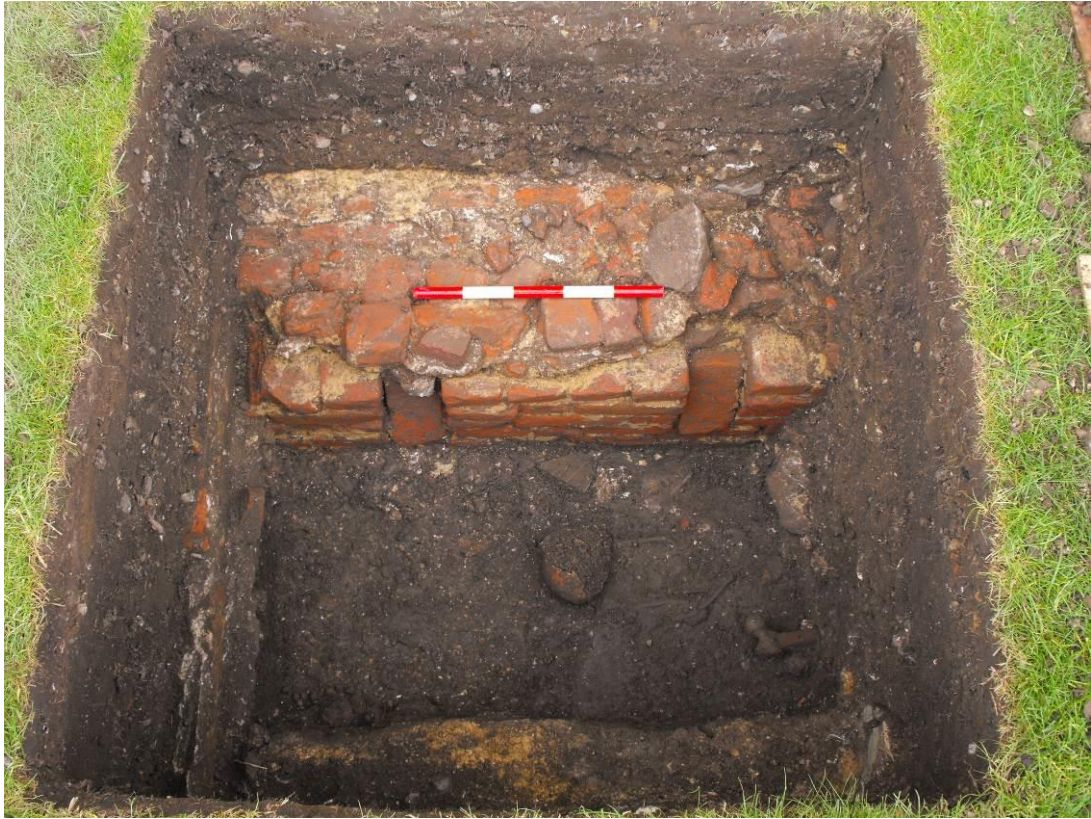
*A length of the monastic drain was exposed in Pit 9, containing weep holes in its southern side designed to allow water to seep into the surrounding ground. These had later been blocked, perhaps when the drain capping was replaced. A feature in Pit 3, with straight sides, a flat base and containing charred wood within its base, is of uncertain function.*

Plate 19. South Precincts Pit 9, looking north, showing monastic drain (6) with its new vaulted capping (4). Grave [11] lies south of the drain and mortar deposit (14) furthest south. Scale 0.5m.
