**Mitchinson's House,
Mint Yard,
Canterbury:**
Report on
evaluation trenching,
test pitting and
boreholing

**Mitchinson's House, Mint Yard
King's School,
Canterbury,
Kent**

Evaluation, test-pitting and boreholing report

Project Code: MHC-EV-16
Planning Ref: n/a
NGR: 615100 158113
Report No: 2016/126
Archive No: 3750

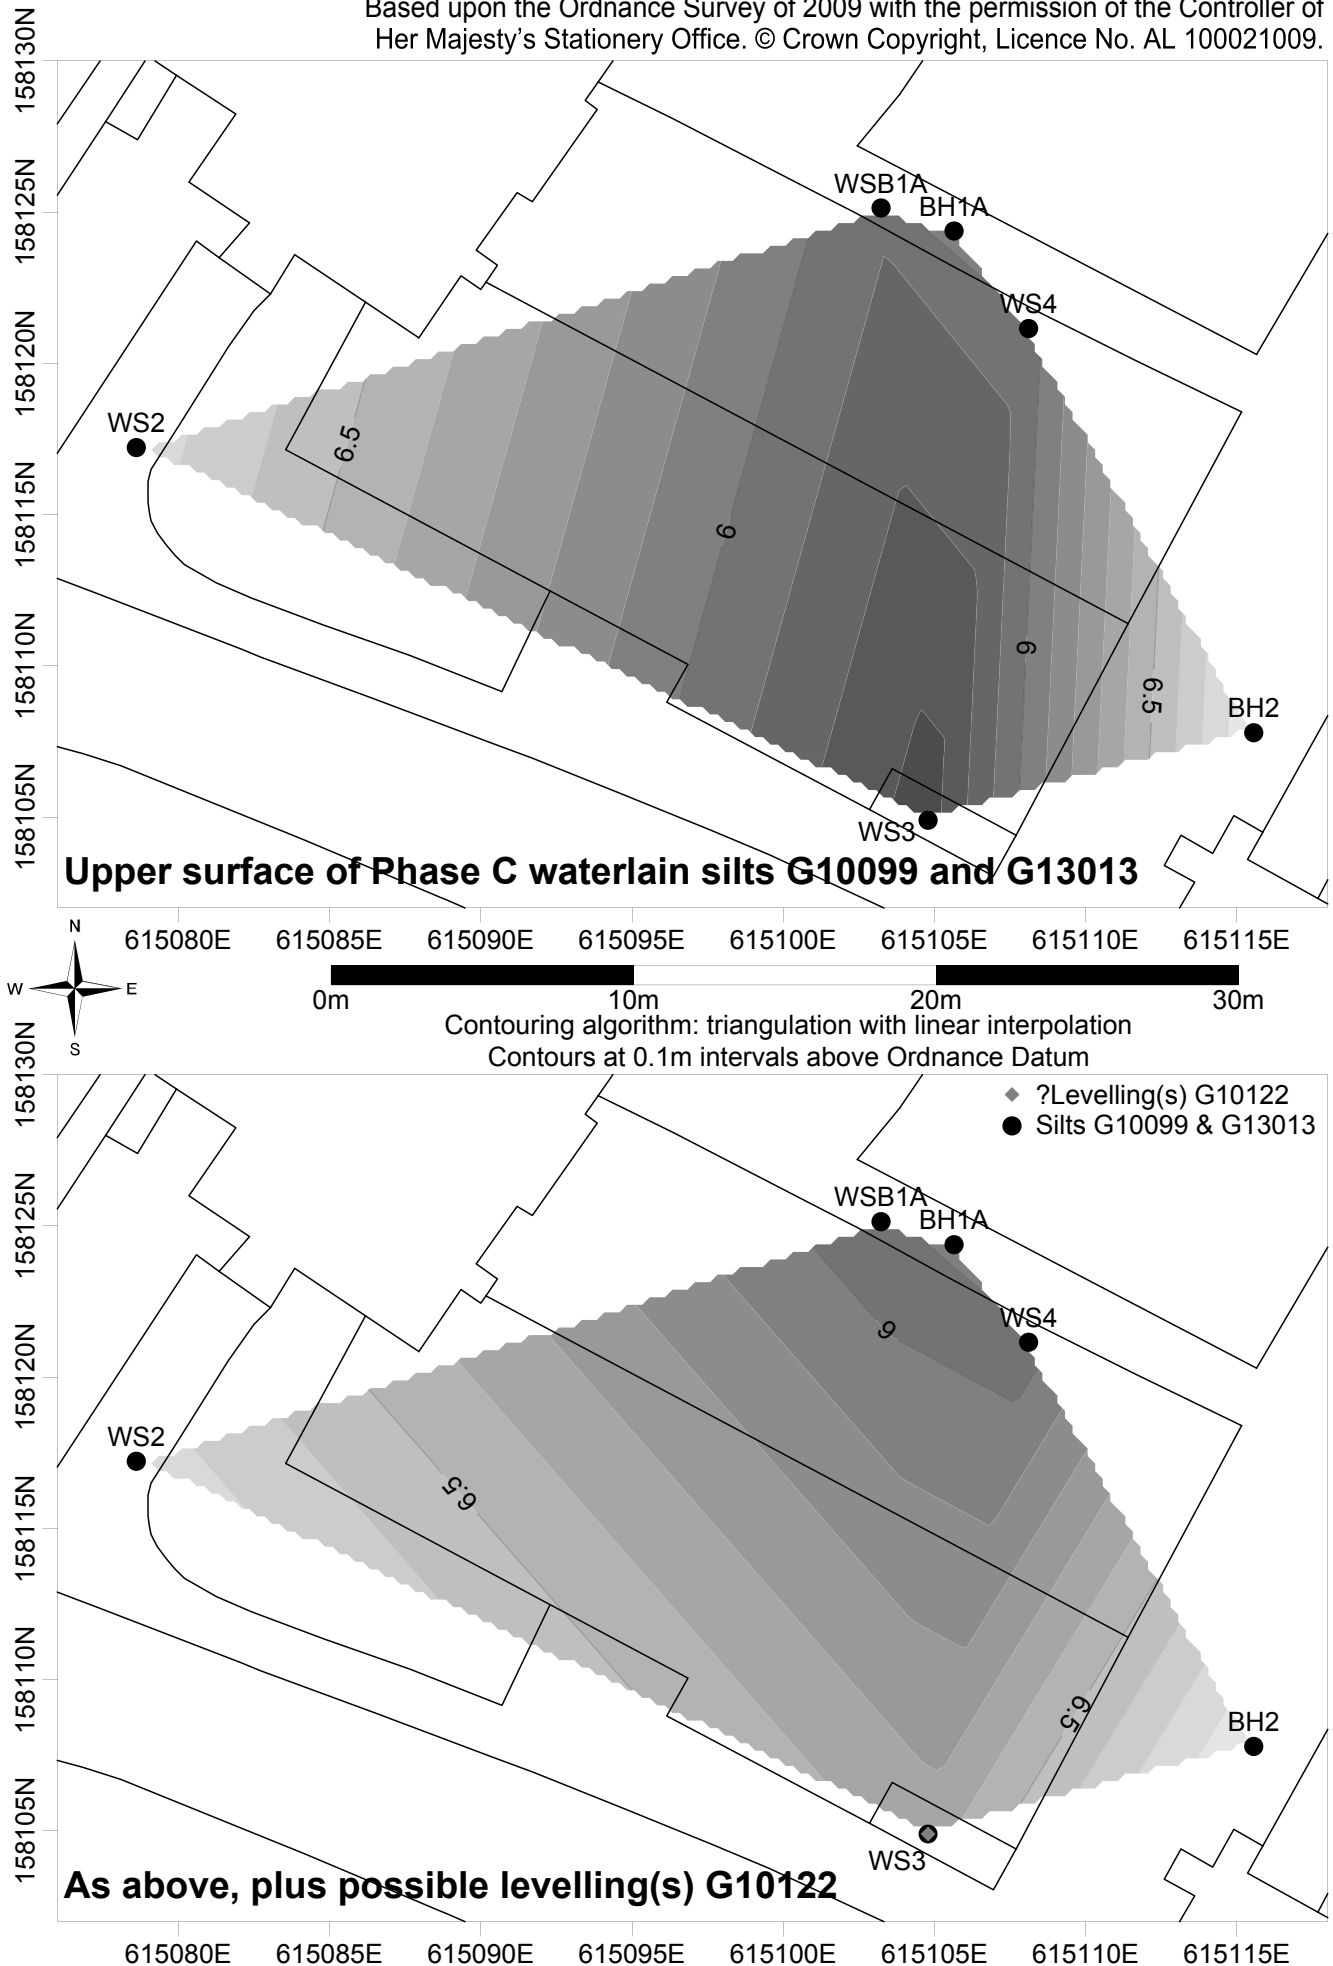
Fig 11. Probable pre- or early Roman ground level.

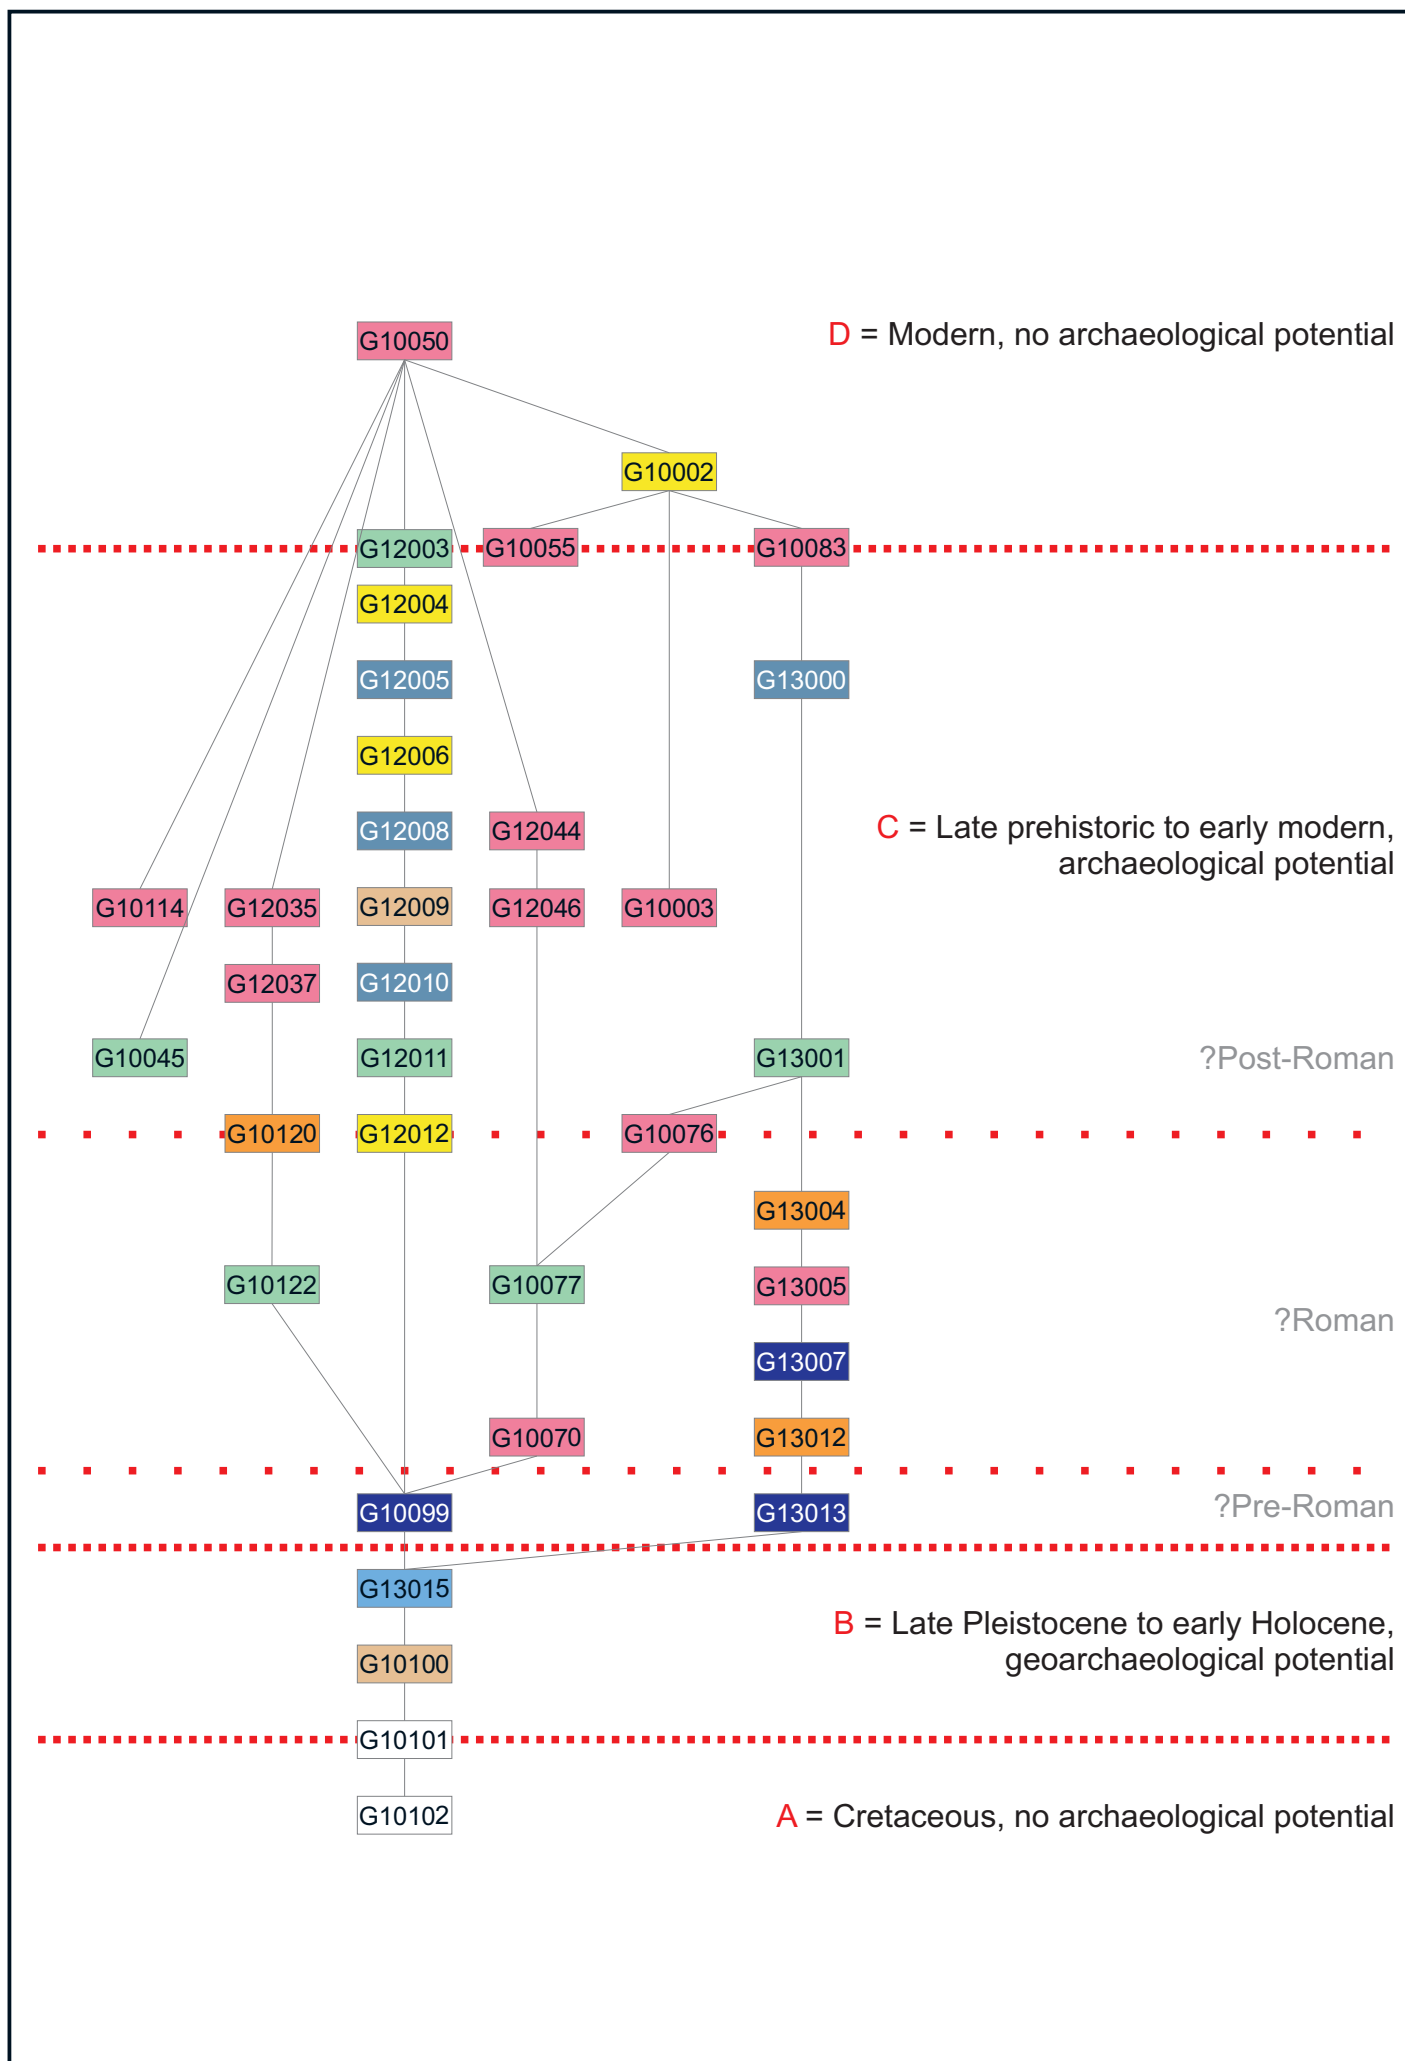
Fig 12. Stratigraphic group matrix of borehole and test pit results.

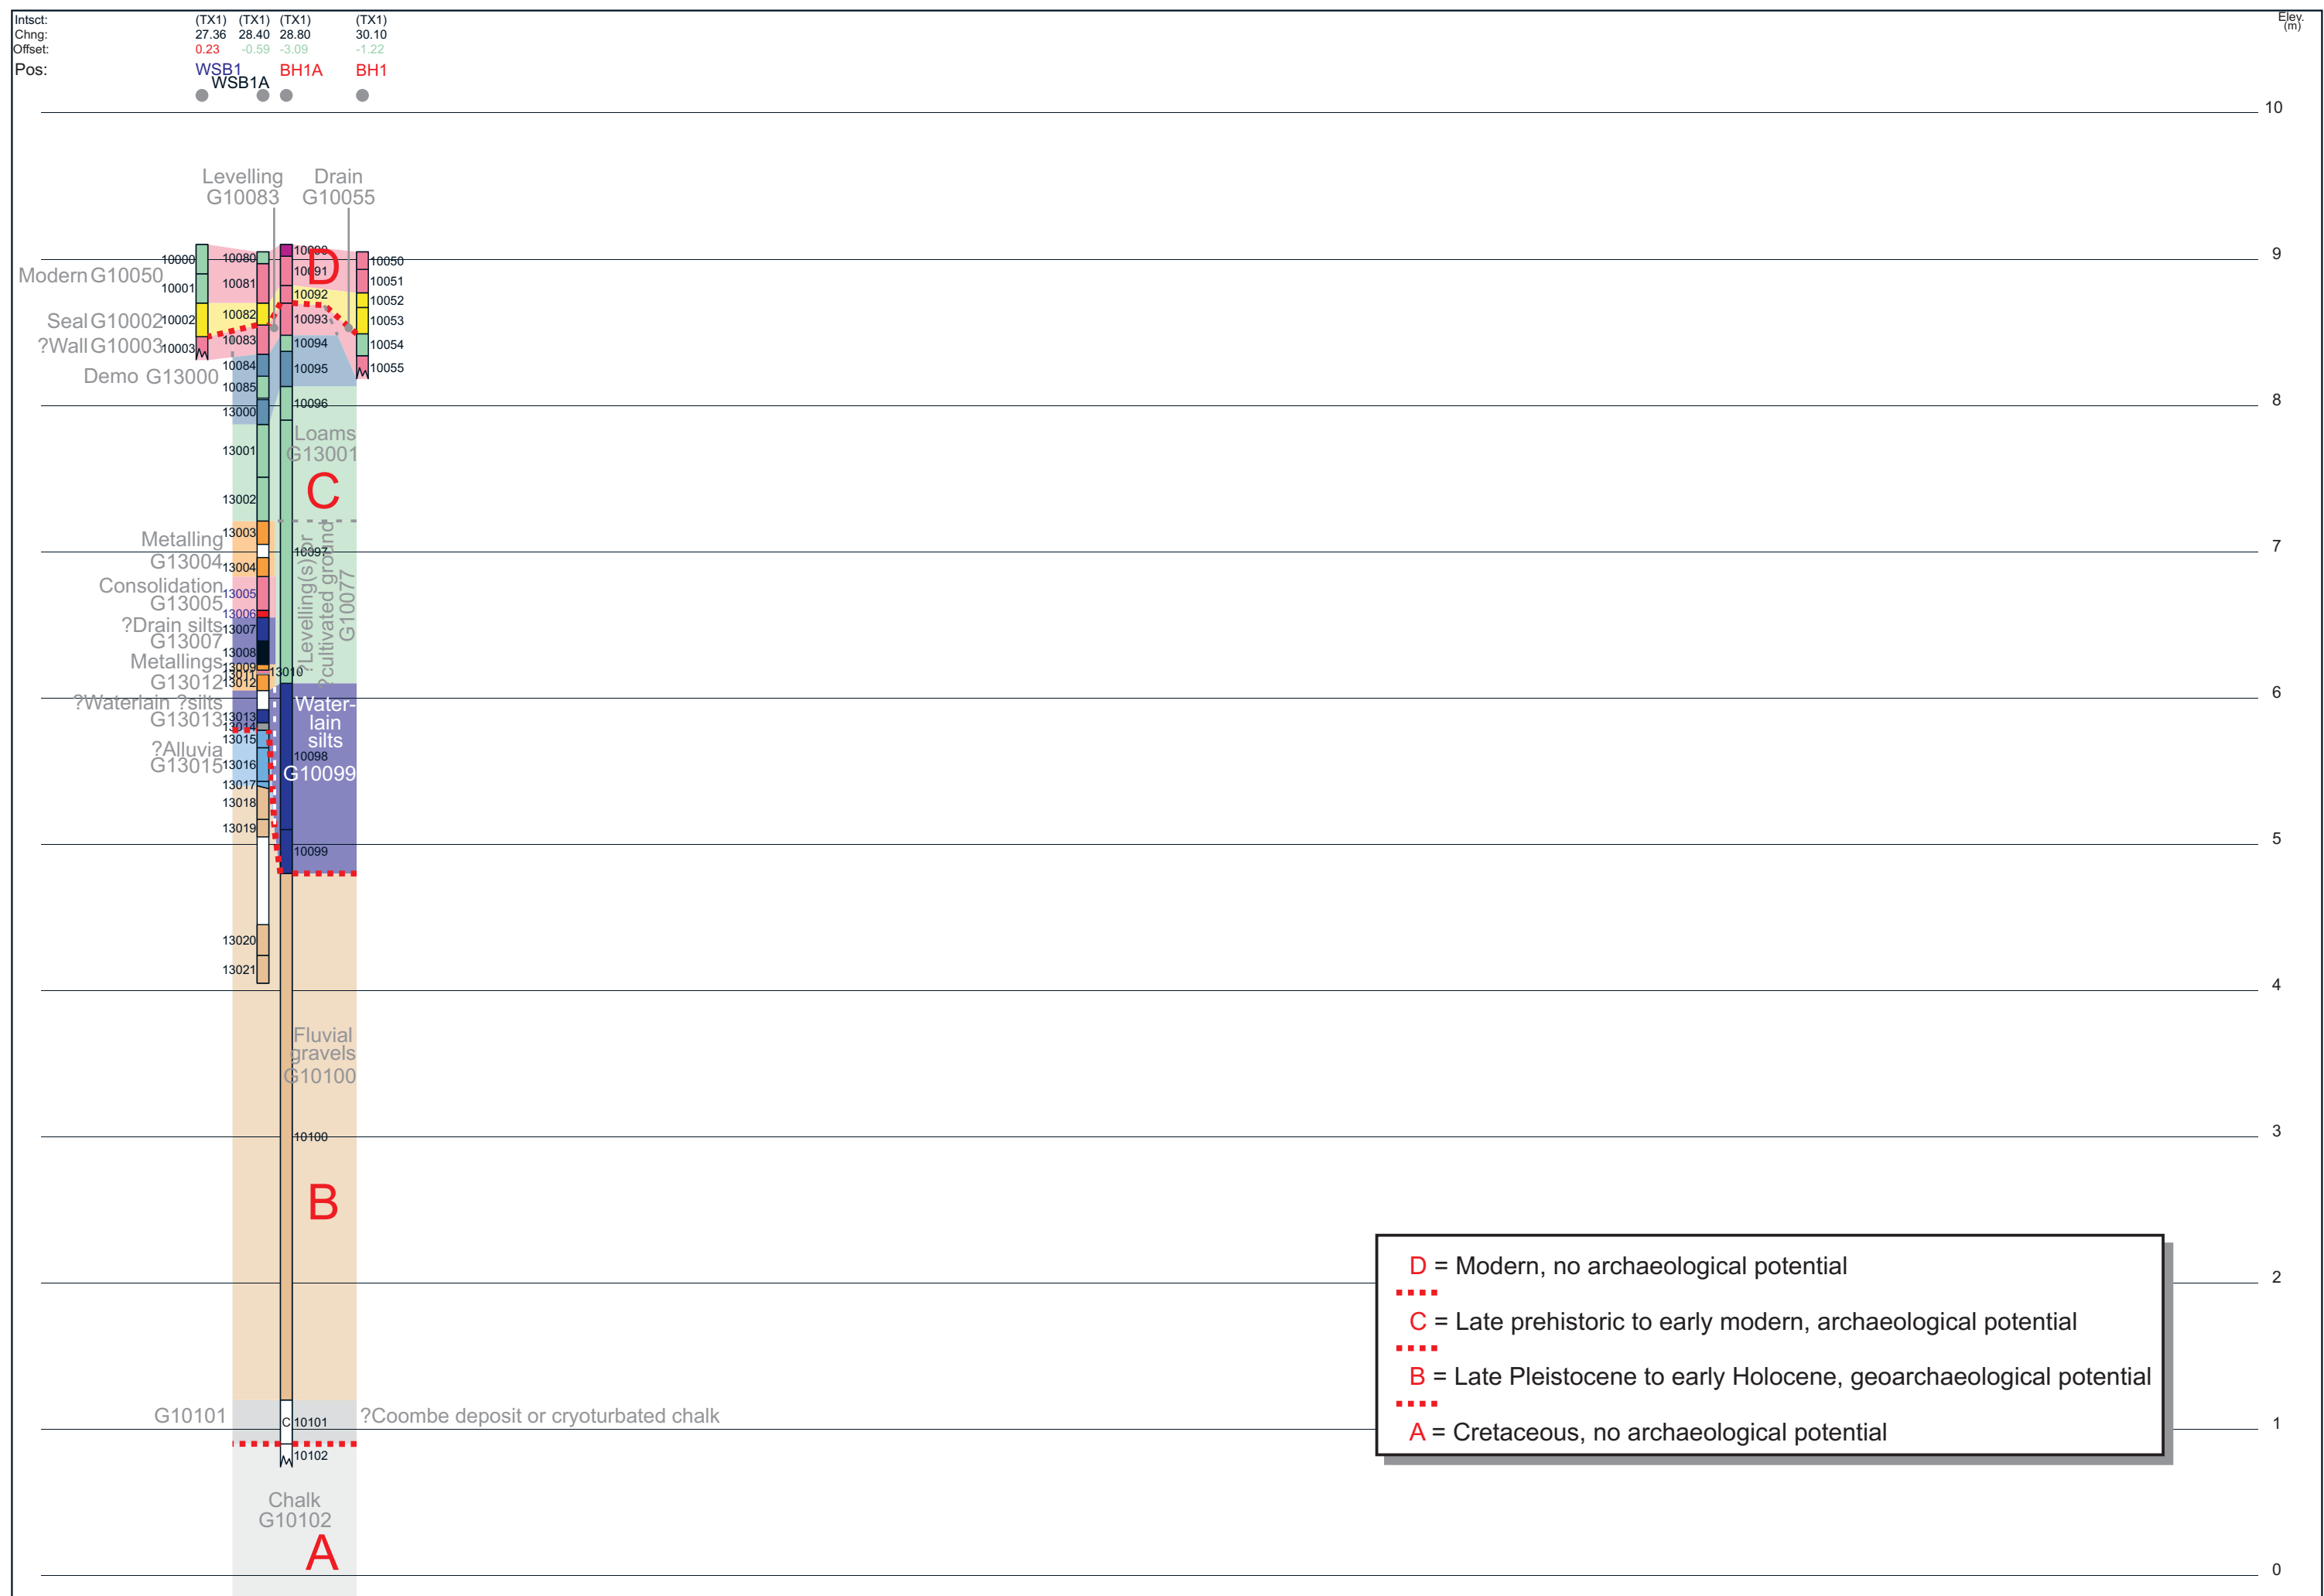
Fig 17. Transect TX11 (vertical scale 1:40, ave. horizontal spacing 1:100).
