REPORT ON THE
DEFENCE
HERITAGE SITES
AT CHATHAM
COMMERCIAL DOCKS

Victor Smith
February, 1997

DEFENCE HERITAGE SITES AT CHATHAM COMMERCIAL DOCKS, KENT

Historic Building Survey

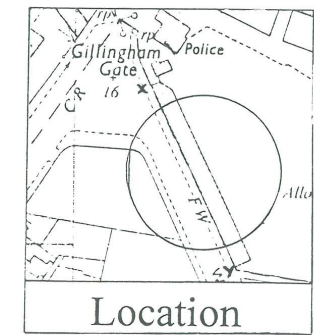
FIG. 3 SITE 'B'
AIR RAID SHELTER
ON EASTERN SIDE OF
THE GILLINGHAM GATE

The three shelters at the Gillingham Gate will have satisfied regulations for shelter construction but, with their exposed 16 cm thick concrete roofs, only at a minimum level, akin to the broad mass of civilian surface shelters. The physical evidence remaining of the shelter on the eastern side of the Gillingham Gate includes the provision of traverses to limit the destruction and casualties from a bomb actually bursting inside. The absence of traverses had been criticised in the case of a bomb damaged shelter at the dockyard at Plymouth which had received considerably greater overhead cover than the shelters examined by the writer at Chatham.
