A HALL-HOUSE AT UPPER BUSH

By E. R. SWAIN

THE structure described in the following text is known as 66, 67 and 68 Upper Bush, near Cuxton, NGR. 696668. The building is basically a hall-house with storeyed ends without jetties, this part being divided at present into two cottages, numbered 66 and 67. The east end was later extended and is now known as number 68, the composite building lying on a west to east axis (Fig. 1).

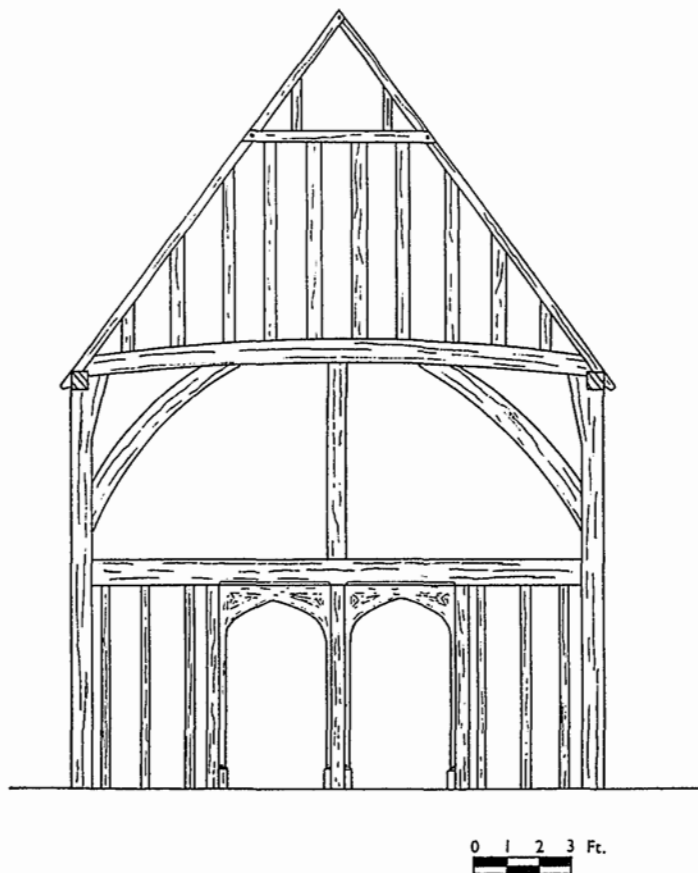
FIG. 2. Truss C, west elevation. The portion below first floor level is diagrammatically reconstructed, whilst the positions of some of the partition studs above this level remain uncertain and they are therefore omitted.

Truss C, marking the further end of the hall, has mortises on the underside of the cross-beam indicating stud partitioning and doorways leading into the services, the buttery presumably being on the north side, and the pantry on the south. Nothing is now left at ground-floor level of these door openings, but a reconstruction based on the extant mortises is included in the elevation shown in Fig. 2. Little can now be seen of the area once containing the services, the space being filled with

inserted stairs and chimney stack, with a passage on the south side. There is, however, evidence that the two service rooms were separated from each other by a partition, the mortise and peghole for the ceiling beam occurring in the cross-beam of truss C at a point intermediate between the service doors.

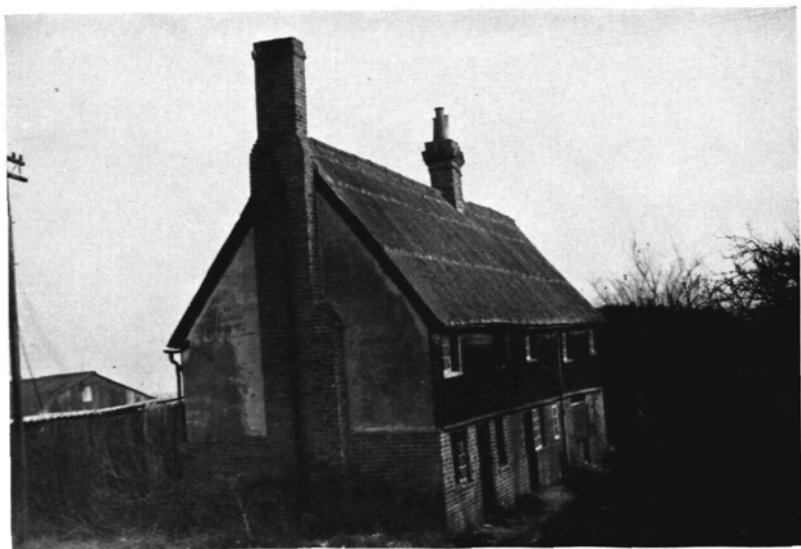
A. Upper Bush hall-house from south-west.

The exterior of the cottages has yellow brick under-pinning up to the first-floor level and weather-boarding over the timber-framing above this as far as the eaves. The roof is now clad with corrugated asbestos (Plate IA) and the ends of the structure are gabled, this being a later alteration at the west end from the original hip. The east end of the original building was also hipped before the extension was added. There are two features only which indicate an early structure when the building is observed from outside, these being the steeply pitched roof and the central chimney stack. The latter is comprised of three separate shafts each being offset to its neighbour and the whole presenting a stepped appearance in a plan view.

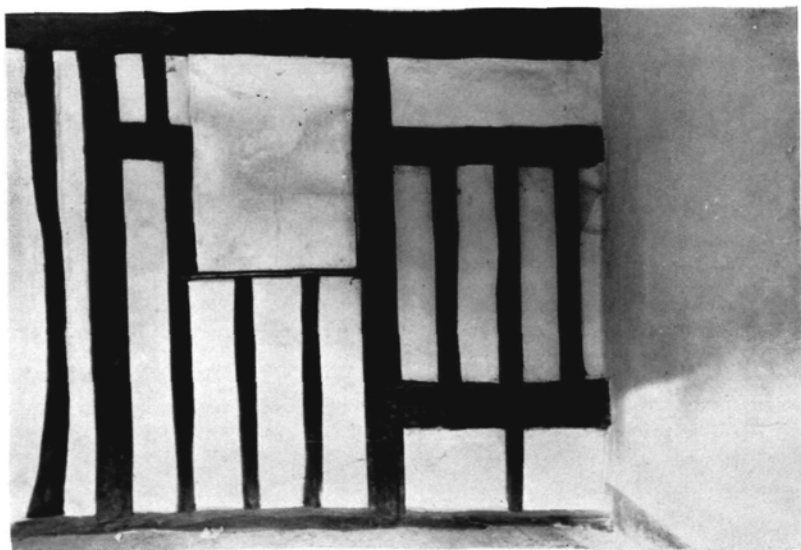
B. Hall window interior.

The inserted floor above the hall is now divided into two rooms, in one of which the original (though blocked) hall window can still be seen on the north side adjacent to truss B (Plate IB). Partly mutilated by a modern window opening, this hall window still contains diamond-set mullions in fine condition. The transom to the right of the illustration carried three mullions above and below, two of the lower ones now being lost. The window opening was unglazed and shuttered with hinged or hanging shutters fitting into rebates. The framing is not grooved for sliding shutters as was the usual local practice. The shutter rebates reveal that even when the window opening was covered, a $1\frac{1}{2}$ in. gap was left at the top, no doubt to provide a little ventilation, although one cannot help wondering how effective this was in conjunction with some kind of roof opening above a smoke-filled hall, unless the shutters themselves had ventilation holes also.

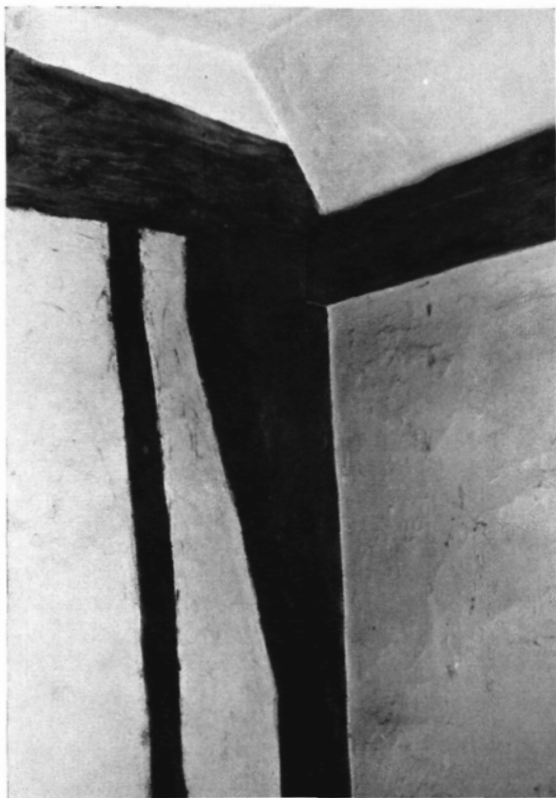
Timber framing within solar (tie-beam, wall-plate, principal post).

The interior of the parlour is simply the inside faces of the brick underpinning, but the solar above still has the original timber framing (Plate II).

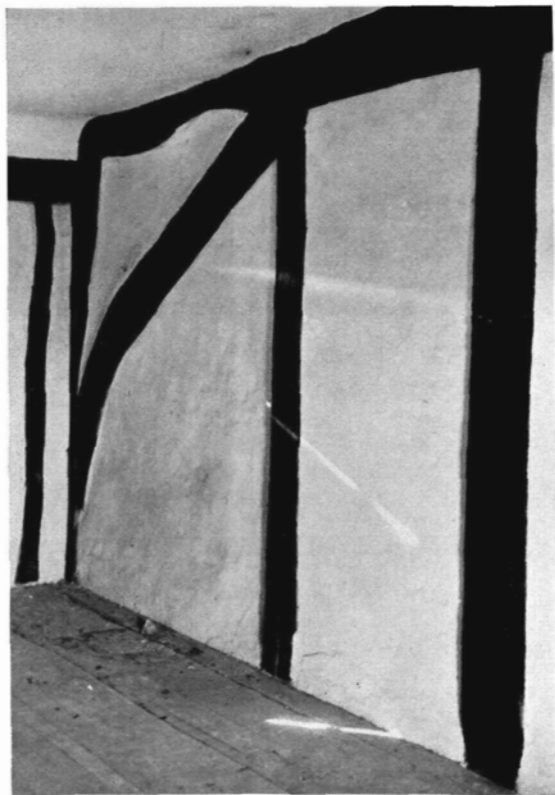
Smoke-blackened framing at west end of hall.

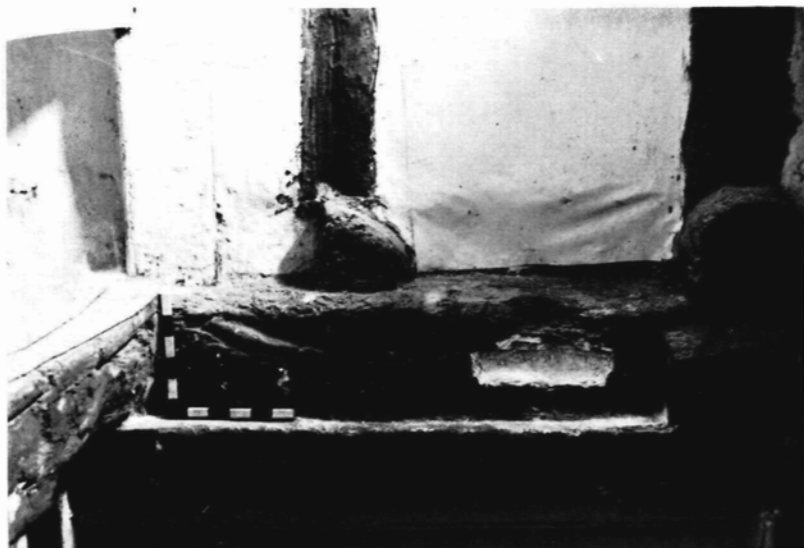
A. Method of supporting original floor over services, and inserted floor over hall.

A further constructional detail is evident at the point where a stairway rises from the ground floor to the first-floor level to the north of the chimney stack. The floor above the service rooms was supported by joists resting on a ledge (Plate III) running the whole length of the cross-beam in truss C. The joists were also tenoned into the beam and pegged from above. The plate illustrating this also includes the joist ends of the inserted floor over the hall resting on the cross-beam. This has resulted in the inserted floor being some inches higher than the solar floor and the floor above the service rooms. The area above the service rooms was lighted by two small unglazed window openings with diamond-set mullions and no provision for shutters. These openings are

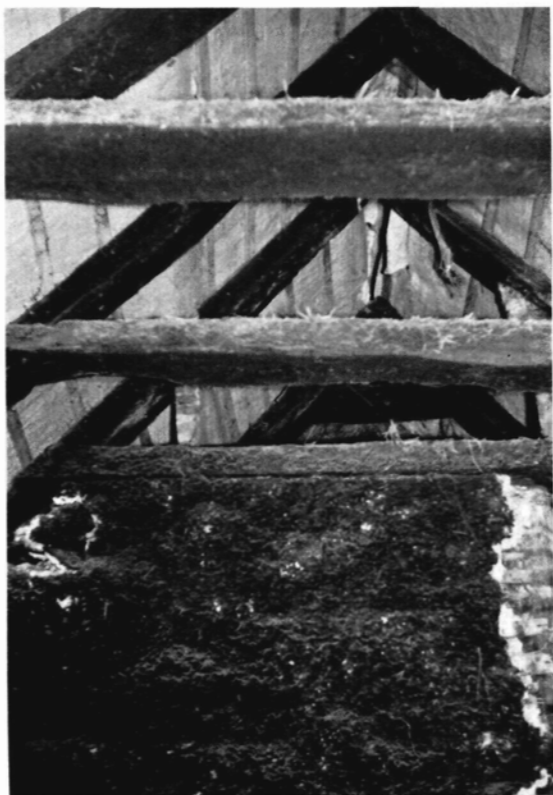
B. Smoke-blackened west face of truss C, with collars and gablet.

All faces of the timber framing inside the hall are smoke blackened (Plate III) and contrast with the comparative cleanness of similar faces inside the solar and service wings. The chimney stack of three flues has one fireplace opening only in this original building, facing into the hall at ground-floor level, the other two openings serving the extension as later described.

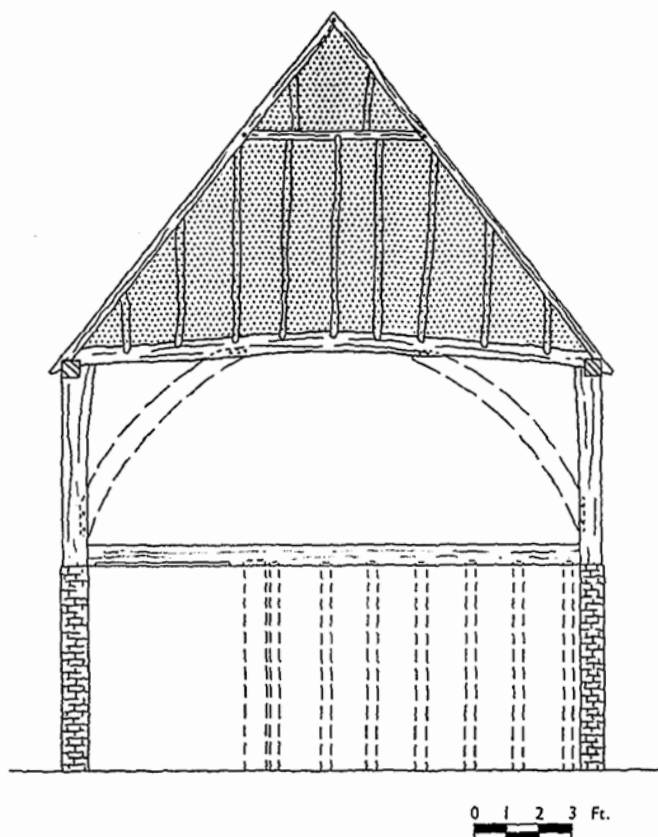
FIG. 3. Truss B, east elevation. The stippled area represents the extant portion of the inserted partition dividing the hall. The positions of the studs between the tie-beam and inserted floor were not ascertainable and are omitted from the drawing.

The cambered tie-beam of truss B (Fig. 3) has no mouldings or chamfers but is finished very carefully as befits the centre beam spanning an open hall. Near this point the wall plate is spliced, the method being of some interest, as illustrated in Fig. 4. From an exterior view this merely appears to be half-lapped, but in fact each beam continues into a longitudinal mortise and tenon and is secured with a single peg, one peg being at the top and the other nearer the bottom.

This division of the hall was contemporary with the insertion of a floor over its west end and the mortises in the cross-beam enable this truss to be reconstructed showing the inserted lower partition and doorway (Fig. 3). The shortened hall between trusses B and C, acting as a vast open flue, necessitated removal of the screens and allowed smoke deposits to collect upon the face of the bressumer formerly covered by the butt end of the screens cross-beam as described earlier.

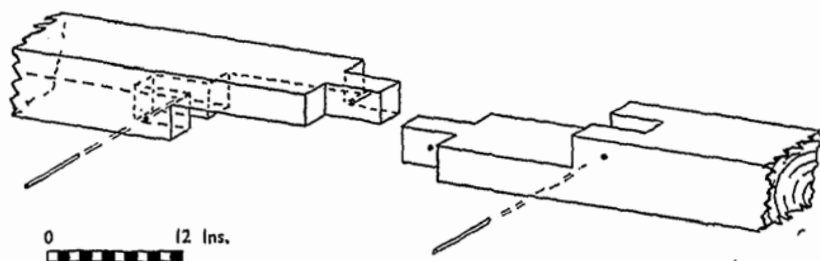
FIG. 4. Method of splicing the wall-plate.

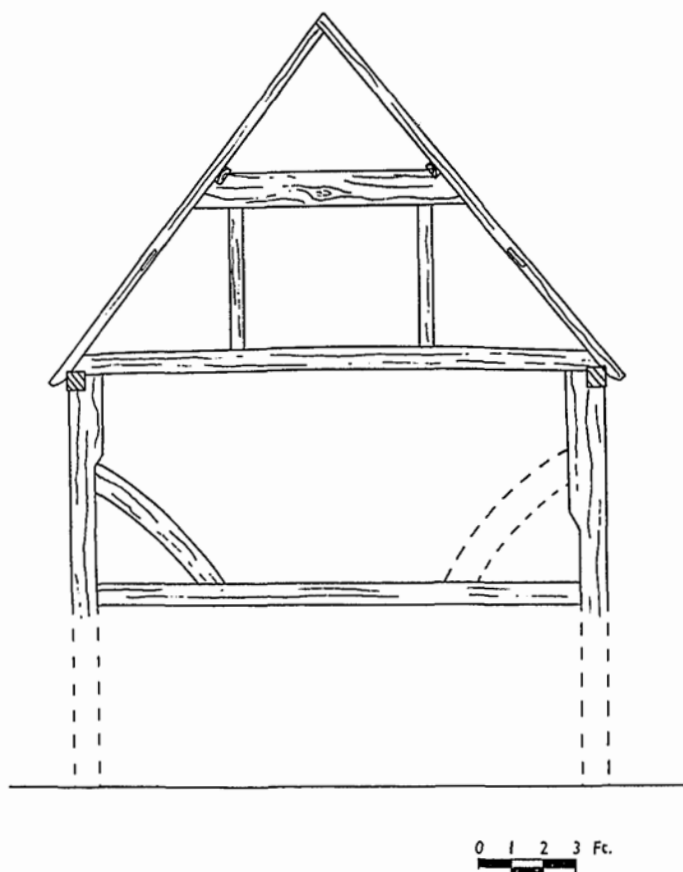
FIG. 5. Truss E, east elevation.

The roof of the extension, together with the roof of the original building, form an instructive comparison since they illustrate a developmental trend from the early, simple type of construction over the original building, to a queen-post structure over the extension (Fig. 5). In addition to side purlins, curved windbraces were fitted at the four corners of the roof, and some of the rafters appear to have been re-used from elsewhere.
