# ARCHITECTURAL NOTES ON ST. MICHAEL'S CHURCH, OFFHAM

P.J. TESTER, F.S.A.

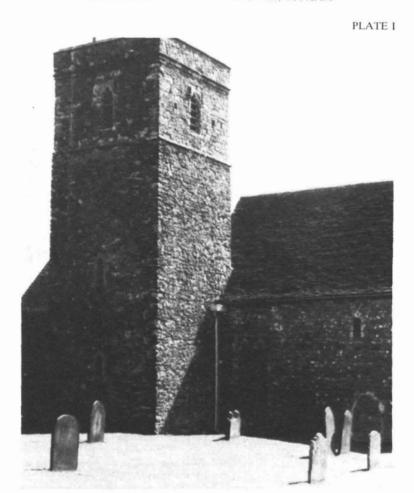
Offham Church. Tower viewed from the North-west.

Attached to the north side of the chancel, overlapping the northeast corner of the nave, is a plain unbuttressed tower, its ground storey opening into the chancel by a wide pointed arch. The tower is contemporary with the chancel and has pointed-arched internal recesses in its north, east and west walls. Single lancet windows occur on the north side at both ground and upper levels, while the uppermost storey is a late-medieval addition. A fourteenth-century window in the east side of the ground storey is probably an enlargement of an original lancet.

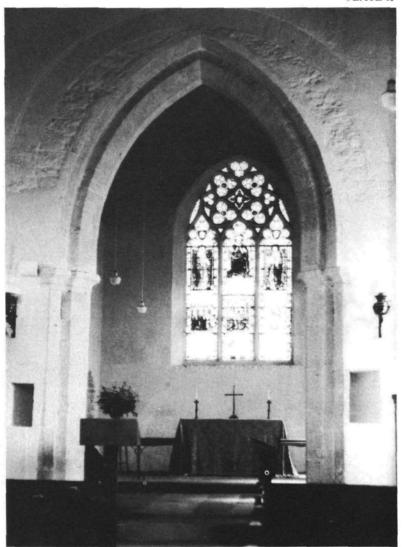
# PLATE II

Interior looking East.

Paddlesworth described by Canon Livett in *Arch. Cant.*, xxi (1895). Over the head of the later chancel arch can be clearly discerned the semicircular head of its Norman predecessor, which appears to have been approximately 10 ft. 8 in. wide.

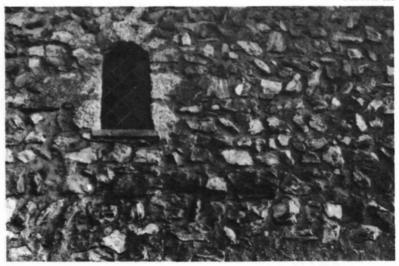
### PLATE III

Norman Window in the north Wall of the Nave. A typical area of roughly coursed rubble wall is shown adjoining.

Evidence of Early Norman construction is evident in the nave, the north and west walls being of roughly-coursed Lower Greensand rubble with some stones set aslant, very similar to what occurs in St. Leonard's Tower, just over a mile to the south-east - generally regarded as having been built under the direction of Bishop Gundulf in the closing part of the eleventh century. At Offham, the nave walls are only 2 ft. 8 in. thick, a surviving characteristic of Anglo-Saxon construction, whereas typical Norman walls are usually not less than 2 ft. 10 in. or, more generally, 3 ft. At the north-west corner, the quoin is constructed of neatly squared blocks of tufa and this is also used for the external jambs and voussoirs of two internally-splayed Norman windows occurring high up in the north wall. This material was in common use in the late eleventh and early twelfth centuries, but was seldom employed beyond that period unless re-used from an older construction. In the south wall, the semicircular rere-arches of two other similar windows can be observed from the inside, proving that the upper part of the wall is of Norman age and survived alterations in the thirteenth and fourteenth centuries.

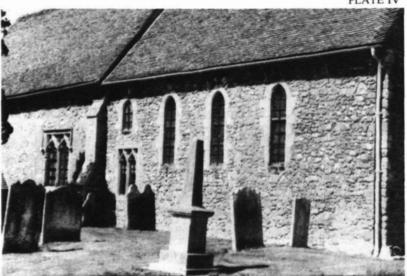
# PLATE IV

South Side of the Chancel with thirteenth-century Lancet Windows and Walls of uncoursed Rubble.

Comparison of the external face of the rubble walls of the thirteenth-century chancel and tower with the Norman nave shows a contrast in construction indicating plainly that they are of different ages.

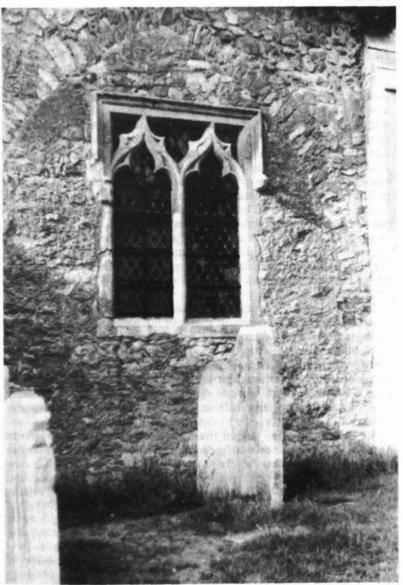
PLATE V

Fourteenth-century Window set in the Blocking of a thirteenth-century Arch to the former south Aisle.

At about the same time that the chancel was rebuilt, a south aisle was added to the nave. This was effected by piercing the Norman south wall with two wide pointed arches, now blocked, the outlines of which can be discerned both inside and outside the building. A substantial pier was left between the two arches and the upper part of the wall was undisturbed, as witnessed by remains of the Norman windows previously mentioned.
