THE CHURCH OF ST. MARY THE VIRGIN,
STONE-IN-OXNEY, WITH PARTICULAR
REFERENCE TO RECENT EXCAVATION OF
THE NORTH CHAPEL AND TO THE FIRE OF
1464

THE REVD. S.D. HARRIS

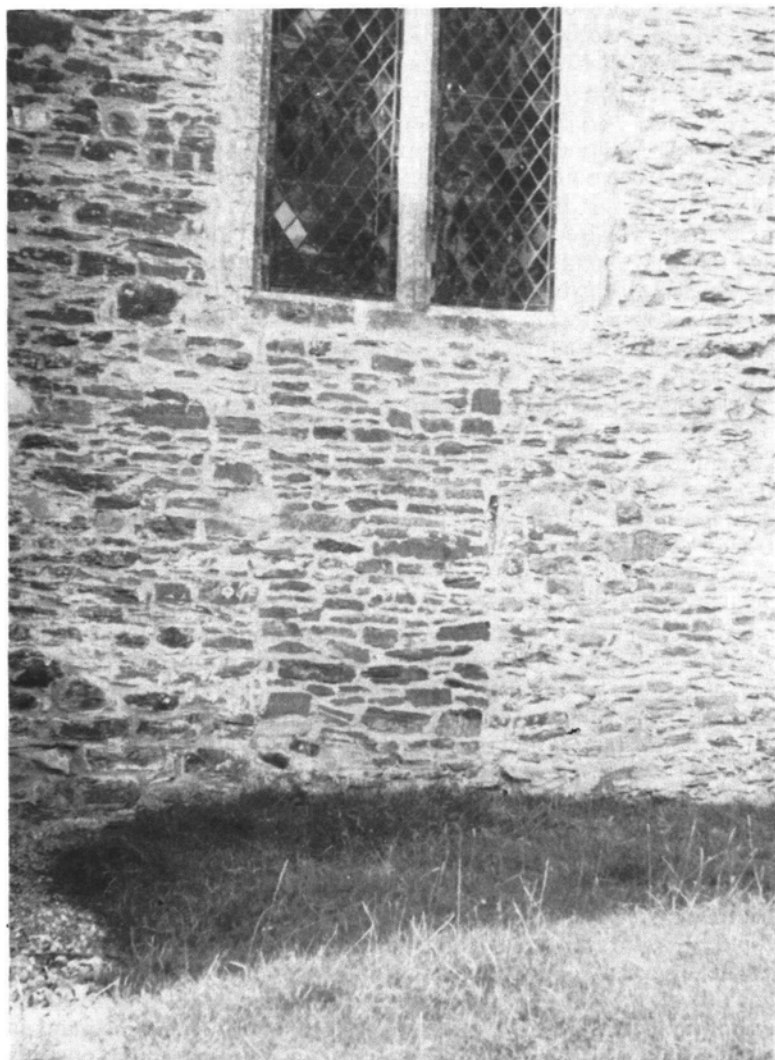
PLATE I

External east wall of chapel, showing closed-up (?school-room) door under east window.
