CHALK MINING

and associated industries of

FRINDSBURY

Research Report 3

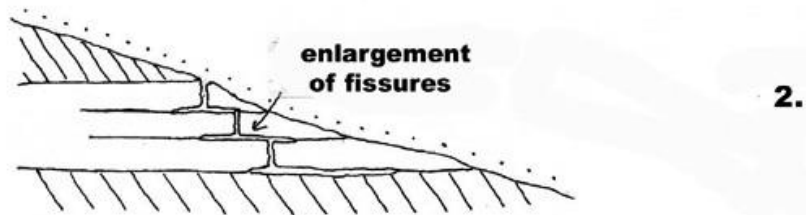
Fig.9 Cave Formation

3.1.5a Phreatic Systems - are formed below the water table where the rock is saturated. If there is a small fissure present it will be filled with water which will gradually dissolve away the sides to make a larger hole called a pipe (see Fig.9). Earth movements in our geological past often caused layers of rock to be pushed up above the old water table and the phreatic pipes could be filled with other material. This is why such features are sometimes found in quarries. A large phreatic pipe was found during the sinking of a well at Strood Pumping Station but it was 10ft below the water table. There must be similar systems under Frindsbury and in fact it was recorded that several were broken into during the driving of the Strood-Higham tunnel. Since any phreatic system in this area must be at a depth of about 0ft O.D., they cannot have any surface effect in causing subsidence.

3.1.5b Vadose Systems - are formed above the water table through the enlargement of natural fissures. This is caused through physical erosion by water passing through the fissures, aided by the weak solution of carbonic acid present in rainwater. The entry point of a vadose system from the surface is called a swallet and the exit back to day is called a resurgence. To have any appreciable effect there must be a sufficient flow of water and many swallets occur at junctions of impervious and pervious rock. Thus a stream flowing along an impervious rock will have sufficient volume to start eroding a fissure when it comes to the pervious section. It will follow the line of least resistance (whether it be a vertical or horizontal route) and, if it meets a deeper impervious layer, it will follow this until it perhaps comes out to the surface again (see Fig.9).

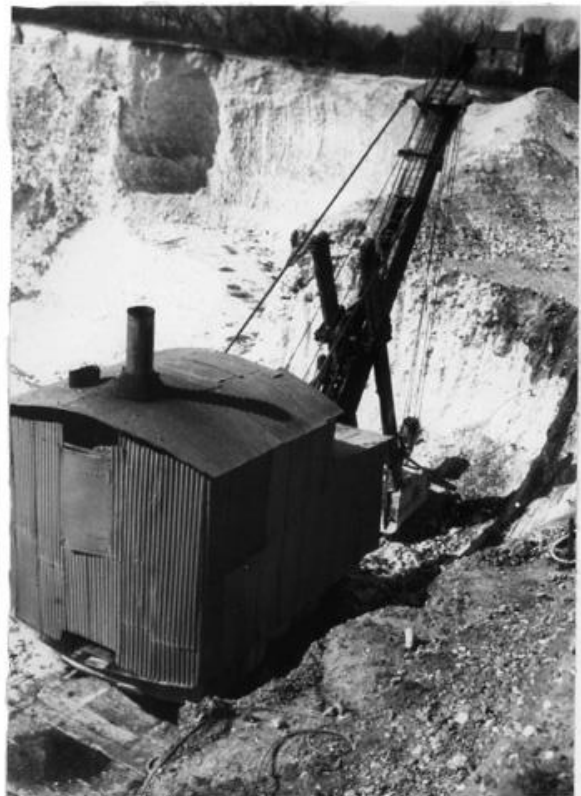
Mill Road Chalkpit

Much of the original area has disappeared due to infill and landscaping. The only part of the original chalk face can be seen at top left and the adit entrance lies at the base of this under the infill

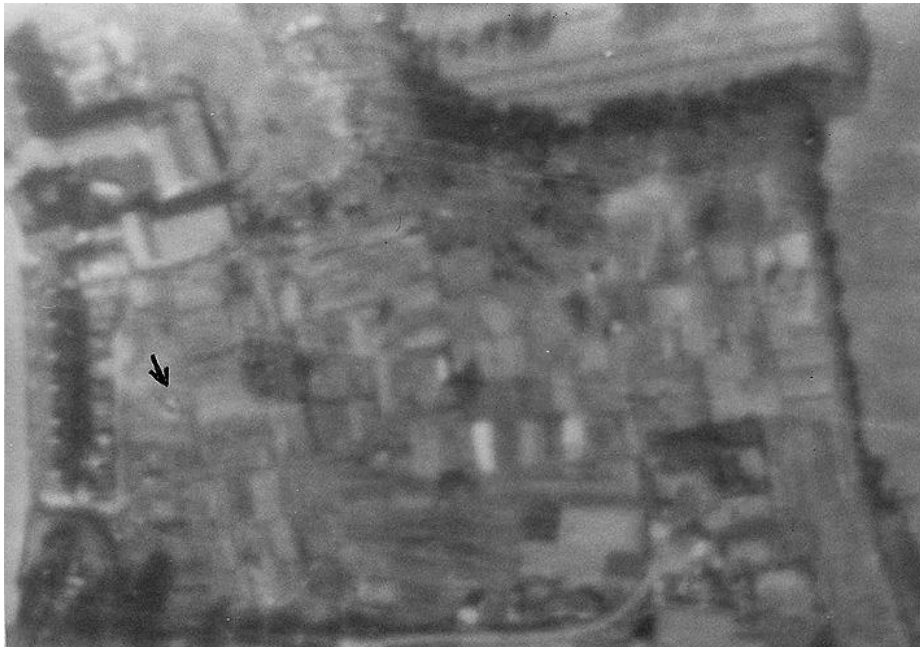
Aerial Photos from 1946

Frindsbury Brickfield (West) – washbacks have been converted into allotments. Despite grainy film, the line of deneholes can be picked out. The mine shaft is hidden in shadow.

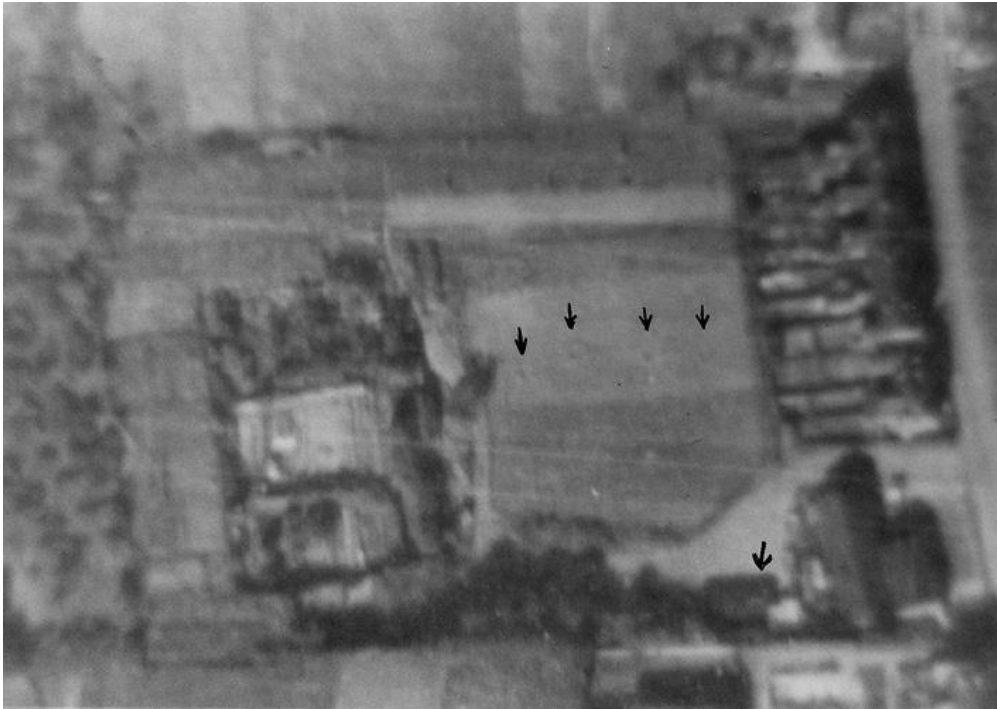
Frindsbury Brickfield (East) – the mine shaft appears as a slightly darker patch just right of centre and the engine shed, etc is above this.
