LOWER HALSTOW CHURCH.

BY THE REV. E. R. OLIVE, VICAR.

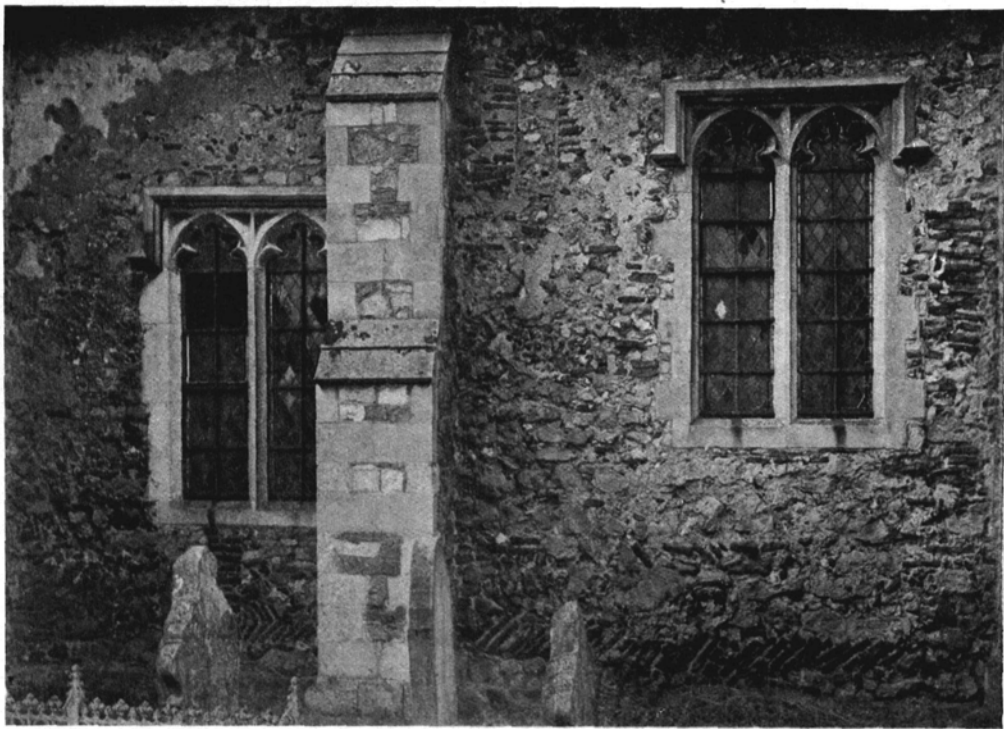
LOWER HALSTOW CHURCH.
Detail of South Wall of the Chancel.

It is evident that a Romanesque structure existed upon the site, and that it was largely constructed of Roman bricks. The earliest existing portions of the building are to be found in the south wall of the chancel where a semi-circular-headed brick window (walled up) and some brick herring-bone work still remain *in situ*. This work belongs either to the early part of the ninth, or else to the latter part of the eleventh century. It is not improbable that the
