## MEDIAEVAL DISCOVERIES AT STONAR.

BY BERTRAM W. PEARCE, M.A., F.S.A.

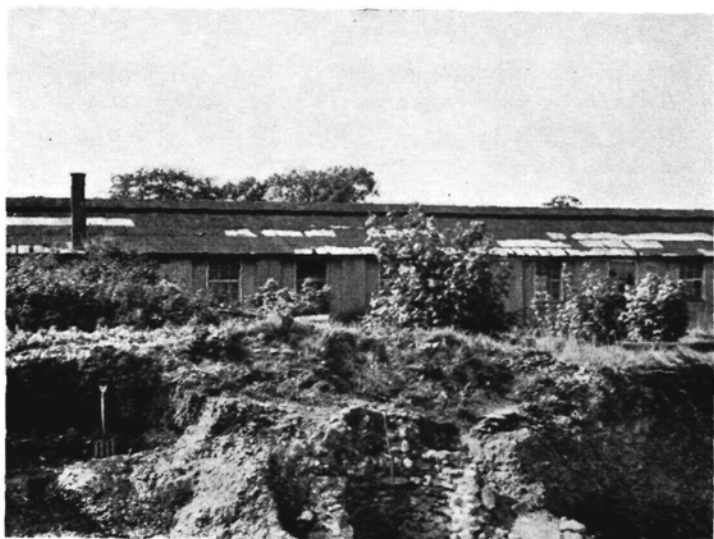
STONAR. MEDIEVAL POTTERY DUMP (L.) AND WELL.

The top of the well was about 2 ft. below the bottom of the pottery dump which lay a little to the east. A small quantity of pottery fragments of type similar to that in the dump, was found around the well at a low level.

The photographs show the well with the pottery-filled trench to the left above; and a detail of the walling of the well.

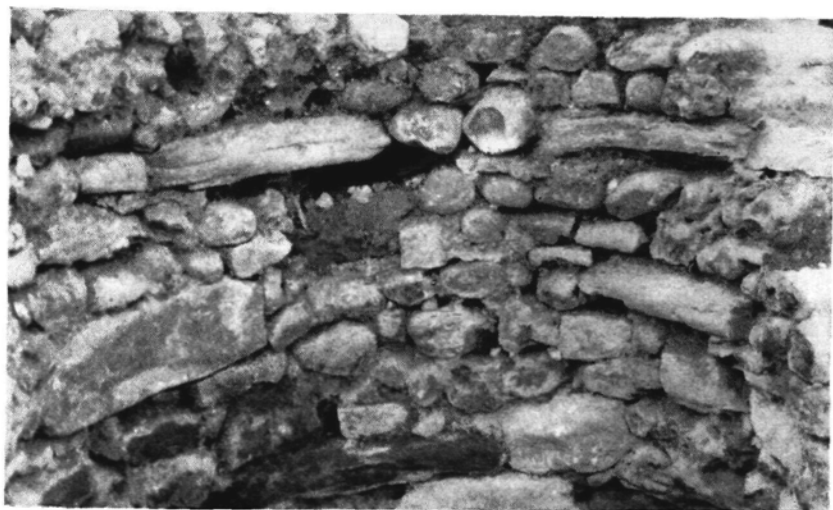
STONAR. MASONRY OF UPPER PART OF MEDIEVAL WELL.

While the bank was being cut back for a second line of rails, a mediæval well was disclosed. Its centre was c. 92 ft. from the corner of the nearest shed, and 226 ft. W. of the hearth. It was 4 ft. in diameter (see illustrations). The upper part was built of large slabs of Folkestone stone, concave on the inner side, with a few reused pieces of Caen stone, and flints, often faced, inserted here and there. Lower down the blocks were usually continuous all the way round with layers of faced flints inserted occasionally. One of these blocks *in situ* measured 18 in. by 6 in., while another, evidently a curb stone, which had been broken away, was 22 in. by 14 in. by 6 in. Two curb stones still remained in position. The front

had been destroyed, either this year in the course of discovery, or previously, and the well was filled with and covered over with large flints, rubble stone work and a few broken blocks of faced Caen stone from some building already in ruins. The filling was removed down to water level which was at 7 ft. 3 in. from the top of the curb stones, and 5 ft. 9 in. from the level of the rails. Resting partly in and partly out of the water was a forked oak post 3 ft. 10 in. in length which had evidently been one of the uprights for the windlass. Nothing else was found. Close to the outside of the well were several large blocks of chalk, and also stones with very poor mortar containing sea sand with *littorina*, *pecten* and other shells. Some of the stones in the well, however, had mortar of a much better and harder type still adhering to them.
