## THE OLD CANONRY AND CANON COTTAGE, WINGHAM

E. W. PARKIN

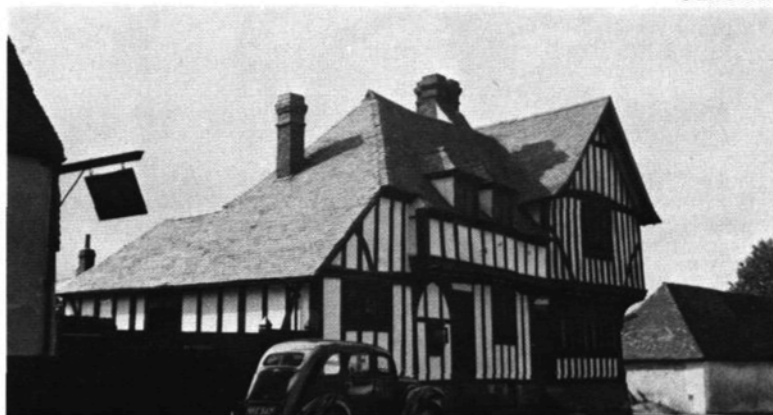
PLATE IA

Canon Cottage and the Old Canonry, from the north-east.

The narrow front door of Canon Cottage (D3 on plan) is reached by four brick steps, while immediately to the left of it may still be seen the original Gothic doorway, now blocked, made from two plain solid oak pieces (Plate IA, and D1 on plan).

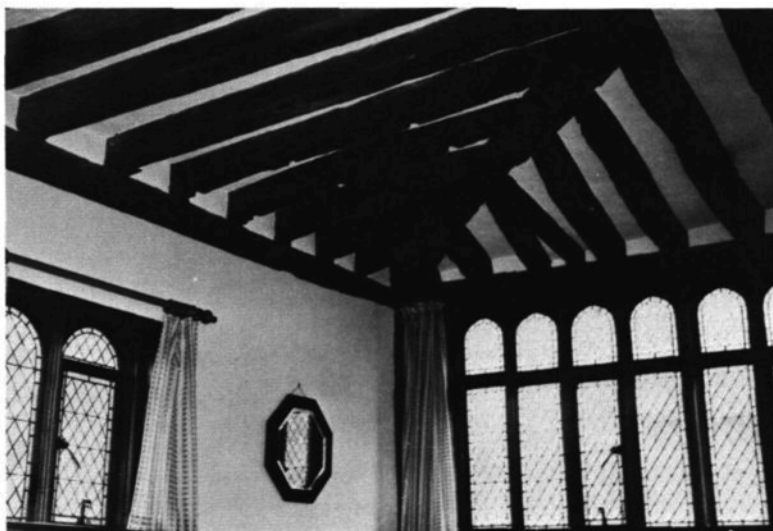
PLATE IB

The Dragon Beam, Old Canonry.

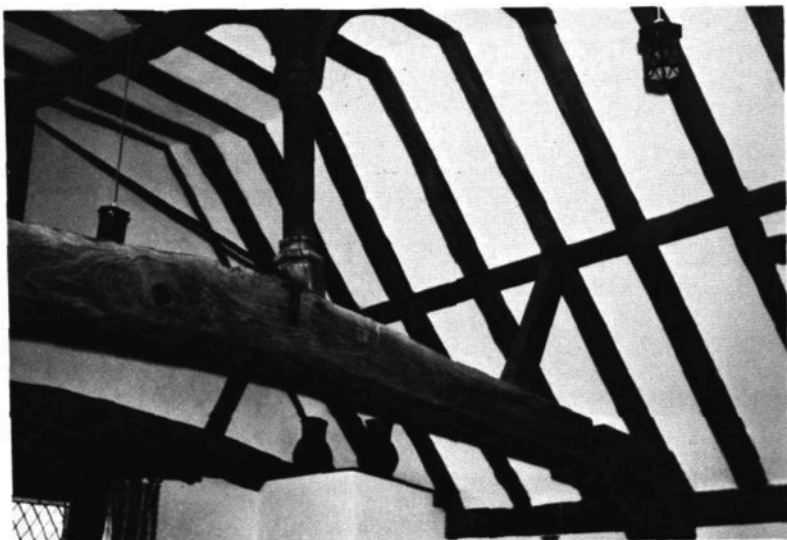
PLATE IIA

The Crown-Post Roof of the Old Canonry.

The main room upstairs, open to its fine crown post roof must be almost in its original condition, except that it has a new hardboard floor, under which the old oak floorboards still remain. The octagonal shaft of the crown post measures 86 cm. (2 ft. 10 in.) and the slightly cambered tie beam 30 cm. (1 ft.) in the centre. It has hollow chamfers underneath it.

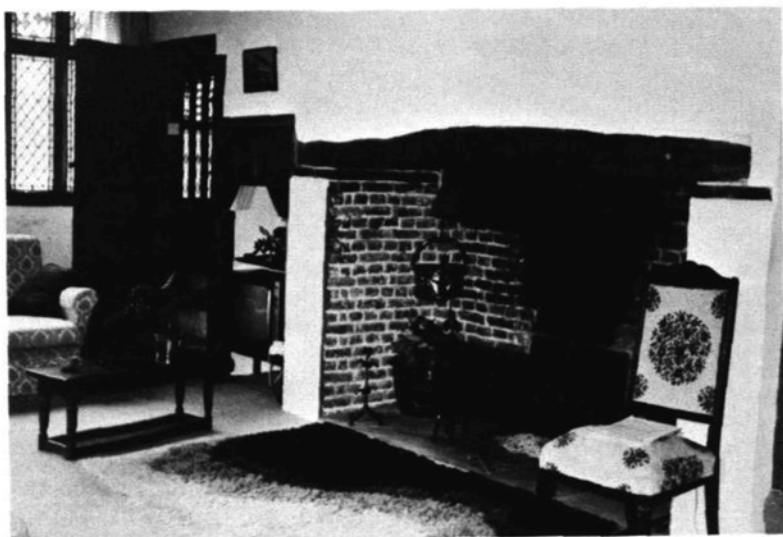
PLATE IIB

The sixteenth-century Fireplace, Old Canonry.

The main fireplace (FP1) is of narrow two-inch Tudor brick, the beam of which is just 3 m. (9 ft. 10 in.) and shows the peg-holes where once a spit machine was fitted. As these houses in Canon Row were sold into private hands in 1549, the fireplaces must have been inserted sometime after that date.

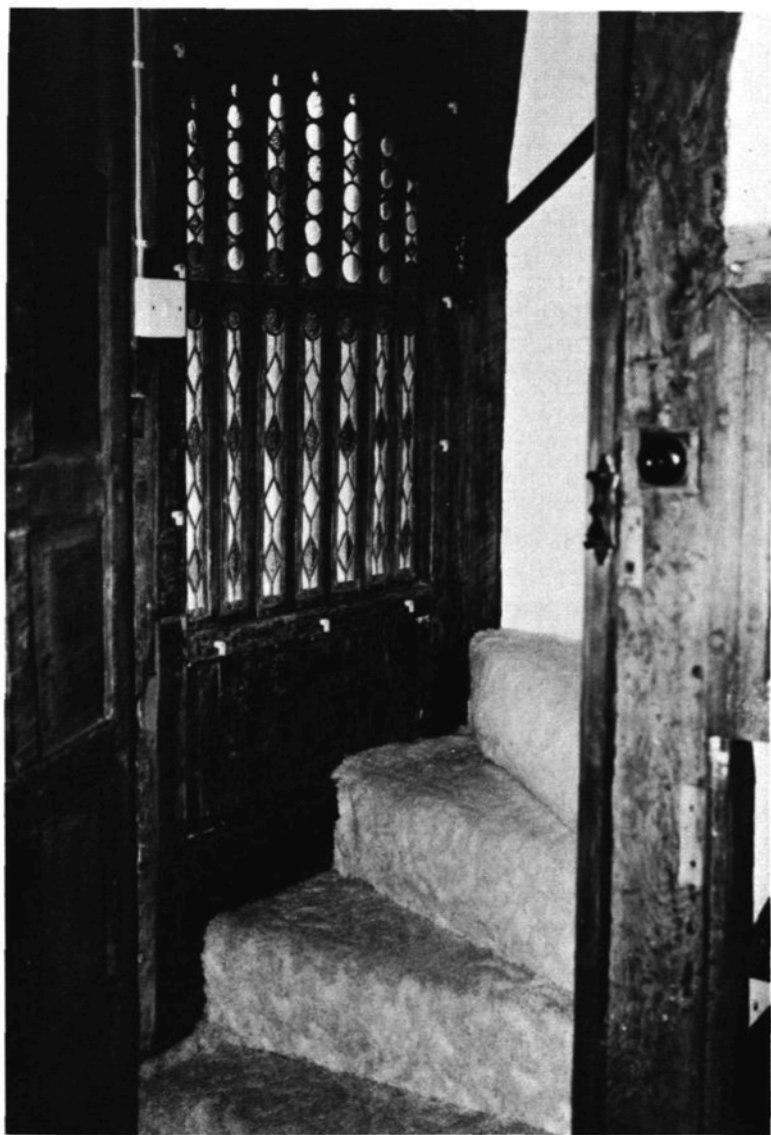
The rediscovered medieval Front Door, Old Canonry.

About 1880, the neighbouring Wingham Court was leased to James Robinson, who came from Dambridge, the attractive old Dutch farmhouse half a mile to the east. When he died in 1893, the Old Canonry was thoroughly 'restored', very much as we see it today, for the use of his widow who lived there until 1906, the house then being known as Canon House.<sup>3</sup> Several original features were uncovered during the restoration, notably the beautiful fifteenth-century glazed front door (Plate III) and the large eight-light window.

During the restoration of 1893, the attractive glazed front door, with its internal shutter, was discovered under plaster (D4 on plan, Plate

III), also the very fine eight-light front window, both of which were thoroughly restored.

During the difficult times at the beginning of the nineteenth century, this pair of houses was converted into three workers' cottages, each with its cottage type stairs, two of which still remain. It is curious that one was fitted immediately behind the lovely old front door, and directly over the thirteenth-century outside stone steps of the cellar next door, which still remain underneath (Plate III and Fig. 1).
