**Cremer & Whiting Brickworks, Sumpter Way,
Ospringe (Nr. Faversham), Kent, M13 7NT**

Historic Buildings Record

**Project no. 170341
Report No. 2017229
Site Code. COW17
OASIS ID. Archaeol6-286456**

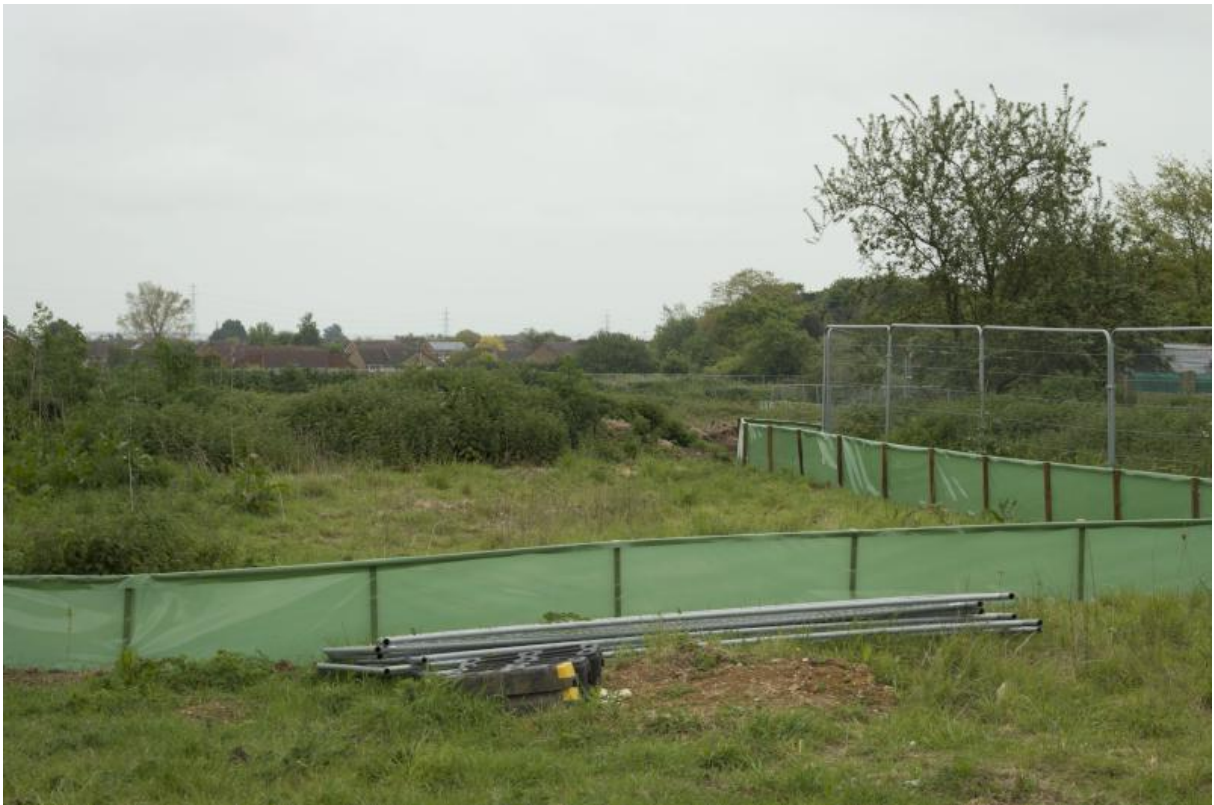
Plate 1: View of the northern half of the site – the former site of the London stock brick factory, facing north-east (118)

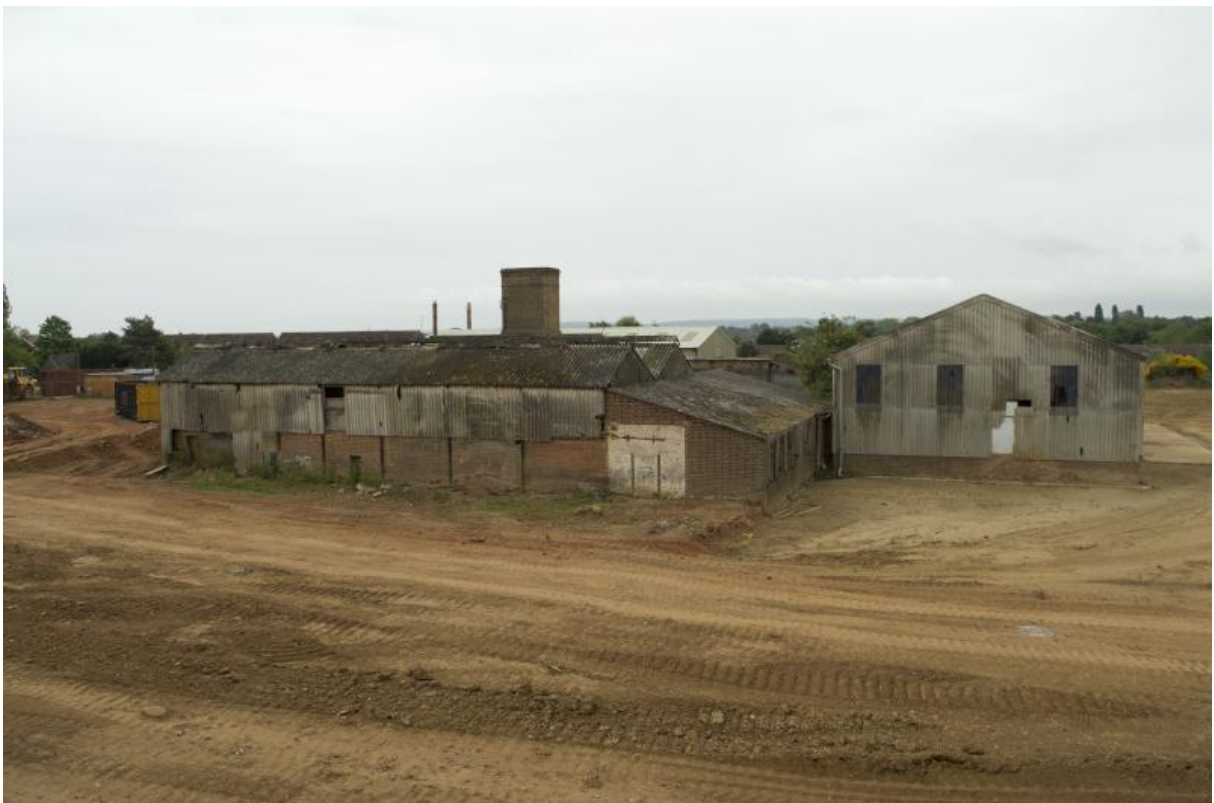
Plate 2: View of the southern half of the site – the former site of the red brick factory, facing south-east (150)

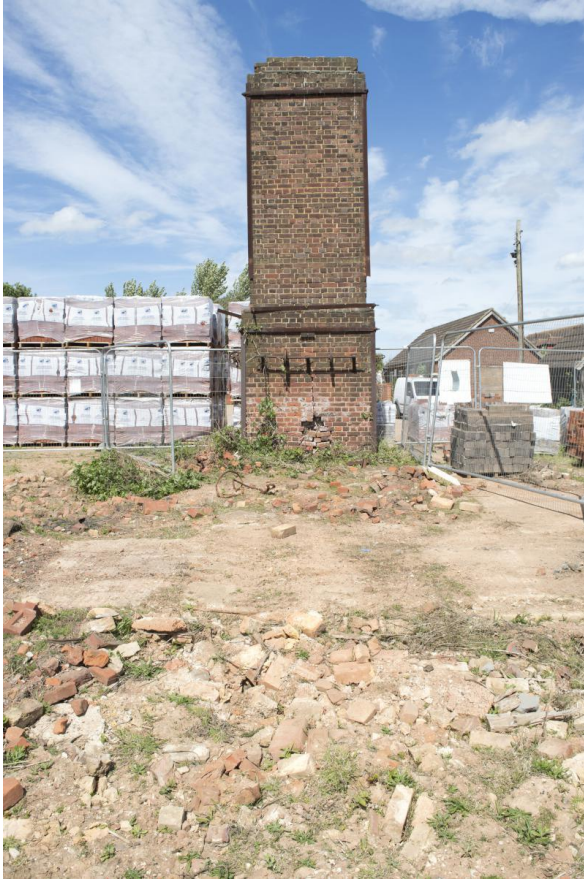
Plate 3: View of the chimney and remains of the former kiln buildings to its south, facing north (205)

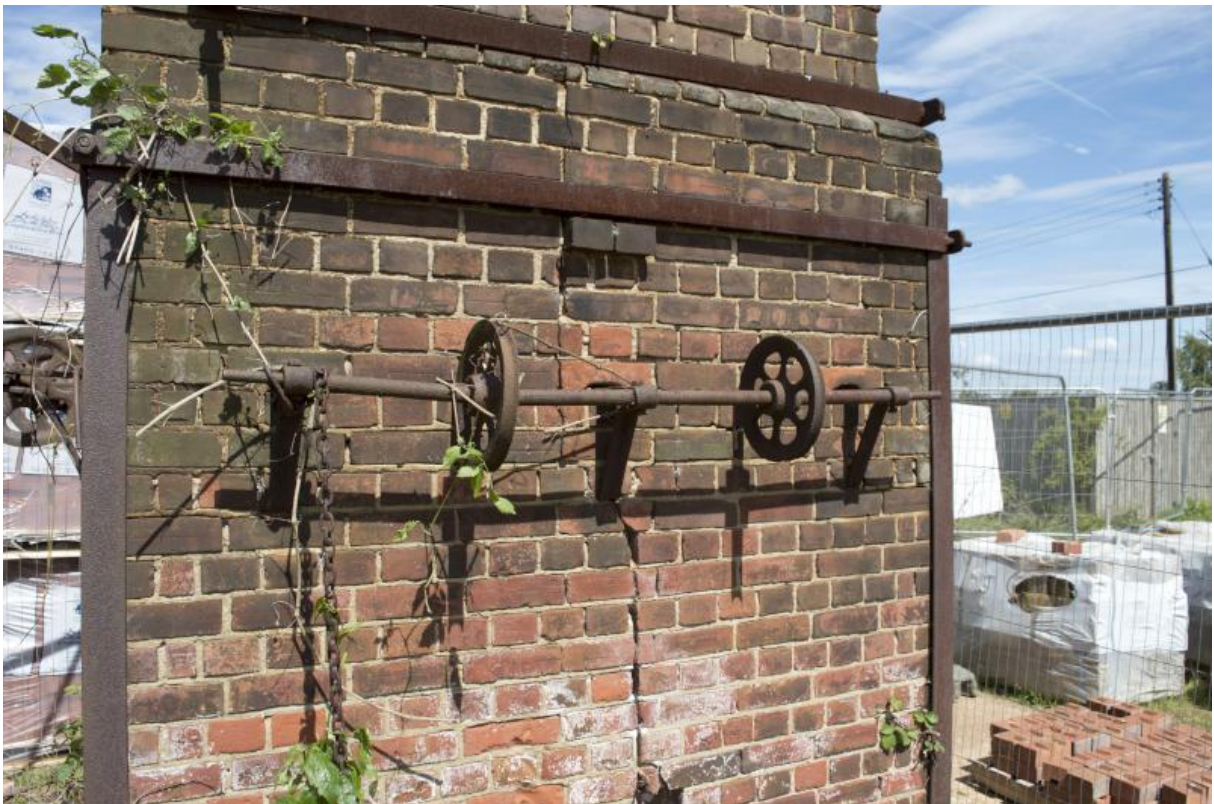
Plate 4: Detail of the pulley mechanism found on all but the north elevation of the chimney, facing north-east (191)

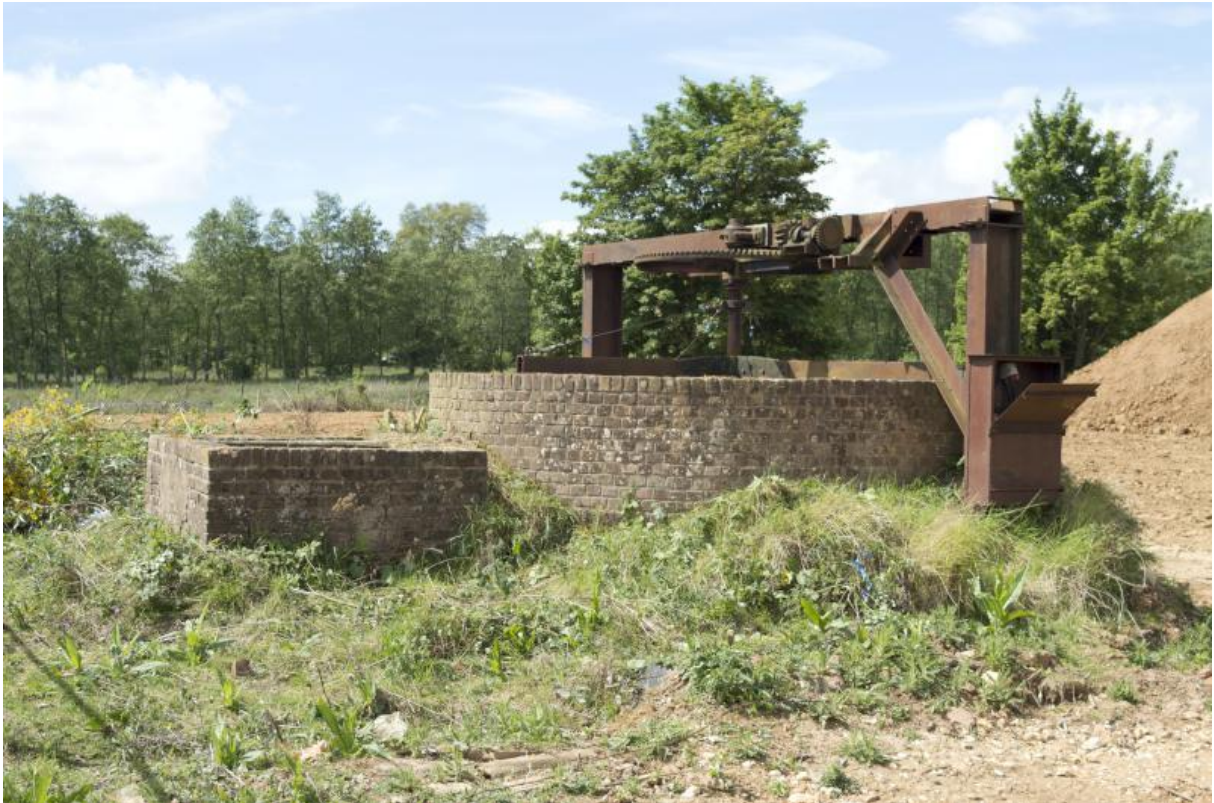
Plate 9: View of the clay wash mill and water tank after vegetation clearance works, facing south-west (161)

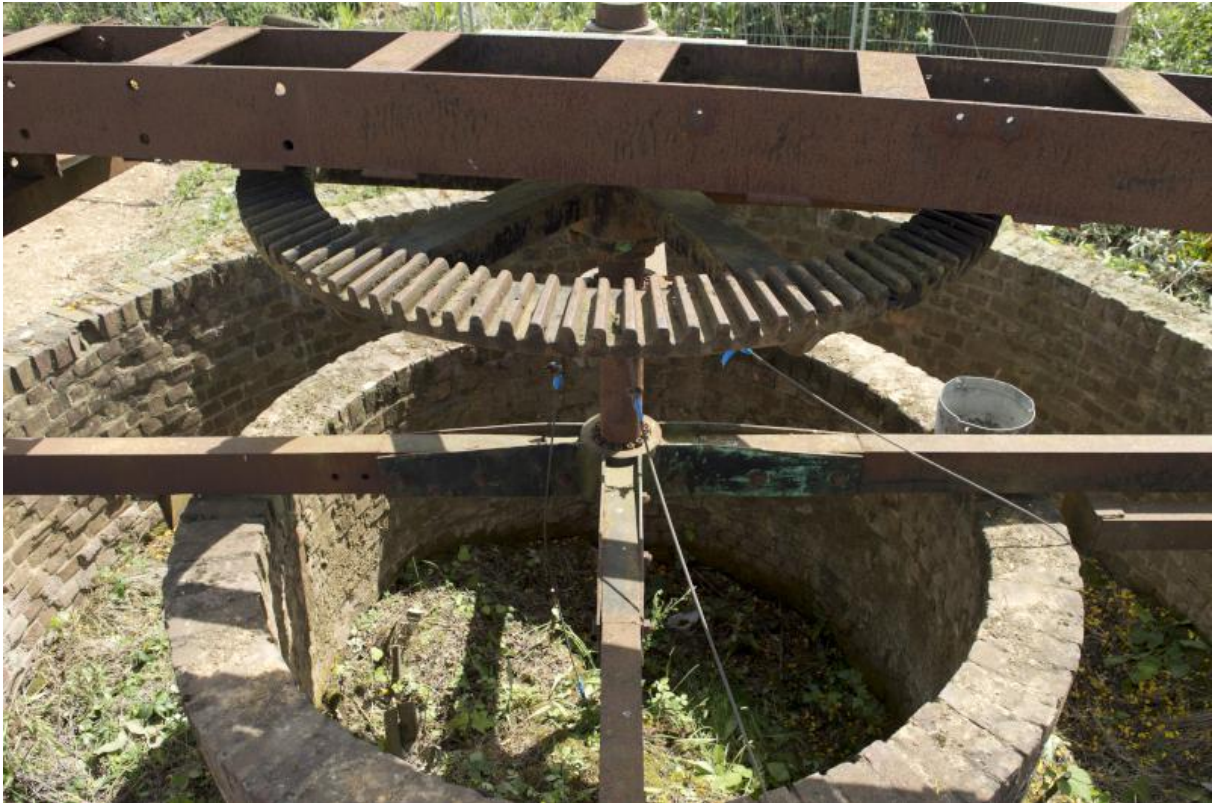
Plate 11: Detail of the mill mechanism (166)

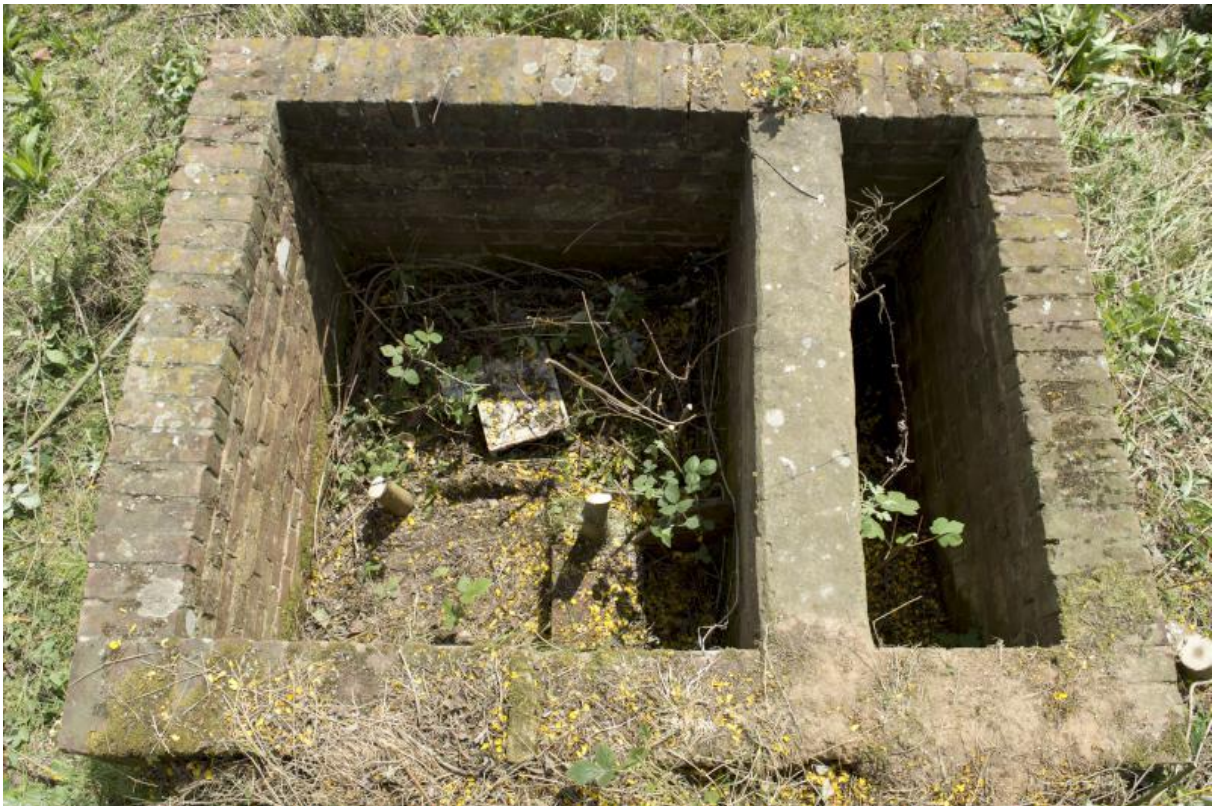
Plate 12: Internal view of the water tank, facing east (169)

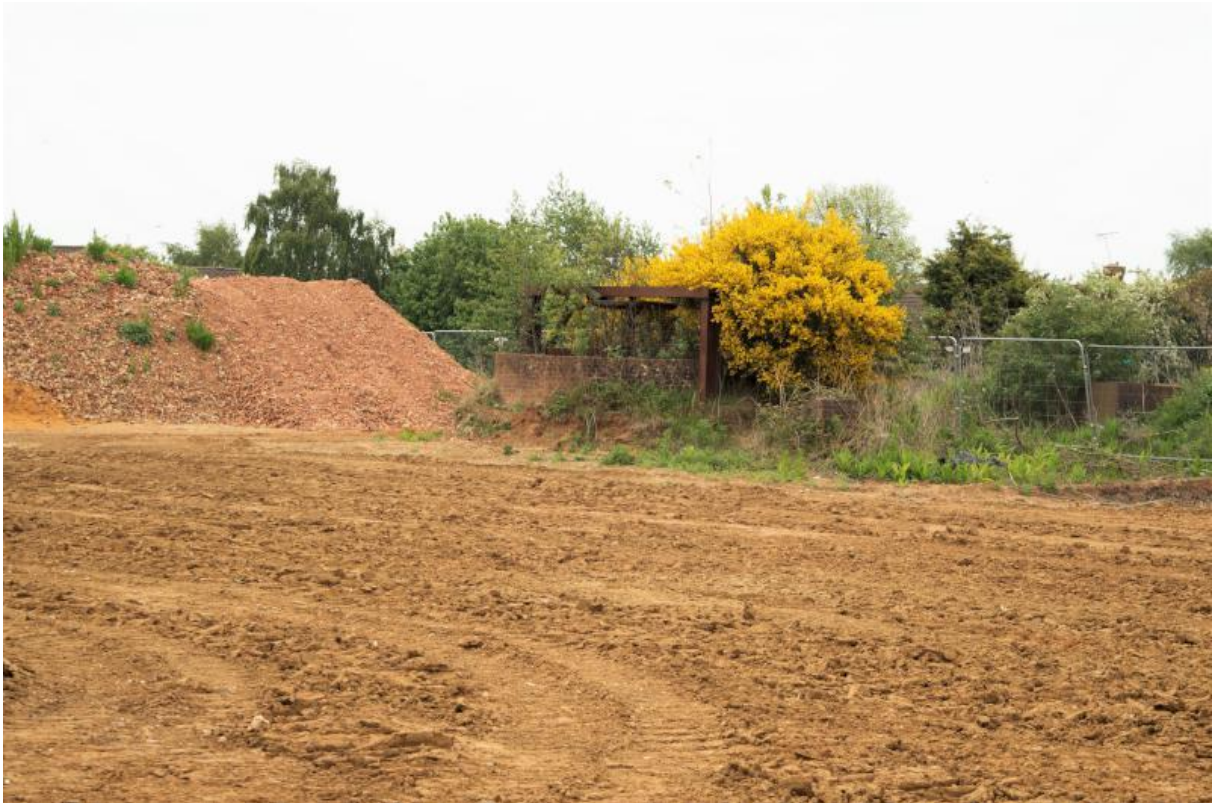
Plate 13: View of the clay wash mill prior to vegetation clearance, facing north-east (143)

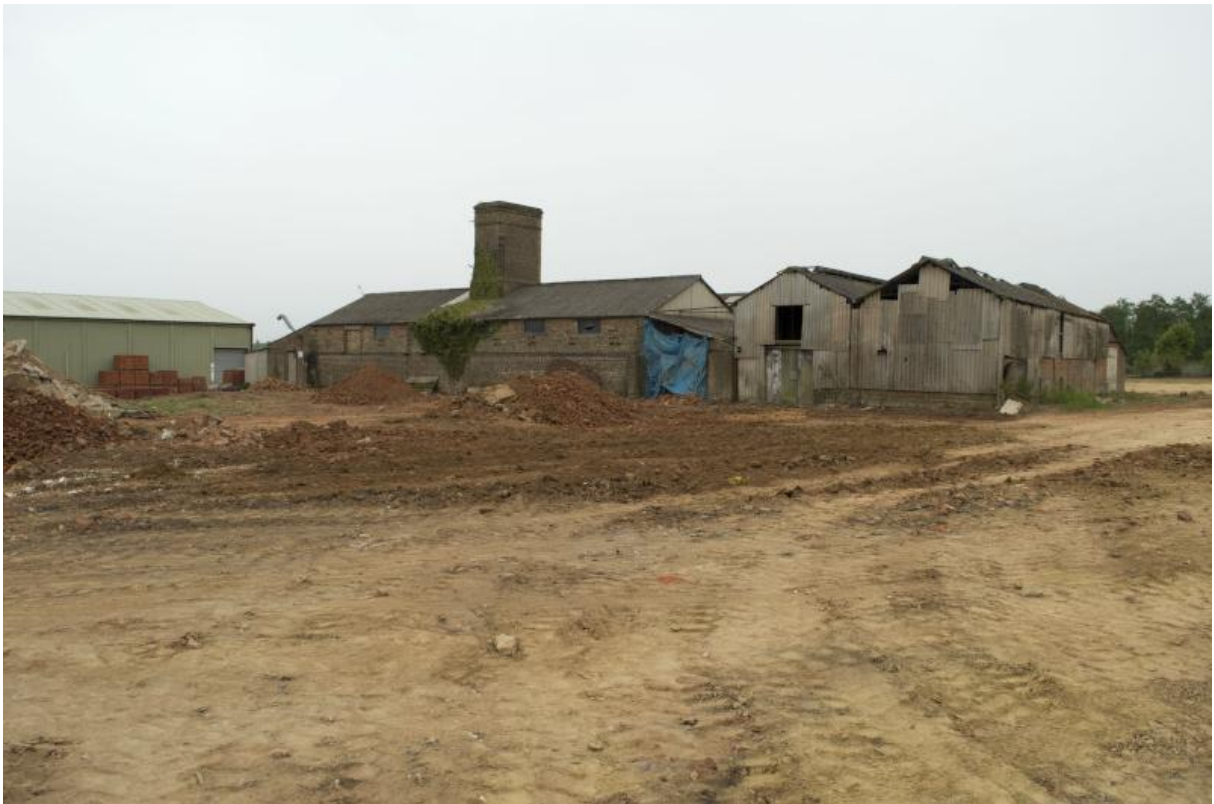
Plate 16: View of the main building, facing south-east (18)

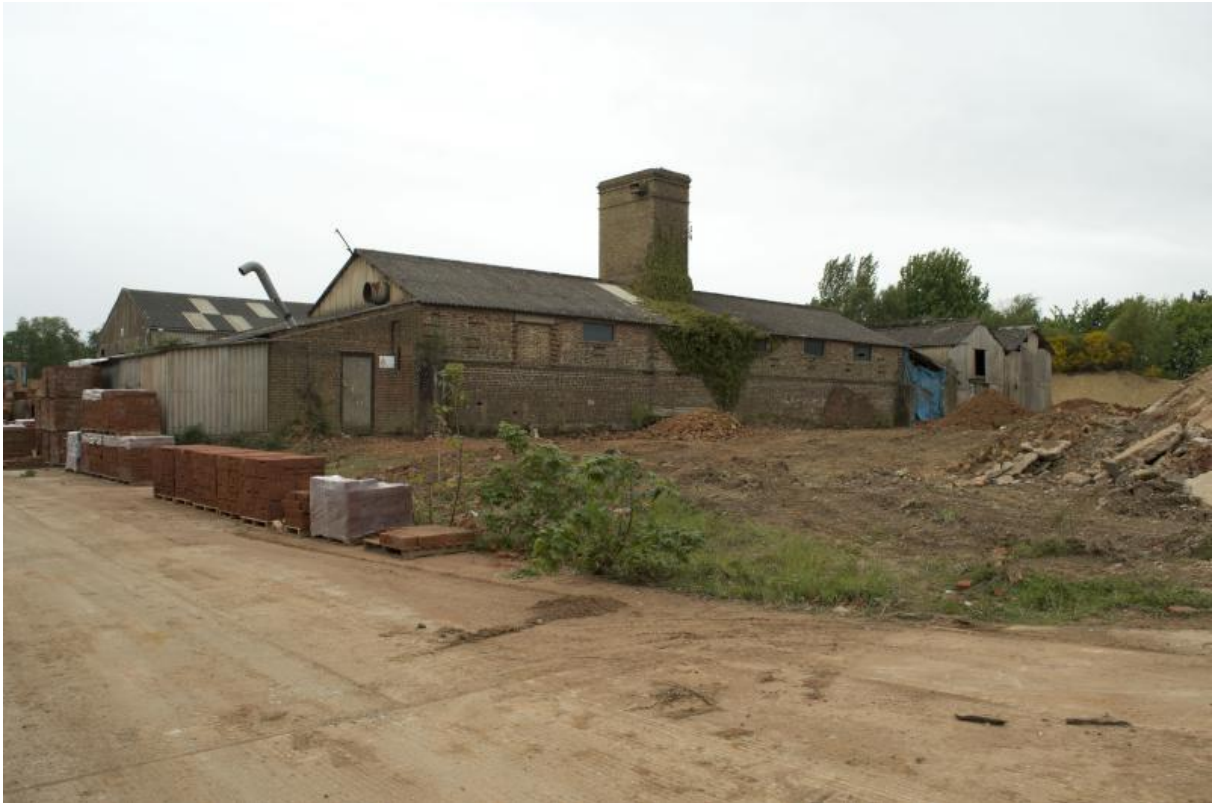
Plate 17: View of Range 1 (background) and Range 2 (foreground) of the main building, facing south-west (1)

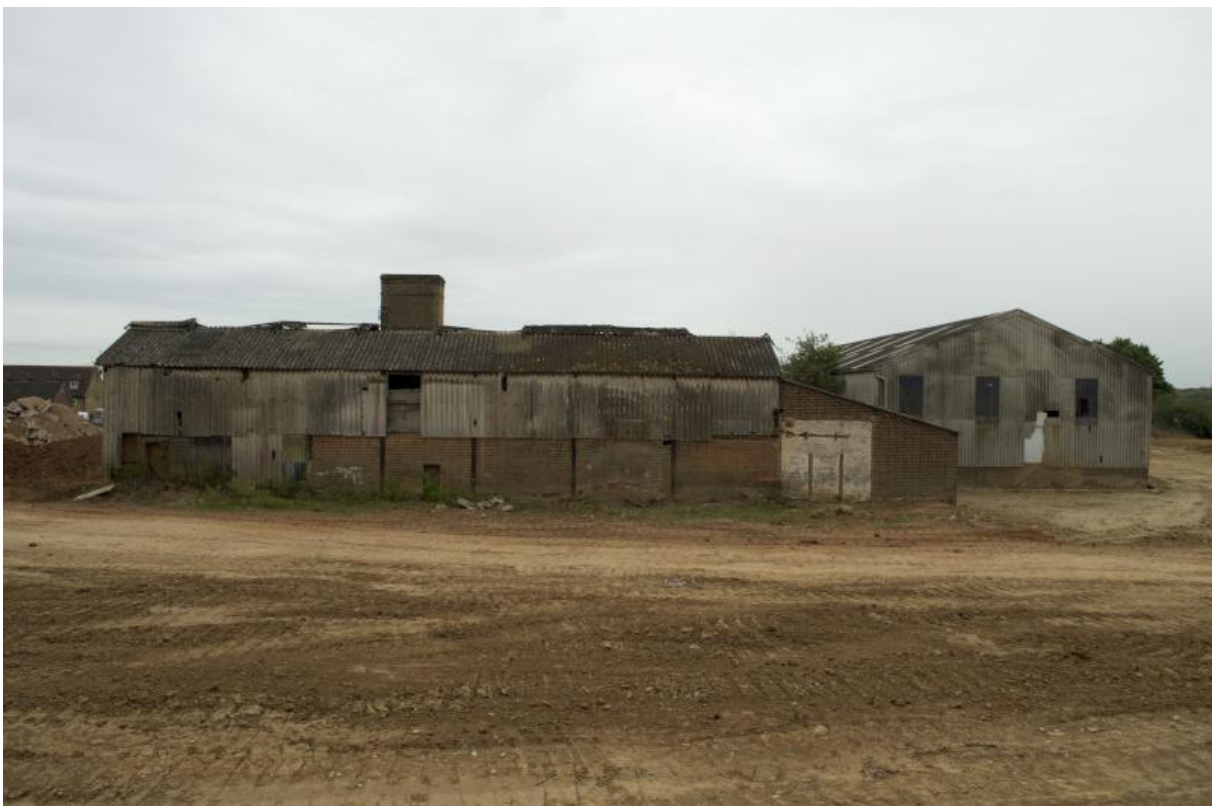
Plate 18: View of Range 3 of the main building, facing east (13)

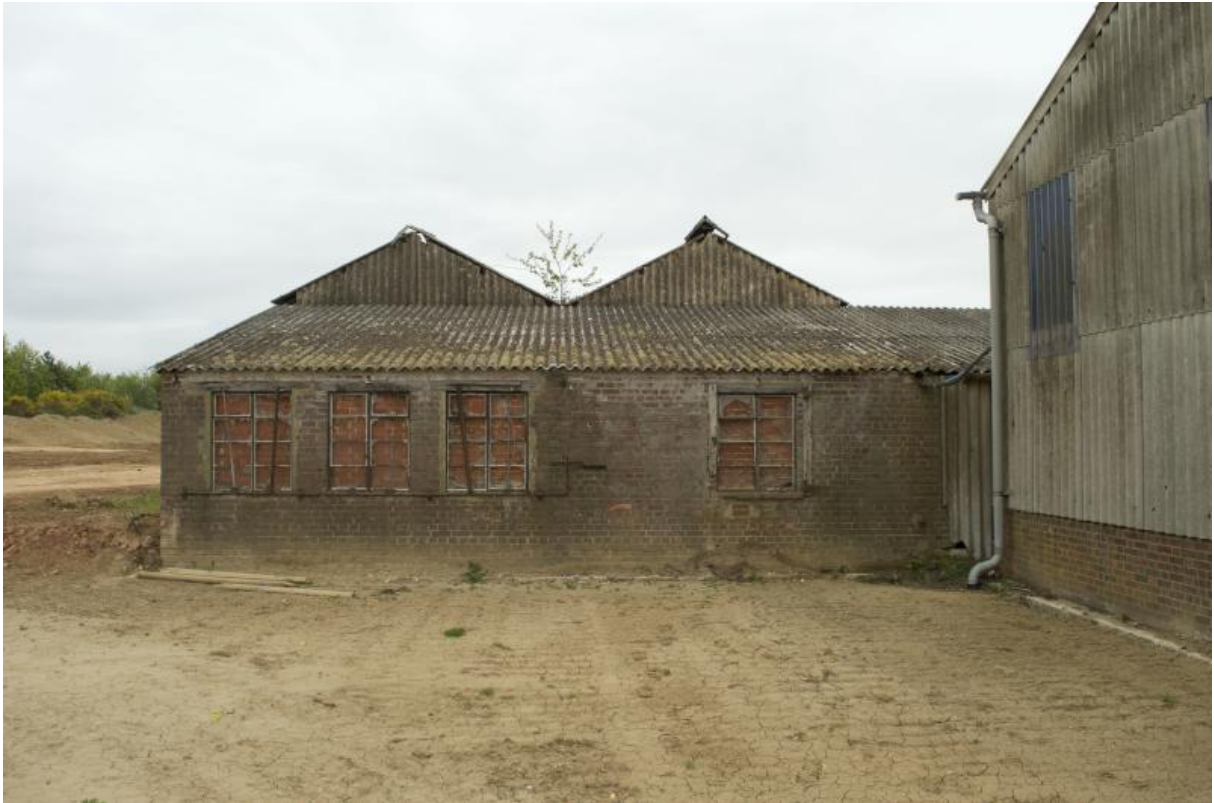
Plate 19: View of the south elevation of the lean-to addition to Range 3 of the main building, facing north (11)

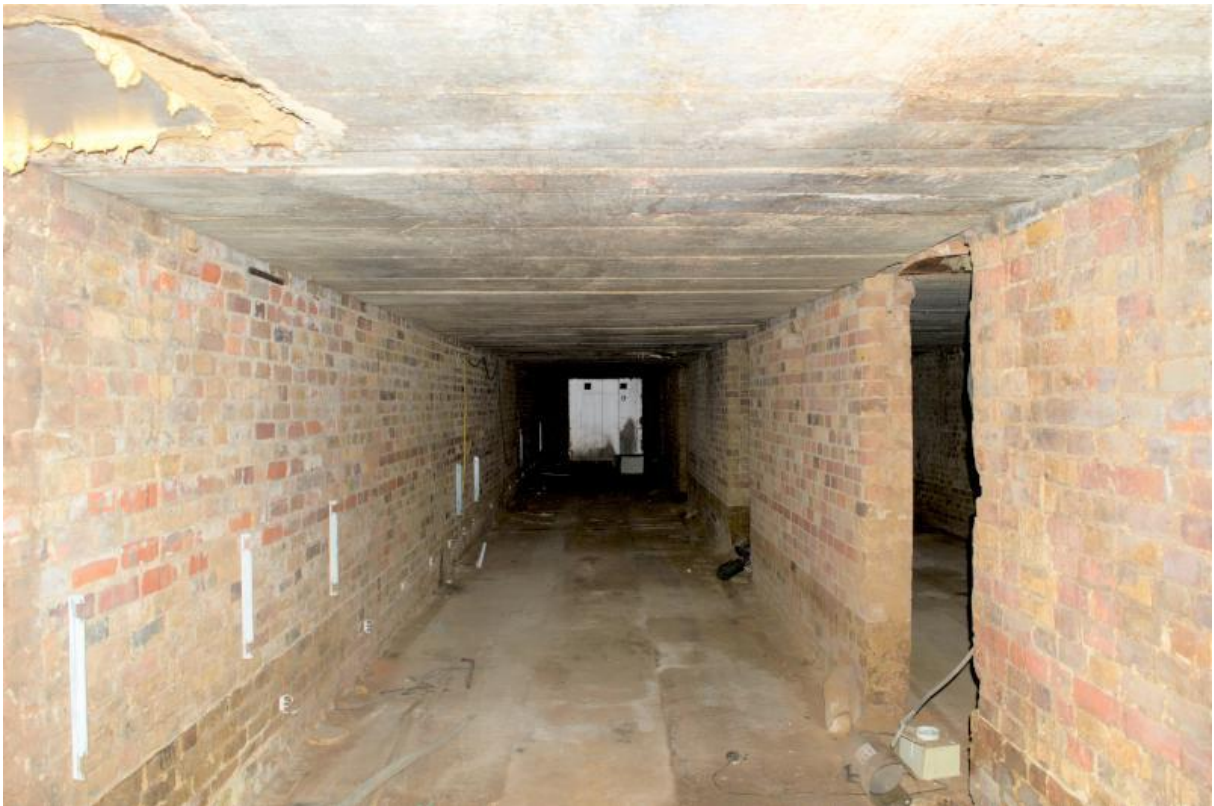
Plate 20: Internal view of No. 1 drying chamber within Range 1 of the main building, facing east (86)

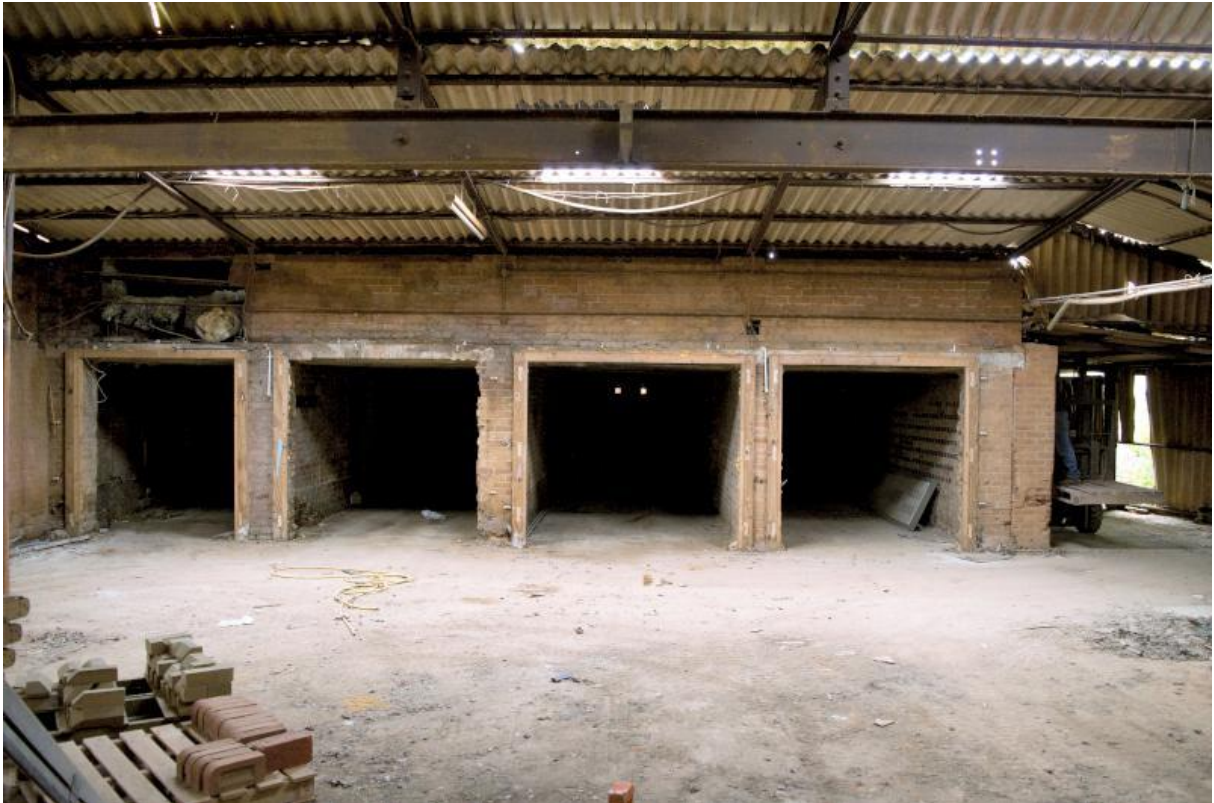
Plate 21: View of the internal entrances to the artificial drying chambers within Range 1 of the main range, facing east (49)

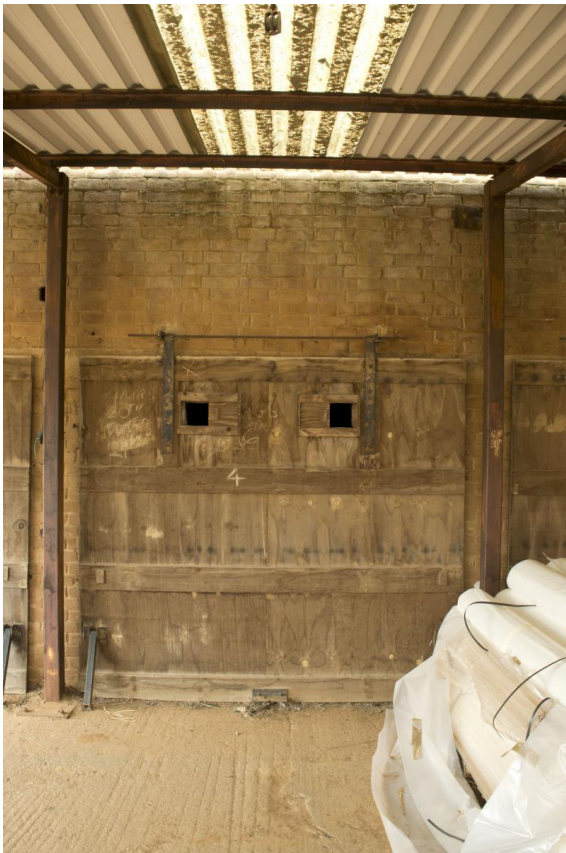
Plate 22: External door to No. 4 drying chamber within Range 1 of the main building, facing west (27)

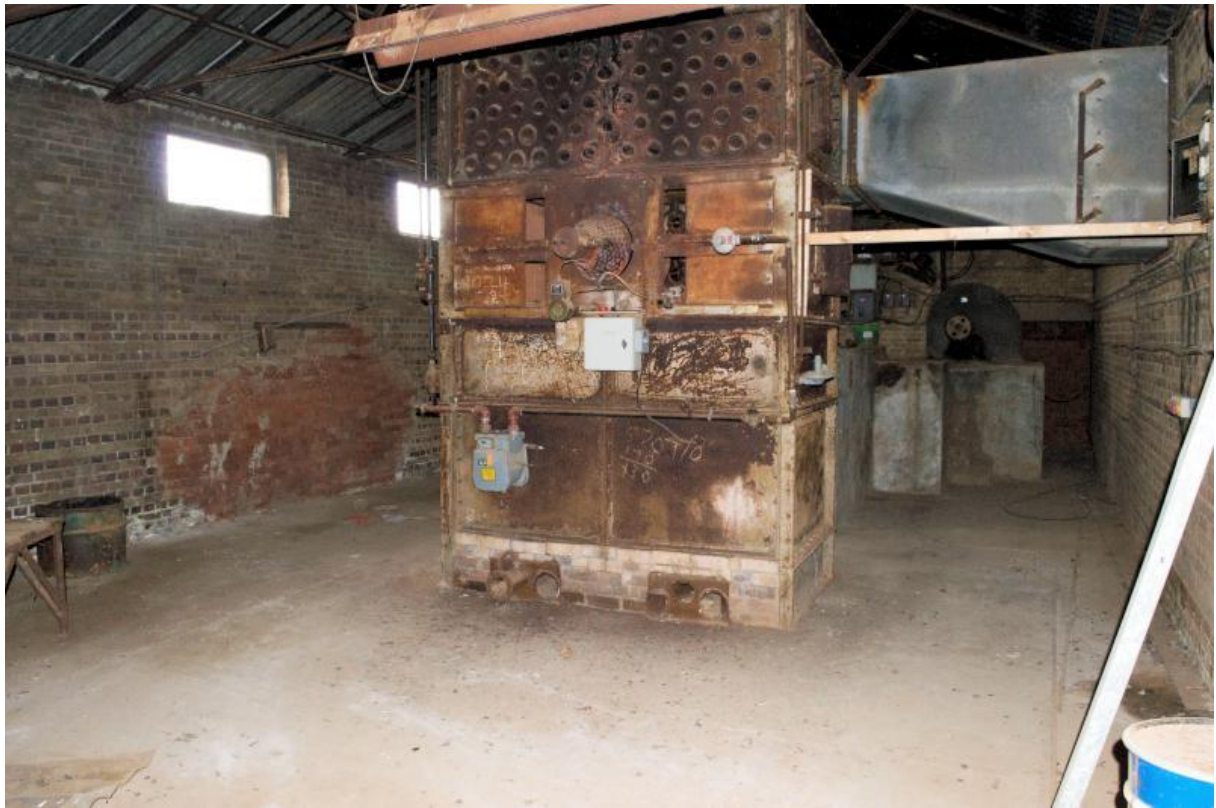
Plate 23: View of the western half of Range 2 within the main building, facing north-east (60)

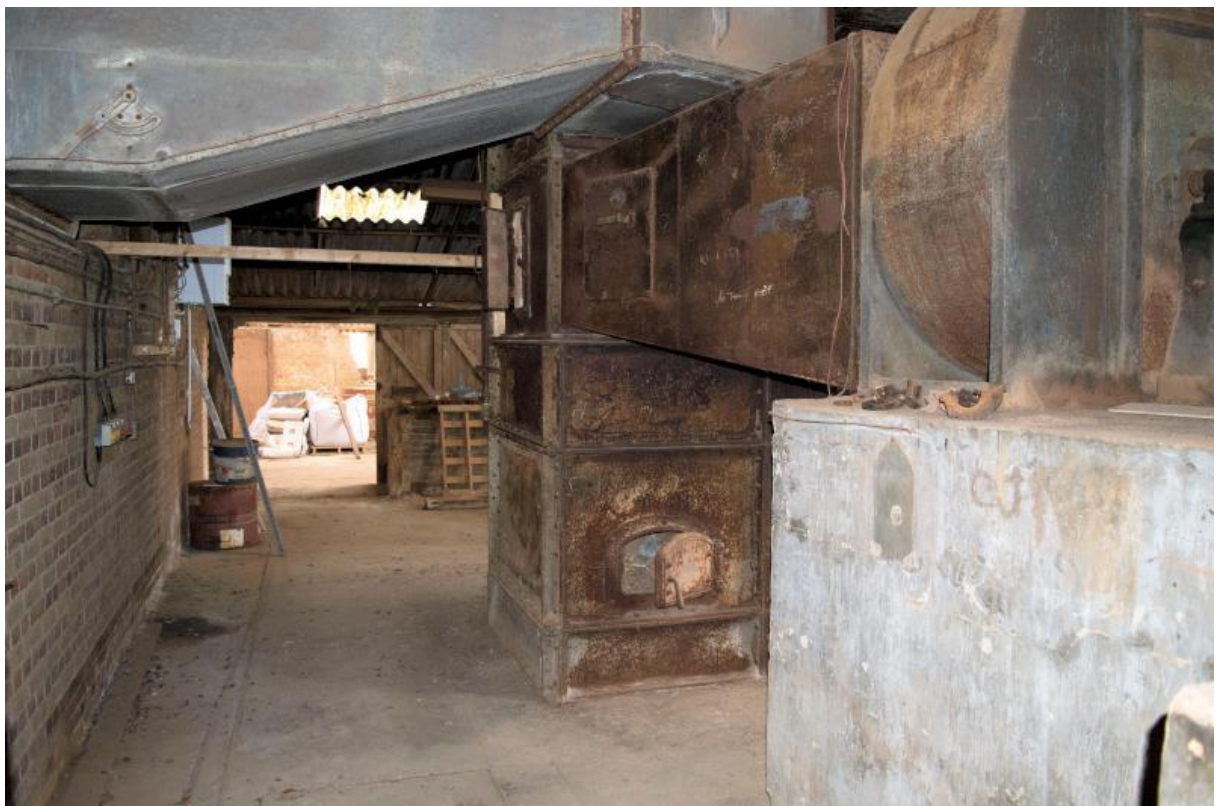
Plate 24: View of the Volex air heater used to heat the drying chambers, Range 2, western half, main building, facing west (67)

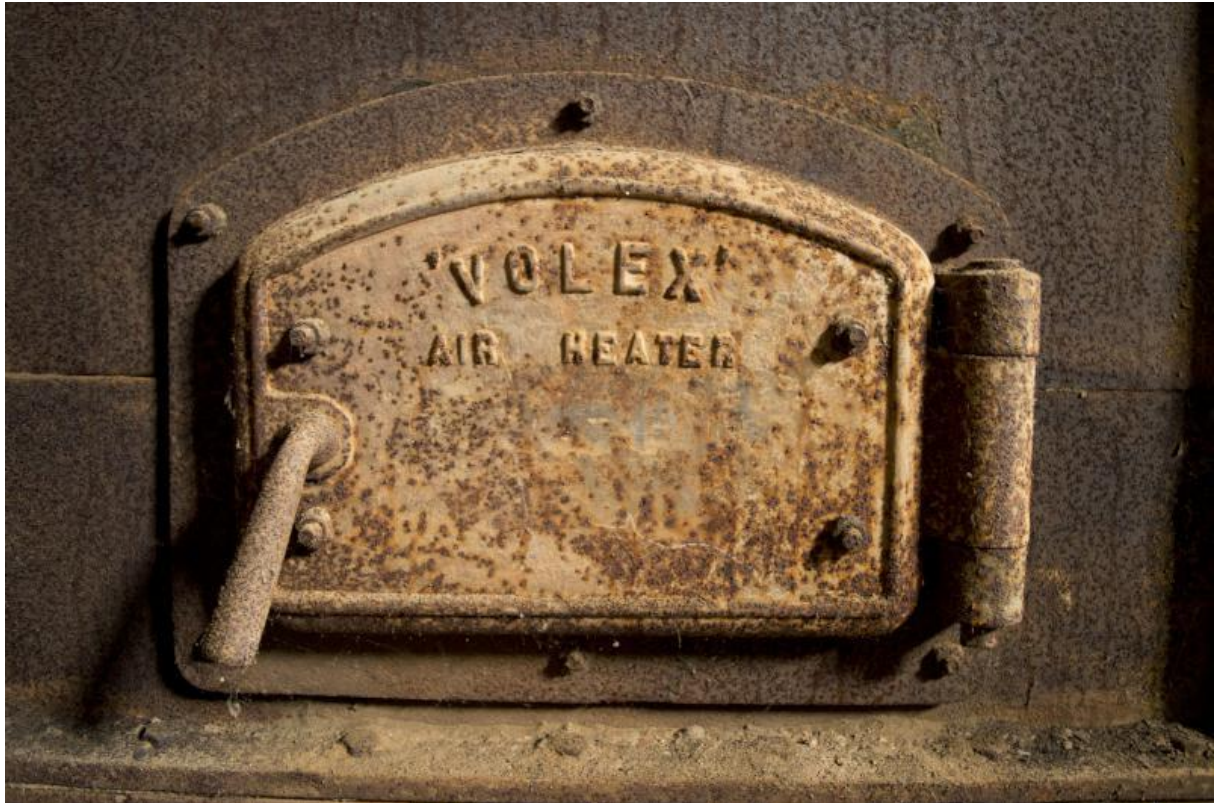
- 5.4.12 Range 2 is split centrally by the brick chimney. The west side (Plate 23) is entered internally via a series of timber-boarded single-leaf doorways which form the west elevation of the western extension. All floors throughout are cement, and the walls are constructed in English-bonded yellow stock brick, with red brick headers. A large rebuilt area of un-mortared English-bonded brickwork within the north elevation, replaces a section demolished by earth-moving machinery. The roof comprises a series of steel trusses, clad with asbestos sheeting, sections of which are lit using uPVC panes. This room contains the mid-20th century coal-fired Volex air heater with two Prior hopper underfeed stockers (Plates 24 and 25), which powered the

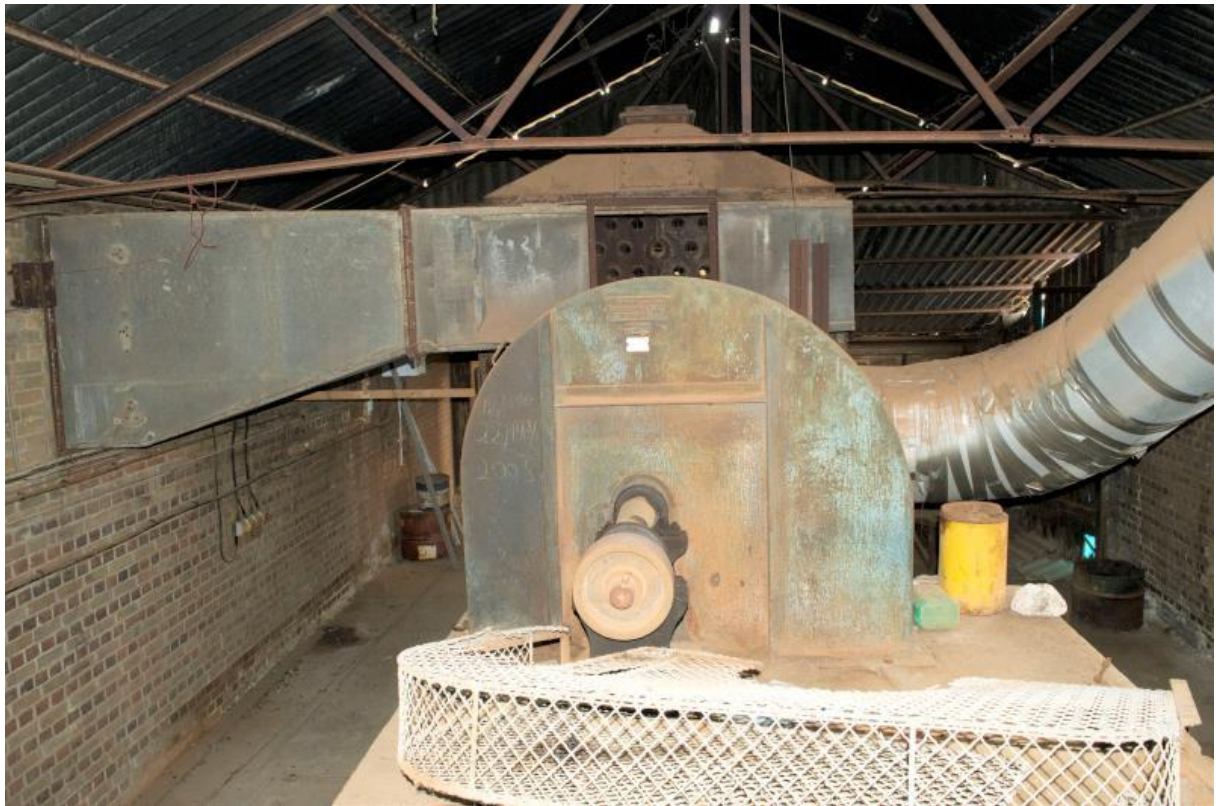
Plate 25: Detail of the Volex air heater within the western half of Range 2 within the main building, facing west (65)

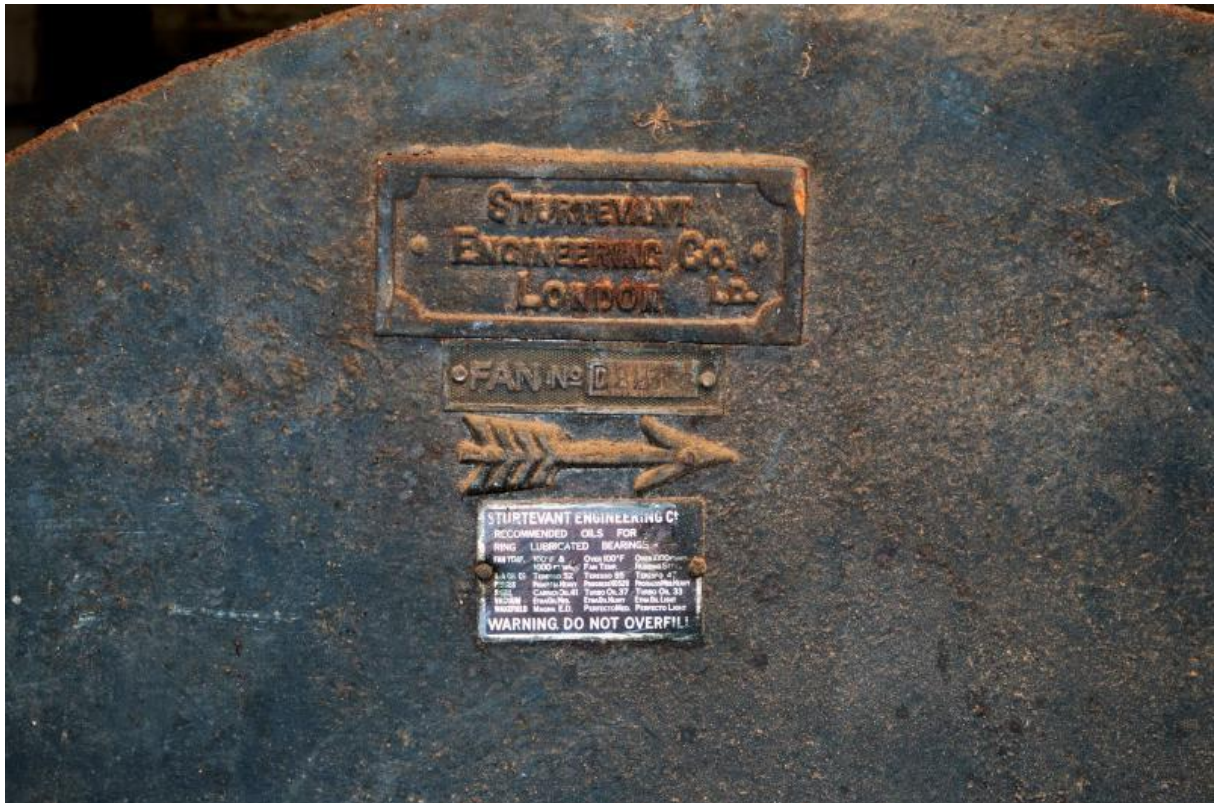
drying system for chambers within Range 1. Two large fans accompanying the heater, each branded with 'Sturtevant Engineering Co. London, Fan No. D22366' (Plates 26 and 27), are fitted to a substantial concrete plinth measuring a height of 1.3m, to the east side of the room. A series of openings punctuate the south wall and allow the passage of large steel air shafts into the southern chambers. The west elevation is made up of the central chimney stack. The base of the chimney supports a collection of mid-20th century 'Royal' electrical sockets, switchboards and breakers which operate the machinery within. The wall to the south of the chimney has a large blocked circular opening which formerly carried surplus heat from the kilns within the eastern half of the range, via ducts, into the drying chambers. A single timber-boarded pedestrian door is set to the north of the chimney, providing access into the eastern half of the range.

Plate 26: View of the Sturtevant fans within the western half of Range 2 within the main building, facing west (70)

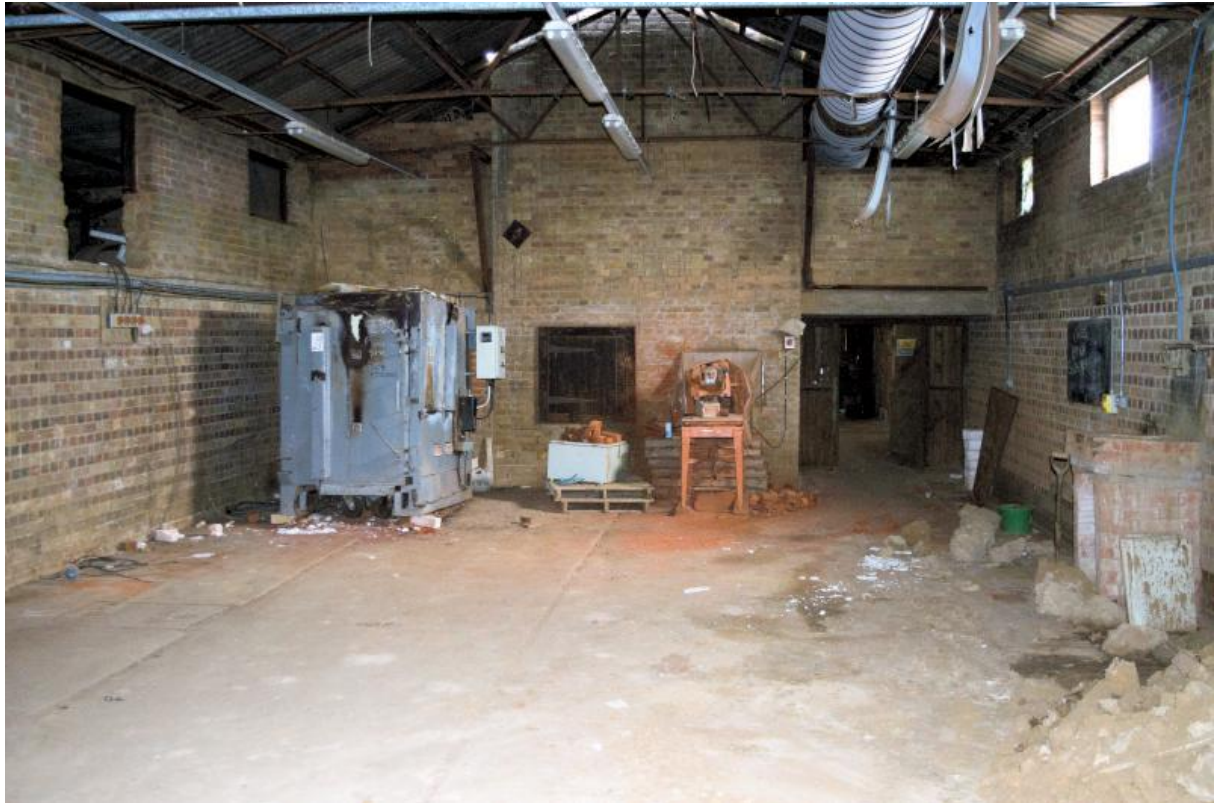
- 5.4.13 The eastern half of the range is predominantly empty, with floors, walls and roof arrangement, as elsewhere (Plate 28). The area served as a workshop, previously equipped with a pug-mill, used to mix and prepare the clay ready for brick moulding. The west elevation is formed by the chimney (Plates 29 and 30), which contains a timber-boarded stocking door at its base. The chimney served to dispose of the smoke, while the hot air was channelled through ducts to heat the drying chambers. Immediately to the north of the chimney is a work bench with clipper brick saw. To the south is a single modest-sized modern kiln, which was more recently heated by propane from a tank to the north of the building (now removed) (SECL 2014). The later extensions to the east side of the range provide shelved storage space for a large range of timber brick moulds (still *in situ*) (Plates 31 and 32).

Plate 28: View of the eastern half of Range 2 within the main building, facing east (75)

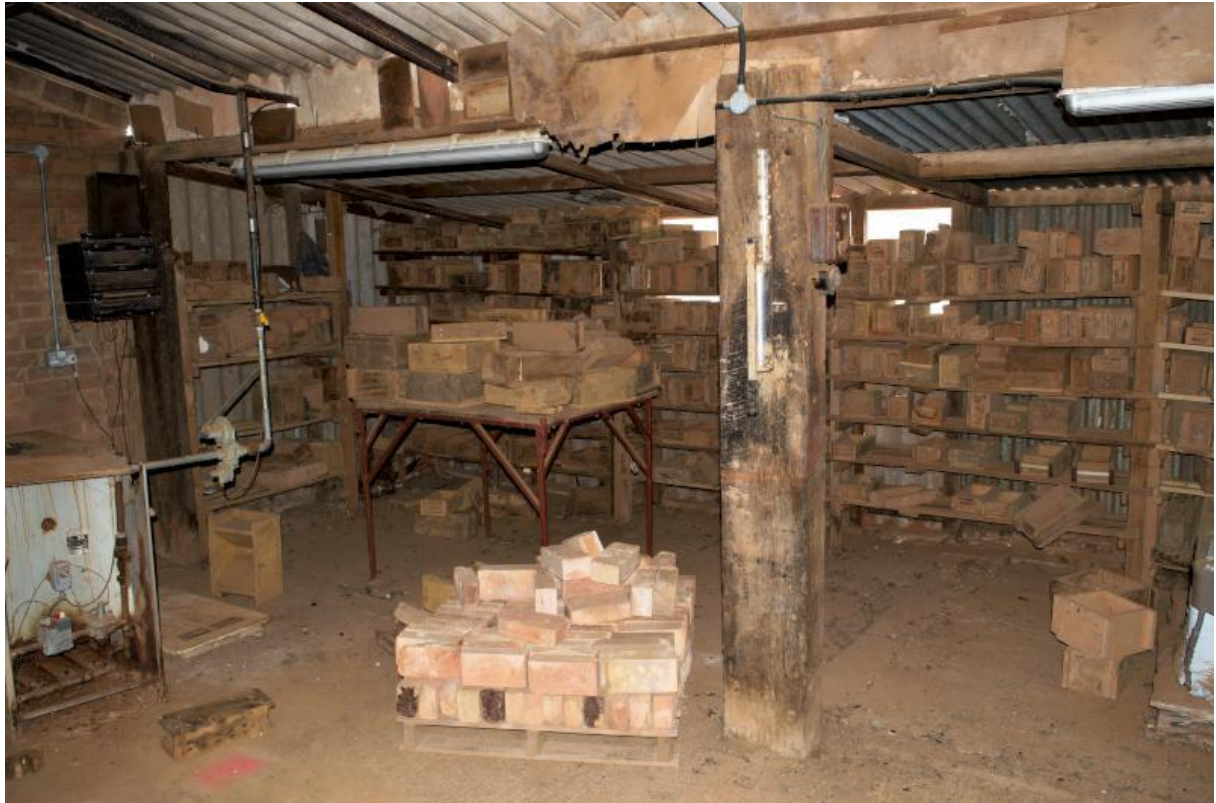
Plate 30: Detail of the chimney door and kiln heat overflow (blocked) within the eastern half of Range 2 within the main building, facing east (78)

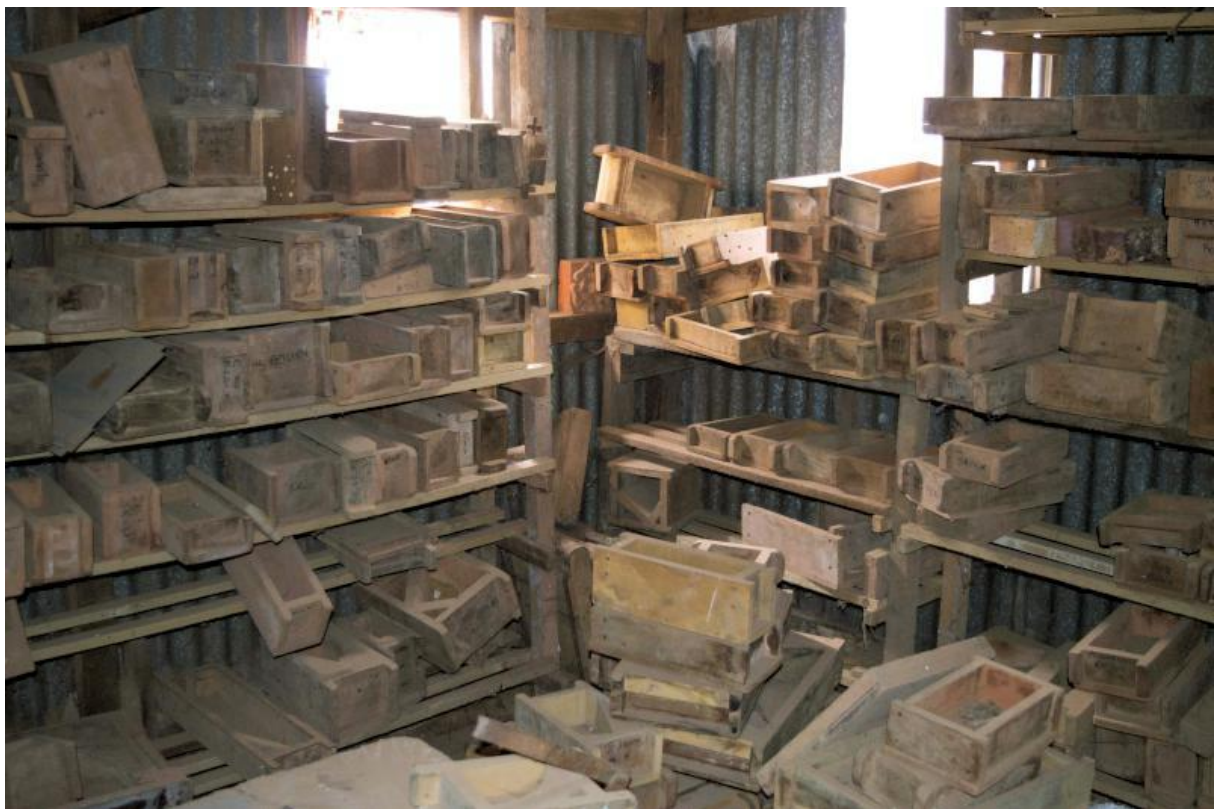
Plate 31: View of the brick mould storage within the eastern half of Range 2 within the main building, facing north-east (83)
