**Cremer & Whiting Brickworks, Sumpter Way,
Ospringe (Nr. Faversham), Kent, M13 7NT**

Historic Buildings Record

**Project no. 170341
Report No. 2017229
Site Code. COW17
OASIS ID. Archaeol6-286456**

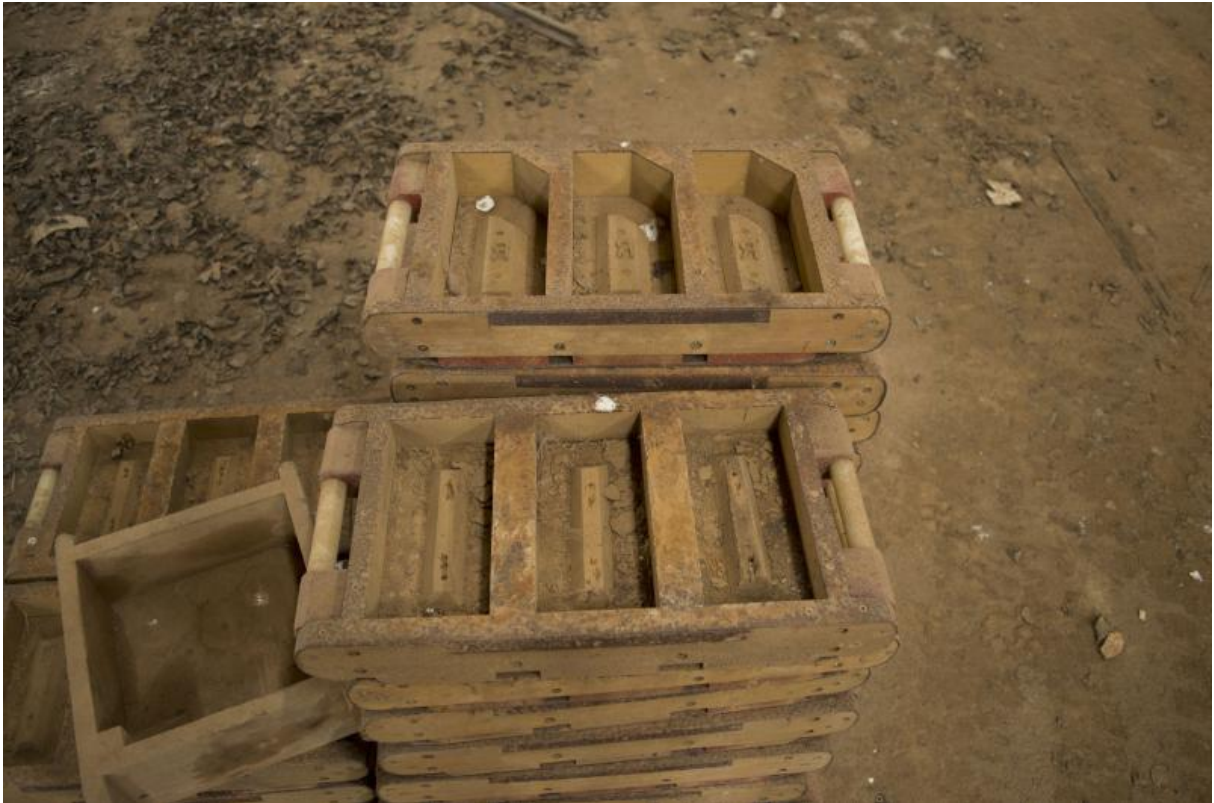
Plate 34: Detail of the treble brick moulds within Range 3 of the main building, facing north (47)

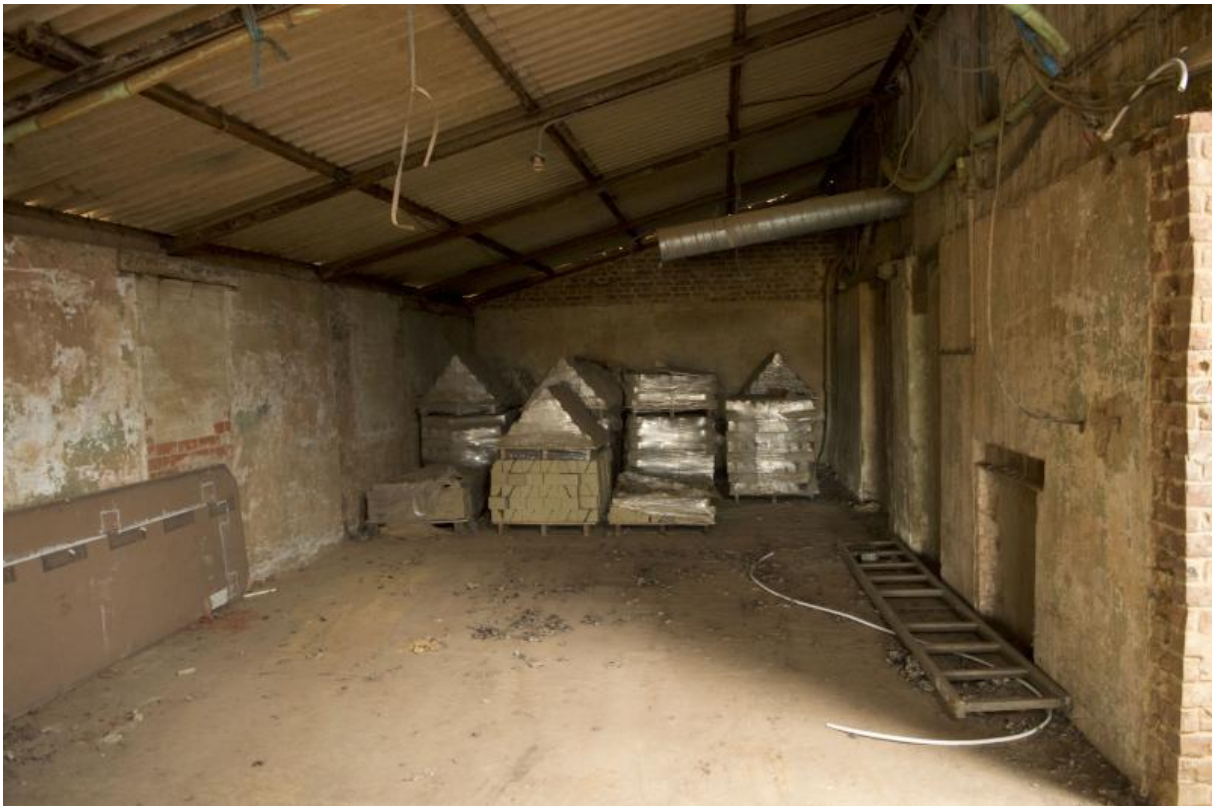
Plate 35: Detail of the treble brick moulds within Range 3 of the main building, facing south (48)

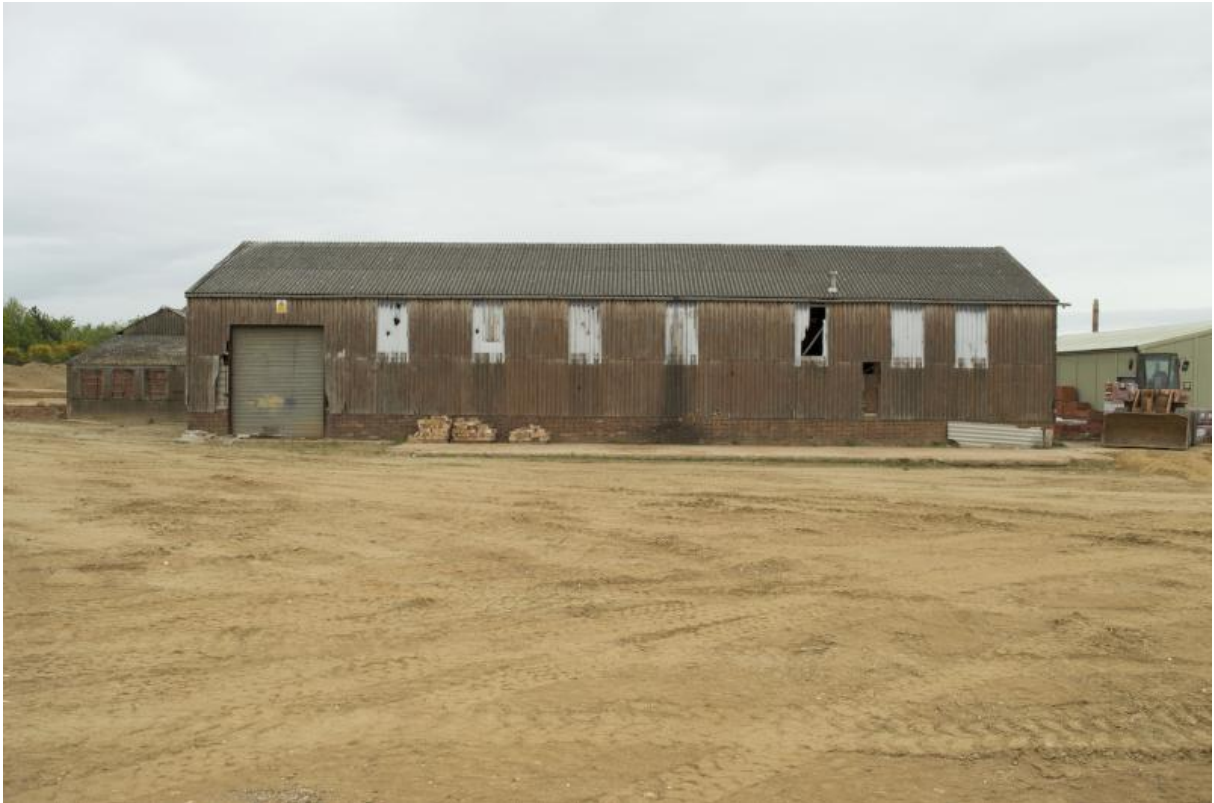
- 5.4.14 Range 3 (Plate 33) forms a relatively simple framework comprising a continuous concrete screed floor and internal brickworks walls (as elsewhere). Steel roof trusses extend above each of the six bays, characterised by vertically-laid narrow-gauge railway tracks, which run throughout the centre of the workshop. Sections of the asbestos-clad roof have been replaced with uPVC panelling for natural lighting. The central ridge line between the roof pitches is formed by half-round sections of asbestos sheeting and connected via metal valley gutters. The south elevation separating the range from the southern lean-to, has three blocked openings, two doorways and what appears to be a blocked fireplace for a former chimney, which has since been removed. The interior originally served as a workshop for the manufacturing of the bricks, including preparing the raw material (post washing and settling) for the moulding process. The space is now predominantly empty, retaining a large collection of treble timber brick-moulds (Plates 34 and 35), supplying evidence of the building's former use. The lean-to is currently in use as a storage facility of produced bricks (Plate 36).

Plate 36: View of the southern lean-to addition to Range 3 of the main building, facing west (36)

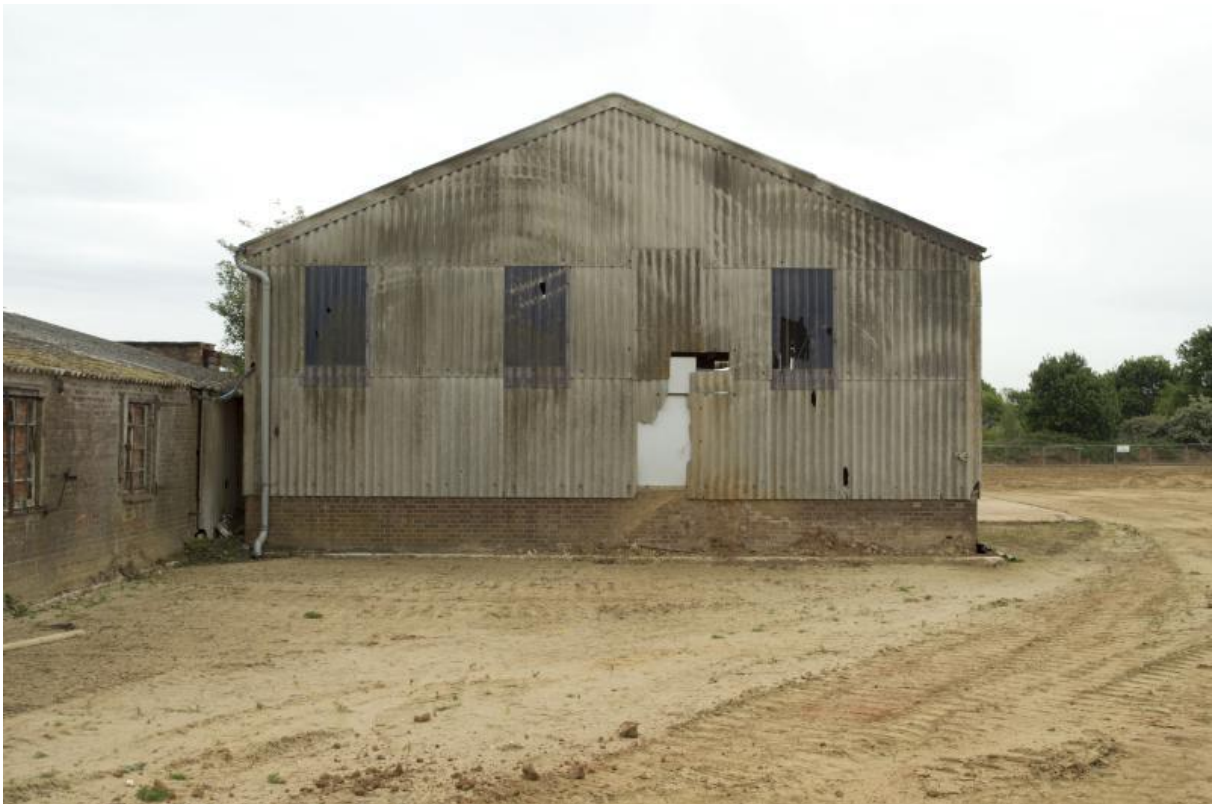
5.5.6 The making shed (Plates 37- was constructed to the immediate south side of the main building during the 1970s or 1980s and is first identifiable with certainty on the Ordnance Survey map of 1984. Aerial photography dating to 1990, shows the present construction to be the original form. The structure is rectangular in plan, and occupies a north-west – south-east alignment (hereafter simplified to east-west). The west end of the structure adjoins the main building on its south side. The external elevations are constructed in a combination of yellow and red brickwork, principally laid in a combination of English and stretcher bond. The western end of the north elevation is constructed using slim orange-red brick, laid in an un-mortared herringbone bond. The upper section of each wall is clad with asbestos sheet, which extends to the pitched roof. The roof is gabled to the east and west ends, and is constructed using simple steel trusses, dividing the interior into five bays. The structure is entered via a pair of double-width, roller shutter doorways, situated at its western end. The interior has been emptied, except for brick storage. A large opening within the east elevation previously served brick-making machinery in this corner with brickearth (SECL 2014).

Plate 37: South elevation of the making shed, facing north (7)

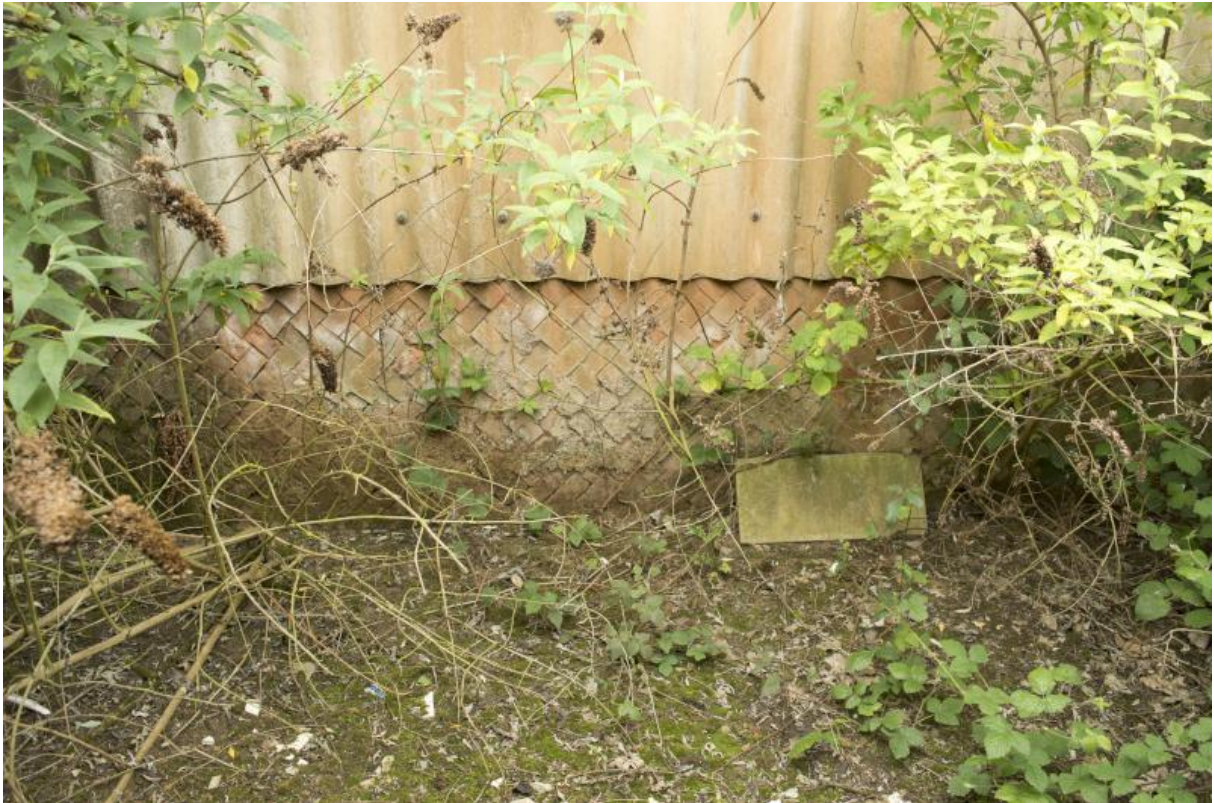
Plate 38: West elevation of the making shed, facing east (10)

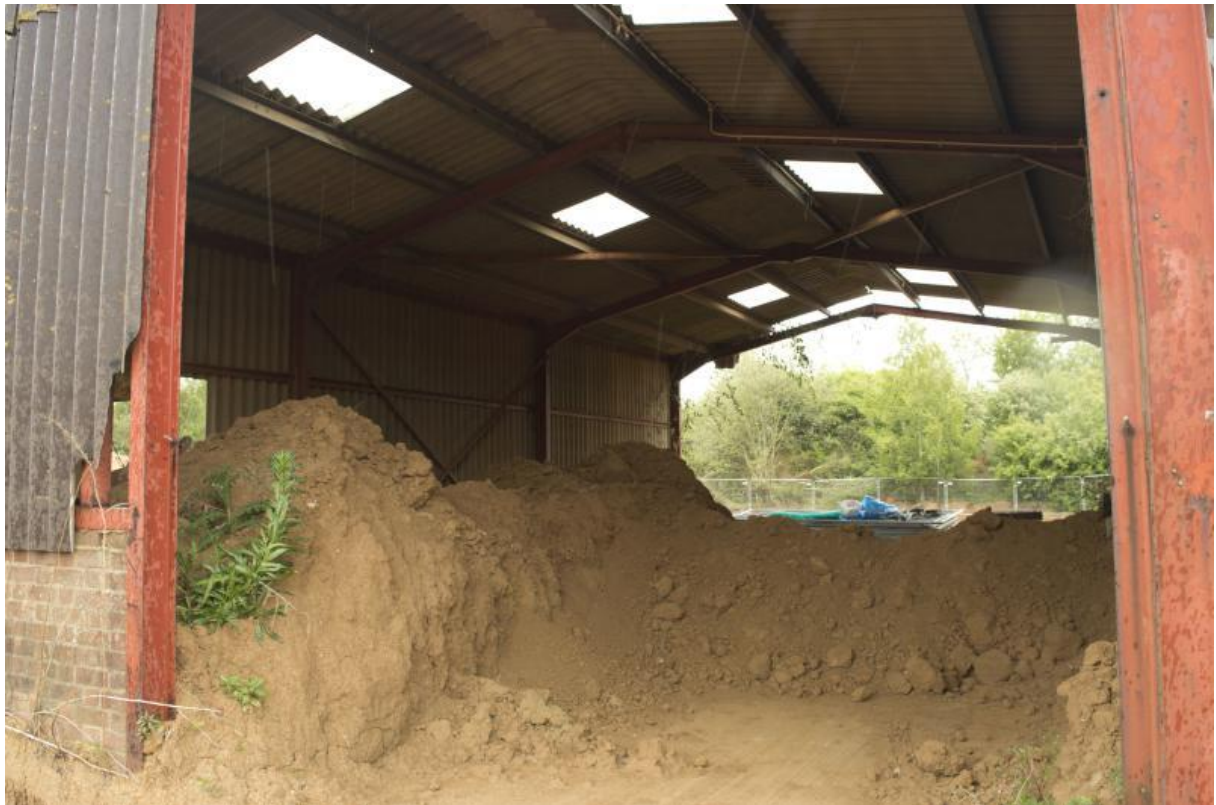
5.7.6 Located to the north of the site is a medium sized rectangular shed, aligned north-east – south-west (Plates 44 and 45). The shed consists of a single storey, with pitched roof, gabled to the north-east and south-west end. The shed appears to have been built during the 1980s and 1990s, between the completion of the Ordnance Survey map of 1984 and aerial photography dating to 1990. The frame of the building is of steel, filled at its lower level with Flemish-bonded orange brickwork, above which it is clad with corrugated asbestos sheets. The shed has large openings on its south-west and north-east sides and contains a mound of brickearth. The structure is lit via uPVC panels which have been inserted into the asbestos sheet clad roof. The structure is ideally located between the northern yellow stock brick and southern red brick manufacturing halves of the site. It is likely to have been constructed to store brickearth being transferred from the northern site half, and a new extraction area of red brickearth east of Bysing Wood, which opened in 1987 after brickearth supplies within the southern half of the site became depleted (SECL 2014; Twist 1984).

Plate 44: South-west corner of the storage shed, facing north-east (101)

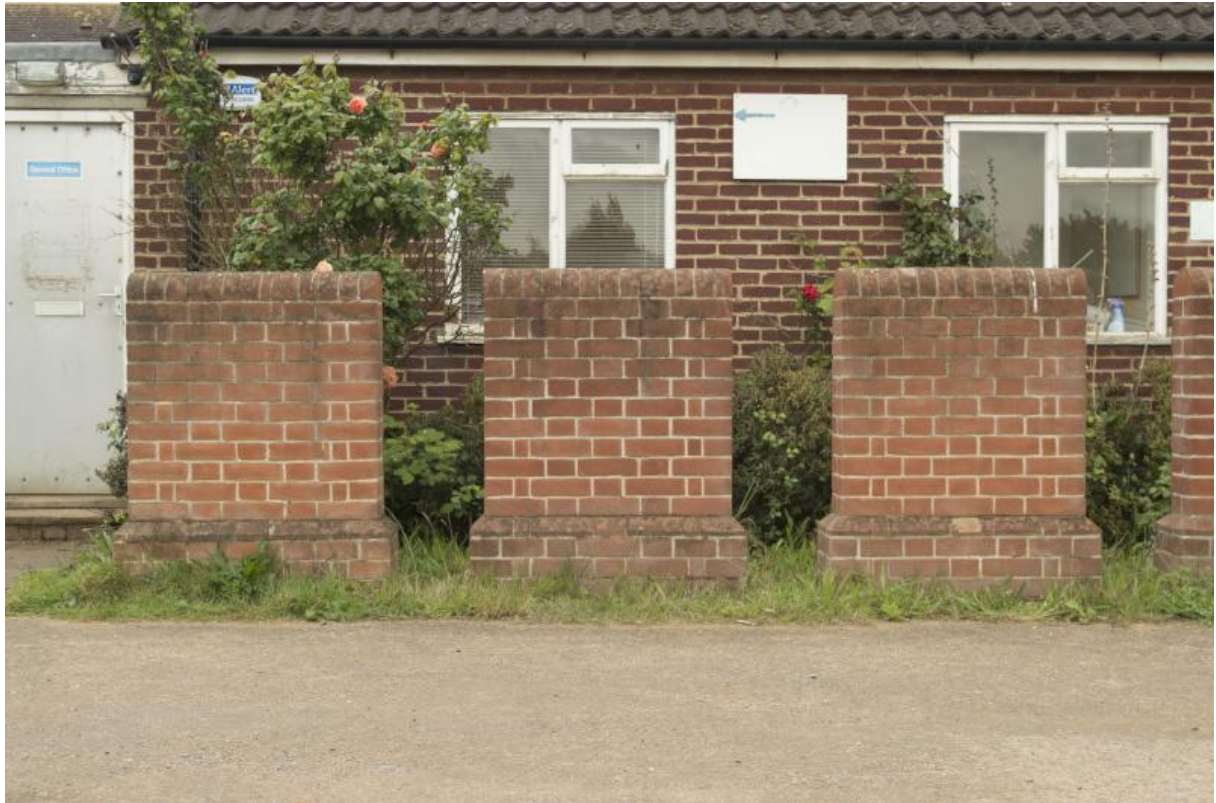
Plate 46: Principal west elevation of the site office, facing south-east (127)

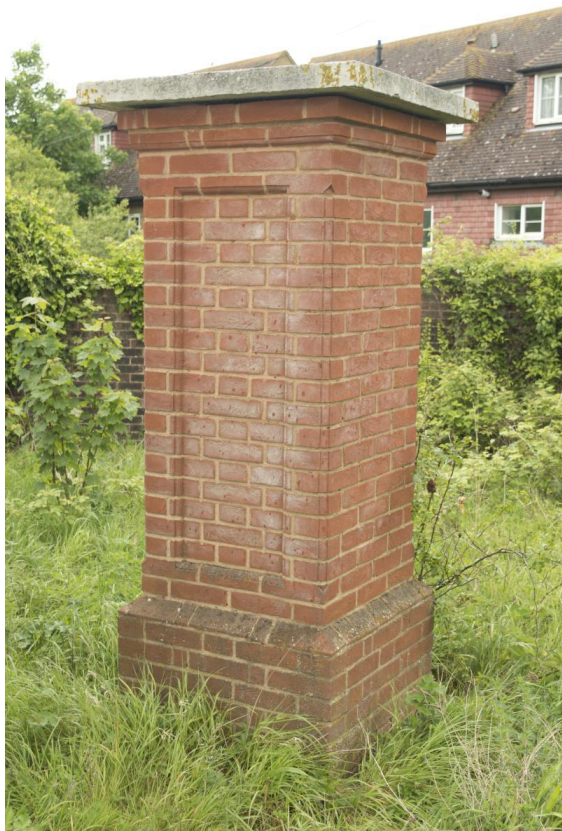
Plate 47: Detail of the brickwork mock-ups built outside the principal elevation of the site office, facing east (128)

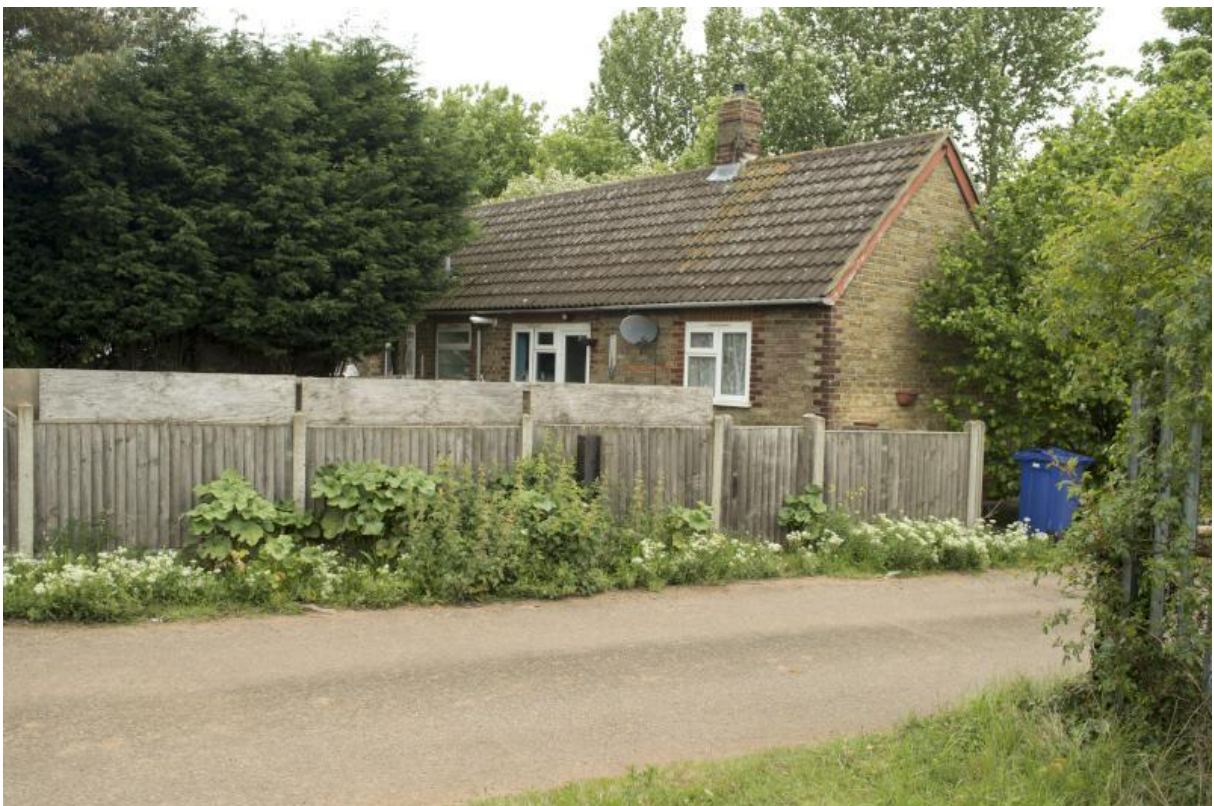
5.9.6 To the west of the site entrance stands a residential bungalow of modern construction (Plates 49 and 50). The structure forms a single-storey, T-shaped building, constructed in yellow brick laid in stretcher bond, with red brick dressings. The roof is pitched and is covered with tiles. All windows and doors are of modern uPVC type. The main entrance faces south-east towards the brickworks driveway. A rectangular structure is shown in roughly the same location of the bungalow from the 1940s until the 1984 Ordnance Survey mapping. The bungalow in its present T-shaped form is first shown clearly on aerial photography of the site dating to 1990. Its external appearance is modern; the interior was not surveyed due to access limitations.

Plate 49: Principal south-east elevation of the bungalow to the west of the main site entrance, facing south-west (115)
